Investigation Report

Type of Occurrence: Serious Incident

Type: B737-8AS

State File Number: BFU18-0975-EX

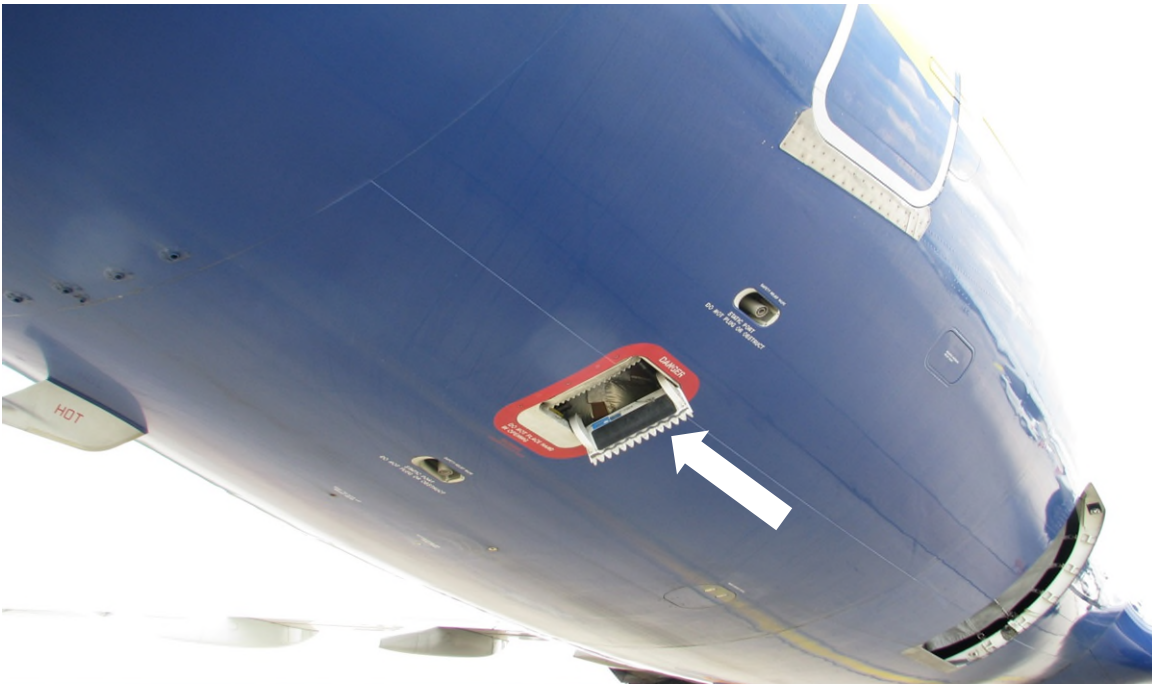
Fig. 4: Outflow valve in open position (arrow)

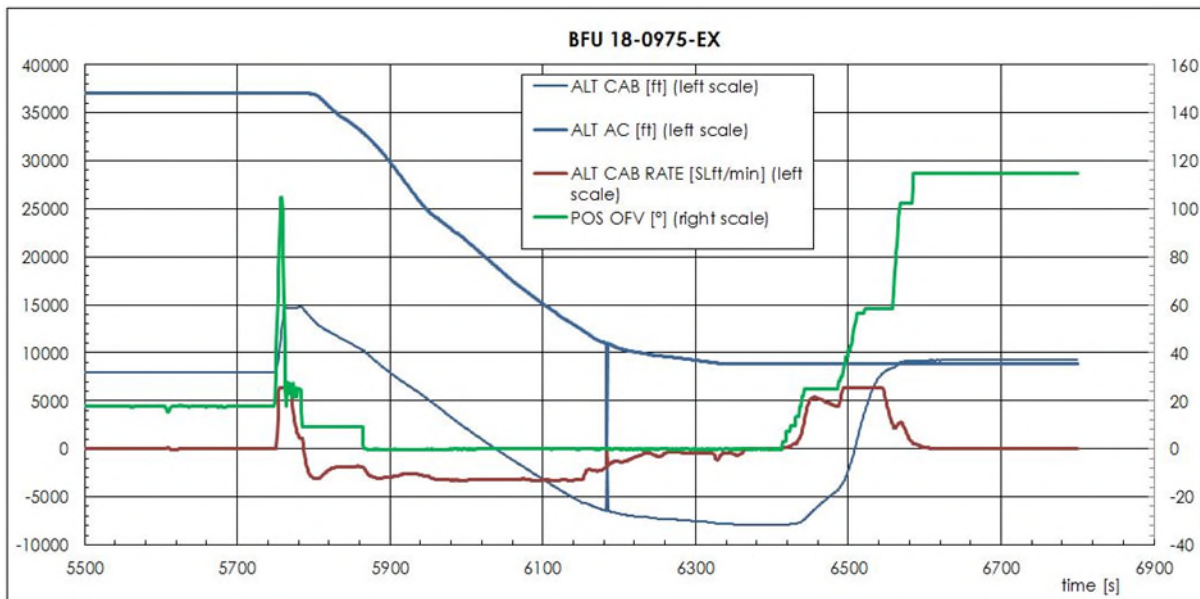
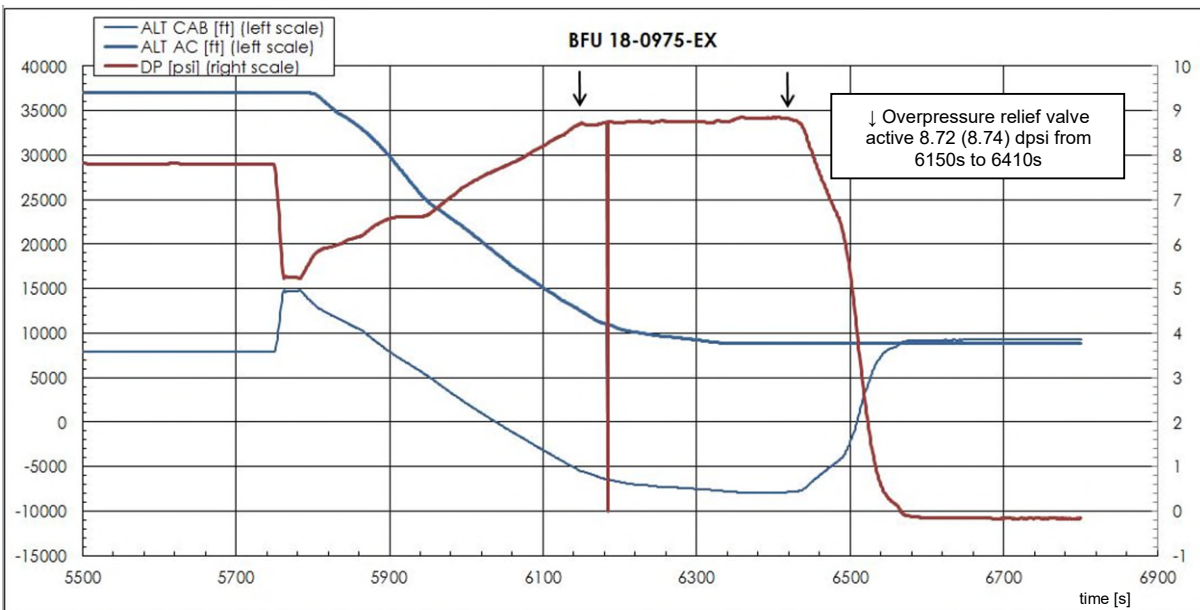
Fig. 9: Operating parameters pressurized cabin 1/2

Fig. 10: Operating parameters pressurized cabin 2/2

The analysis of the main reason for the movement of the OFV showed that it is highly likely that the opening of the OFV was caused by a damaged data record from a Single Event Upset. In the scope of a software analysis, it was possible to prove the sensitivity of this type of CPCs to SEUs. [...]

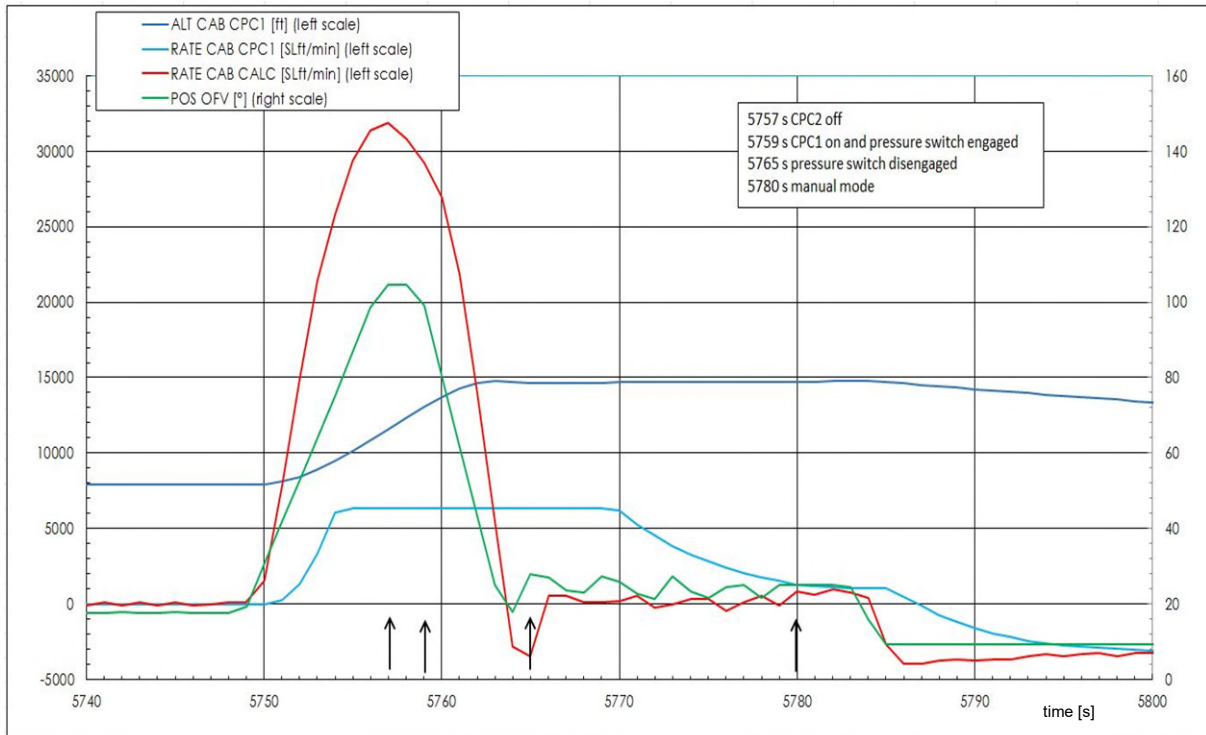
[...] The oscillation after the first pressure switch activation was caused by repeated control transitions between the pressure switch and the automatic control of CPC1. At the time of the first deactivation of the pressure switch, the cabin rate of descent was 3,420 ft/min. In this situation, the command variable of the CPC was 350 ft/min. Accordingly, the CPC commanded reopening of the OFV and the pressure switch was triggered again. This resulted in damped oscillation and the system reached normal operating mode after a few cycles with a cabin rate of descent of 350 ft/min.

Fig. 12: Oscillation of the OFV after pressure switch activation

After the CPC 2 failure, the cabin pressure altitude continued to increase. Due to swift OFV control switches between the remaining CPC and the pressure switch, OFV oscillation lasting for several seconds occurred. This unwanted type of control occurred

After CPC 2 was automatically deactivated, the OFV began to oscillate which caused the cabin pressure to increase further. The oscillation was caused by the rapid change of control between the pressure switch of the OFV and CPC 1.
