## FINAL REPORT

**AAIU Report No: 2010-002**  
**State File No: IRL00909037**  
**Published: 03/03/10**

<b>Aircraft Type and Registration:</b>	Boeing 757-28A, C-GTBB
<b>No. and Type of Engines:</b>	2 x Rolls-Royce RB211-535
<b>Aircraft Serial Number:</b>	32447
<b>Year of Manufacture:</b>	2001
<b>Date and Time (UTC<sup>1</sup>):</b>	29 May 2009 @ 01.53 hrs
<b>Location:</b>	Dublin Airport (EIDW)
<b>Type of Flight:</b>	Public Transport
<b>Persons on Board:</b>	Crew - 8          Passengers - 198
<b>Injuries:</b>	Crew - Nil          Passengers - Nil
<b>Nature of Damage:</b>	None
<b>Commander's Licence:</b>	Air Transport Pilot Licence (Canada)
<b>Commander's Details:</b>	Male aged 54 years
<b>Commander's Flying Experience:</b>	14,000 hours, of which 1,800 were on type
<b>Notification Source:</b>	Operations Manager, Dublin Air Traffic Control (ATC)
<b>Information Source:</b>	AAIU Field Investigation

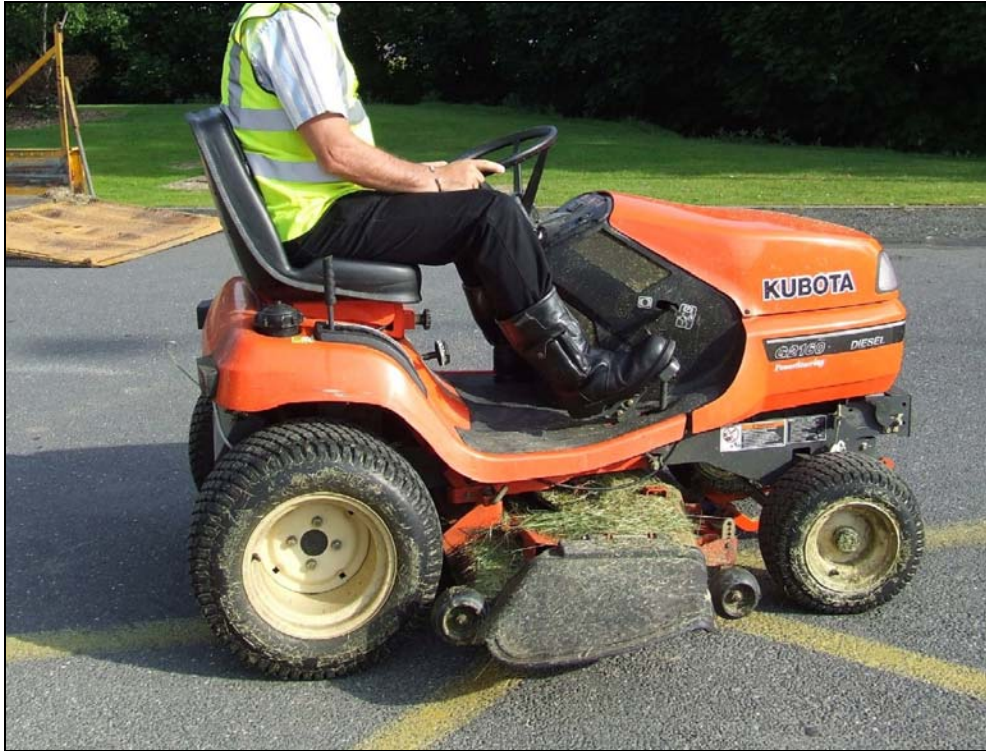
- (c) A ride-on grass mower (T3), **(Photo No. 1)**, operated by a DAA employee. He had also been issued with a hand-held radio by the supervisor for communication with Maintenance 12 on the discrete DAA frequency. He had no airfield radio equipment and thus he was unable to listen out on the Tower frequencies. T3 was not fitted with a transponder.

**Photo No. 1:** Ride-on Mower T3

3. The ride-on mower was equipped with inadequate radio communications equipment and inadequate lighting, and it did not conform to the requirements of Airport Direction 20.

Following the incident, the DAA immediately withdrew the ride-on mower T3 and replaced it with a larger unit with a cab, equipped with a flashing beacon, an airfield radio capable of operating on the relevant ATC frequencies, and a transponder.

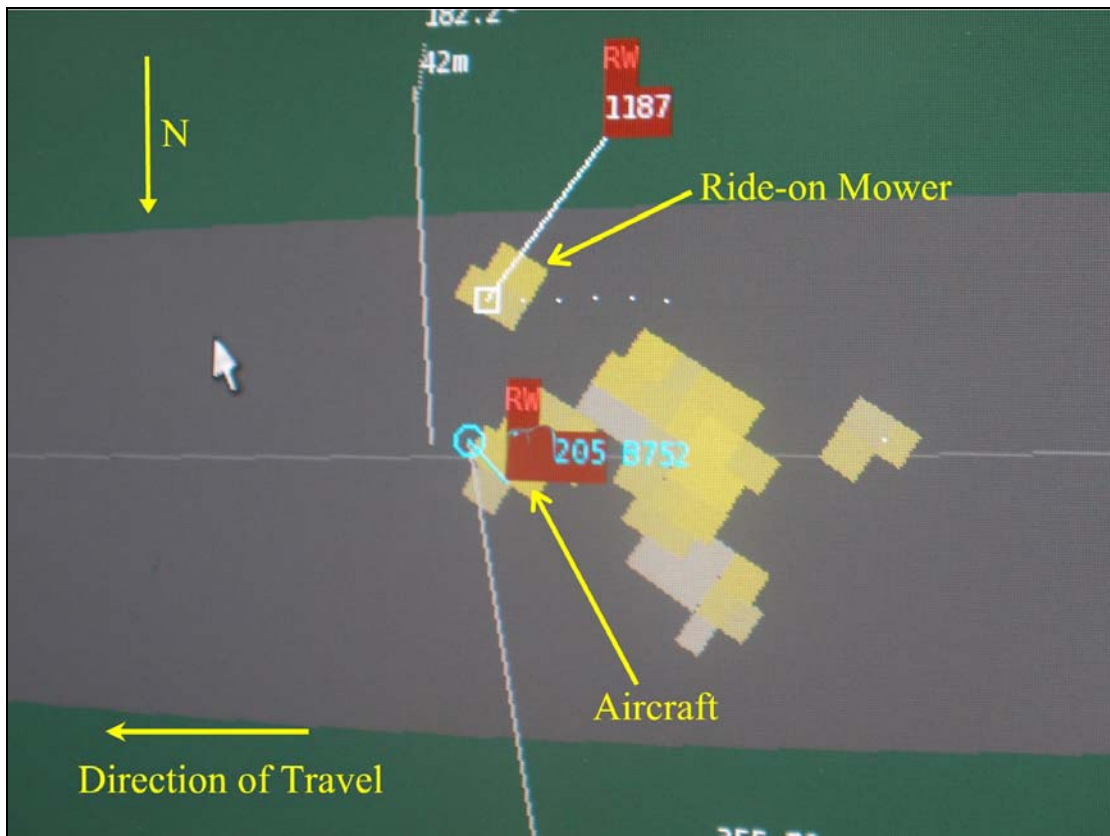
**Figure No. 2:** ASMGCS Image

At 01.52:45 hrs C-GTBB landed on RWY10. The ASMGCS recording shows that the aircraft passed the ride-on mower T3 at 01.53:00 hrs at a point approximately 150 m west of taxiway E5 at an approximate speed of 96 kts. The mower was moving eastwards along the runway, approximately 4 m to the left of the interface between the runway and its right (southern) shoulder pavement, or approximately 18.5 m to the right of the centreline. The wingspan of a Boeing 757-200 is 38.05 m. The mower T3 continued along RWY 10 for a short distance and its ASMGCS target is seen to disappear off the runway to the right at 01.53:15 hrs.

**Figure No. 2** is an image of the ASMGCS screen at the moment that the aircraft passed by the ride-on mower on RWY 10. The image is oriented with south at the top and thus the direction of travel of the aircraft and the mower is from right to left. The aircraft can be seen on the centreline with the port wing clearly defined.

The starboard wing is not as clearly defined due to shielding by the fuselage from the surface movements radar antenna. The ride-on mower is designated by the label "1187". The labels for both the aircraft and the mower are highlighted in red, indicating a conflict situation.
