Air Accident Investigation Unit Ireland

SERIOUS INCIDENT REPORT **Boeing 737-8AS, EI-DAI,** **Dublin Airport, Ireland** **19 November 2009**

AAIU Report No: 2011-007

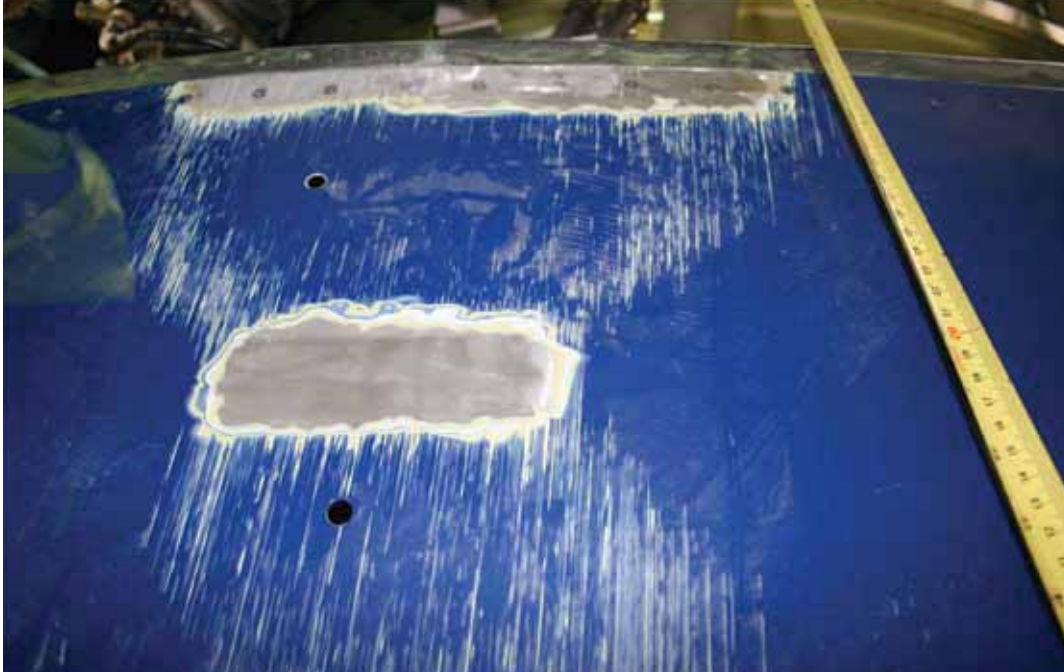
Conditions were blustery and during touchdown the aircraft rolled to the left and pitched nose down. The left engine nacelle scraped the runway surface. Damage was minor. There were no injuries and the crew did not realise that the nacelle had contacted the runway.

Subsequently, a different crew operated the aircraft on the next two sectors to and from Poland. On arrival back in Dublin this commander (for these Polish sectors) learned that a member of the public had reported the earlier nacelle scrape. He reported, "No damage was visible from normal eye level and the crew of the inbound flight didn't report anything unusual". The event was reported to the AAIU on 20 November 2010, an Investigation was initiated and the aircraft was inspected. An area of 300 mm x 400 mm on the bottom of the left engine nacelle was found to exhibit evidence of ground contact, with some related, less significant damage aft of the main area of damage (see **Photo No. 1**). **Photo No. 2** shows the location of the damaged nacelle cowling on the aircraft.

Photo No. 1: Engine nacelle damage

Rolling of the aircraft to 12 degrees left with inappropriate aircraft pitch attitude, at the moment of touch down.

1. The Boeing Aircraft Company should amend the Transit/Pre-flight inspection checklist to specifically require checking of the lower surfaces of engine nacelles for evidence of ground contact. **(IRLD2011005)**
2. The Boeing Aircraft Company should revise the FCTM to advise operators that pitch and roll combinations within the published envelope on the Ground Contact Angles – Normal Landing Chart, can still result in aircraft structure contacting the ground due to the effects of dynamic landing loads on the assumptions used. **(IRLD2011006)**
3. Ryanair Ltd. should conduct a safety awareness programme to communicate to flight crew the threat of engine nacelle ground contact when landing in difficult wind conditions. **(IRLD2011007)**

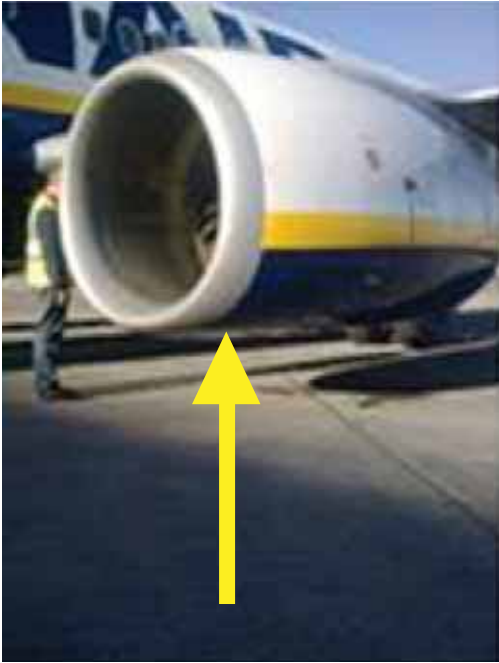
Photo No. 2: Location of nacelle on the aircraft

The Investigation notes that the bottom surface of the engine nacelle is approximately 600 mm above the ground. Inspection can be accomplished from either side but does require the pilot either to squat low/kneel or to use an inspection mirror.

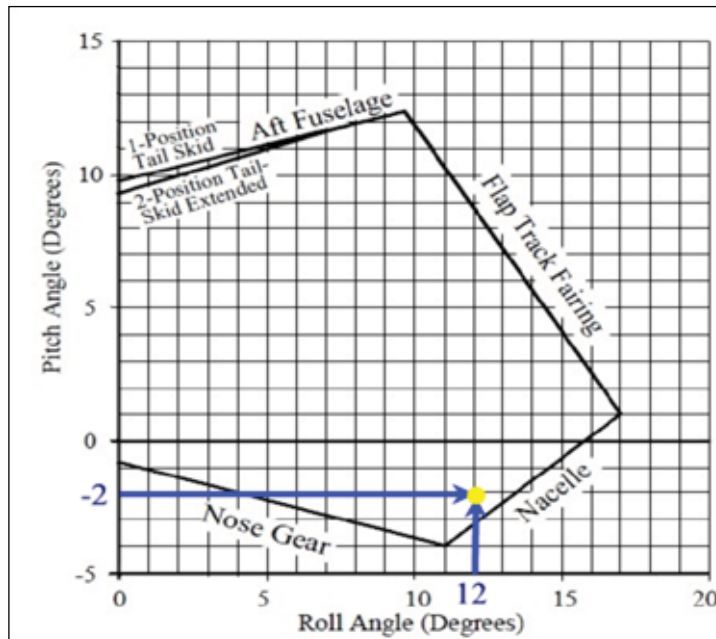
The FCTM contains a Ground Contact Angles – Normal Landing Chart³ that sets out the envelope of body roll and pitch attitudes for landing at which the aircraft structure contacts the ground, given certain assumptions. The maximum roll and pitch attitude data for the aircraft during the touchdown sequence, were 12 degrees roll left and 2 degrees pitch down. These values were plotted on the chart and the result is shown at **Figure No. 1**.

As can be seen from **Figure No. 1**, the data was marginally within the published structural ground contact envelope. However, it must be noted that the chart is predicated on certain assumptions e.g. a rigid wing, strut and tire compression for a static aircraft on-ground at maximum taxi weight (MTW), level ground surface, etc. Structural wing flexing due to dynamic landing and environmental loads, runway crown, as well as tyre pressure and landing gear strut pressure, mean that the ground contact envelope encountered during actual aircraft operations may be smaller than the envelope presented in the FCTM. In addition, data sample rates (for pitch and roll) during a highly dynamic landing may mask the absolute positions that were actually achieved.

Figure No. 1: Pitch and roll limit chart for ground contact.

The FCTM Ground Contact Angles – Normal Landing Chart is predicated on certain assumptions e.g. a rigid wing. Structural wing flexing due to dynamic landing and environmental loads, as well as tyre pressure and landing gear strut pressure, mean that the ground contact envelope encountered during actual aircraft operations may be smaller than the ideal presented in the FCTM. The FCTM does not make it clear that the pitch and roll combinations within the published envelope of the Ground Contact Angles – Normal Landing Chart can result in aircraft structure contacting the ground due to dynamic landing loads.

9. The FCTM Ground Contact Angles – Normal Landing Chart does not make it clear that pitch and roll combinations within the published envelope can result in aircraft structure contacting the ground due to dynamic landing loads on structural wing flexing, strut and tyre compression, and runway crown.

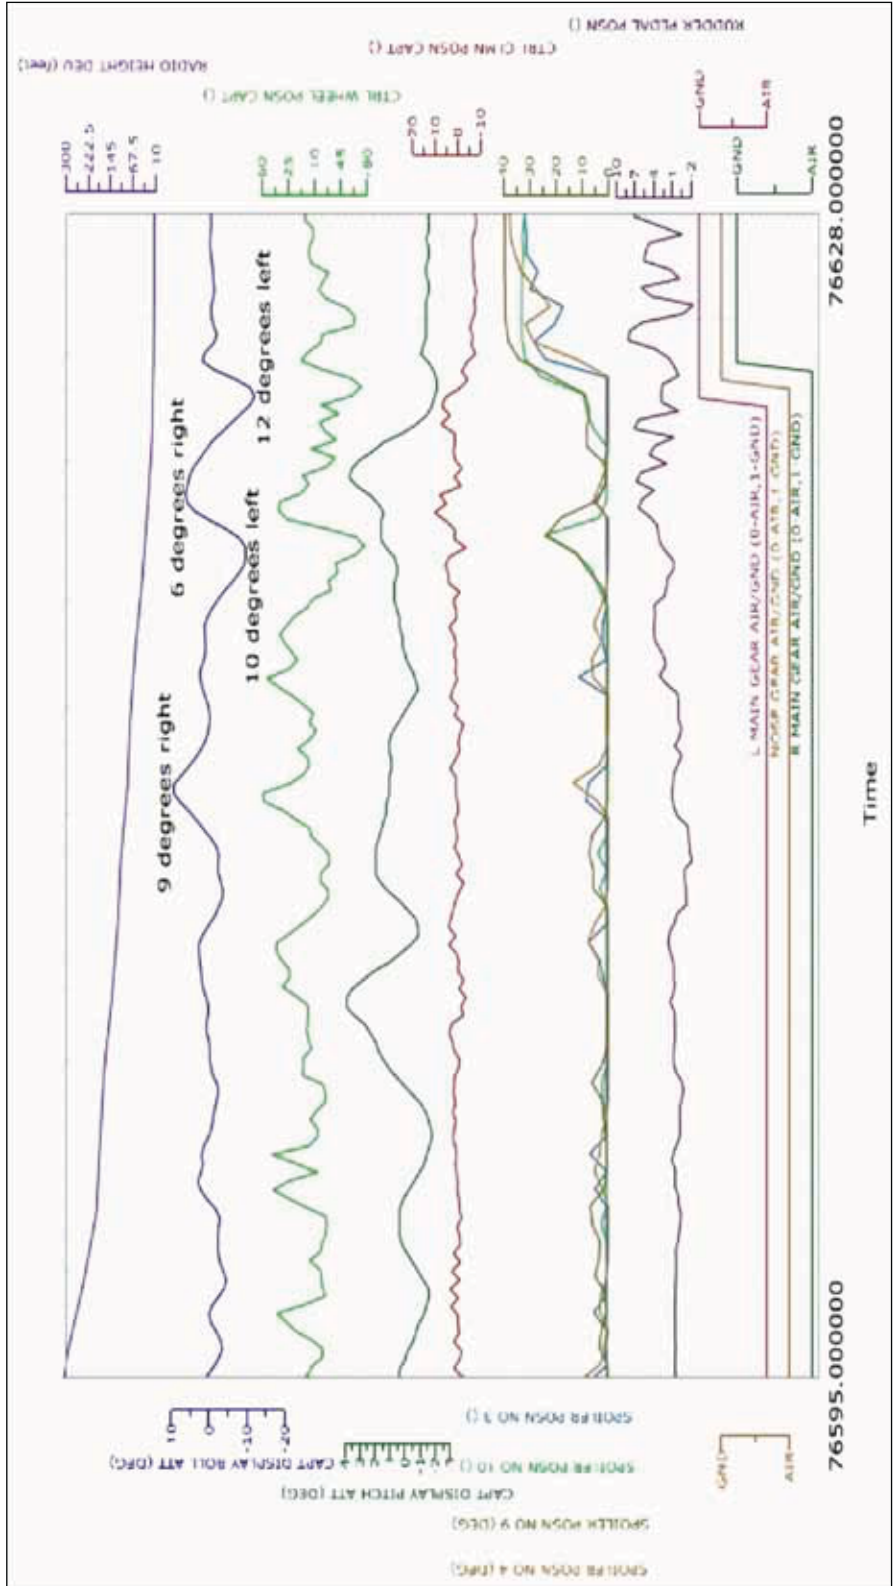
Plot of selected parameters

The Flight Data Recorder (FDR) data was recovered and analysed. The data indicates that at 90 ft Radio Altitude (RA) the aircraft's roll attitude was 9 degrees to the right. Seven seconds later, at 30 ft RA, the aircraft's roll attitude was 10 degrees to the left. Two seconds later at 16 ft RA the aircraft's roll attitude was 6 degrees to the right. Finally, two seconds later, at touchdown, the aircraft's roll attitude was 12 degrees to the left. The aircraft landed on the left main gear first followed by the nose gear and the right main gear.

The data also shows that the autopilot was disconnected at about 400 ft RA. Significant use of the control wheel and rudder pedal inputs were in evidence after autopilot disconnection, increasing in magnitude closer to the point of touchdown. The data shows that at 150 ft the aircraft deviated one dot below the glideslope. The data also shows that no warning or caution for wind shear or pre-wind shear was recorded.

Just prior to landing there were significant rudder inputs and in the two seconds before the left gear contacts the ground the aircraft nose drops from 3.6 degrees nose-up to 1.7 degrees nose-down. The Ground Contact Angles – Normal Landing Chart, **Figure No. 1** (see **Section 1.7**), indicates that the pitch and roll at the point of touchdown were inside the ground contact limits as published by the aircraft manufacturer. While ground contact should not have been expected the chart shows that the risk of engine nacelle ground contact increases as aircraft pitch decreases. **Appendix A** shows a selection of recorded parameters from 300 ft (RA) to landing.
