## REPORT

*AAIU Report No. 2001-001*

<b>Aircraft Type and Registration:</b>	Pegasus XL-R, G-MWUE
<b>No. and Type of Engines:</b>	One, Rotax 447 Air Cooled
<b>Aircraft Serial Number:</b>	SW-WA-1513
<b>Year of Manufacture:</b>	1991
<b>Date and Time (UTC):</b>	13 February, 2000, 1700 hours
<b>Location:</b>	Baltray Beach, Co. Louth
<b>Type of Flight:</b>	Private
<b>Persons on Board:</b>	Pilot – One Passenger - One
<b>Injuries:</b>	Pilot – Serious Passenger - Serious
<b>Nature of Damage:</b>	Extensive
<b>Commanders Licence:</b>	UK Private Pilots Licence (Aeroplanes)
<b>Commanders Age:</b>	29 Years
<b>Commanders Flying Experience:</b>	58 hours
<b>Information Source:</b>	ATC Watch Manager, Dublin Airport. AAIU Field Investigation

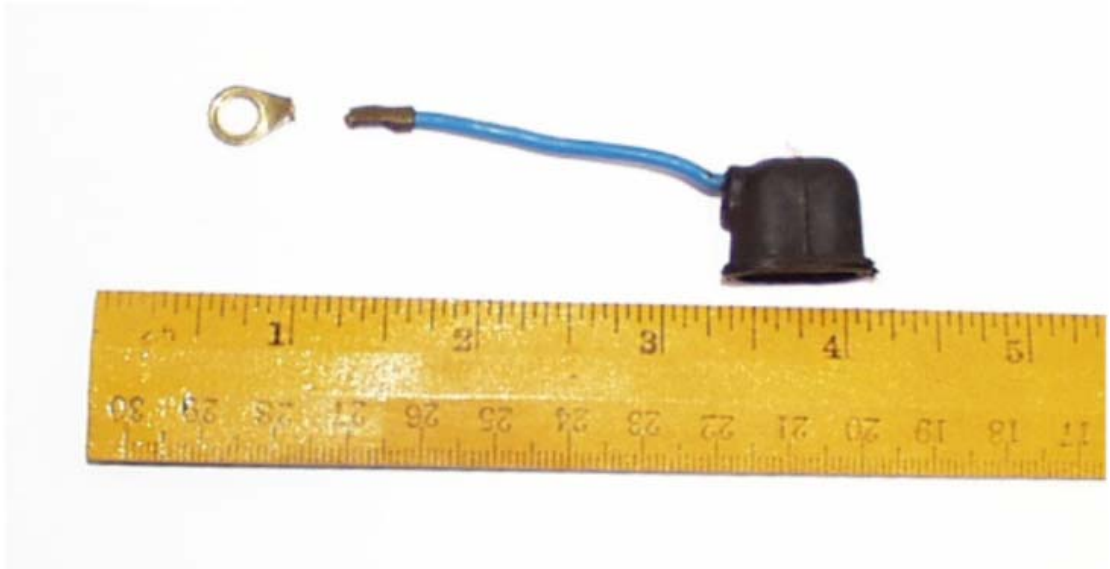
Fig 1

The engine was found to be in good condition and did not appear to have been damaged in the accident. However, the earth lead to one of the magneto coils was found to be broken. The brass connection tab at the end of the lead was broken. The location of this lead is such that it is well protected and it is unlikely that the tab was damaged in the accident or subsequently. The broken connection tab was subjected to detailed metallurgical examination with the following results.

- Failure of the connection occurred over a period of time, through the propagation of a fatigue crack, to the point that the small remaining intact ligament failed through overload.
- The examination did not reveal any indication of a material or manufacturing defect associated with the fracture.
- There was no indication of arcing associated with the fracture. This would indicate that the separation of the connector was sudden and total.

Failure of the earth connection of the magneto coil would result in the sudden and total failure of the spark to one of the two engine cylinders. This in turn would lead to a power loss to the propeller exceeding 50%.

The failed magneto lead showing the separated tab to the left of picture

The single ignition system on the Rotax 447 engine has no such safety protection. Therefore such aircraft should be operated in a manner whereby an engine failure cannot be considered a remote possibility, but rather as a distinct probability. Consequently manoeuvres such as low runs, which would require normal engine power to be available for a safe recovery, should not be attempted in aircraft equipped with such engines. Such aircraft should be flown in manner that, following an engine failure at any time, the flight can be safely completed using a glide (powerless) landing.
