# REPORT

*AAIU Report No. 2001-006*

<b>Name of Operator:</b>	World Airways
<b>Aircraft Type and Registration:</b>	MD-11, N-272 WA
<b>No. and Type of Engines:</b>	Three, P&W PW 4462
<b>Aircraft Serial Number:</b>	48437
<b>Year of Manufacture:</b>	1993
<b>Date and Time (UTC):</b>	18 September 1999, 0524 hours
<b>Location:</b>	Shannon Airport, Co. Clare
<b>Type of Flight:</b>	Public Transport - Passenger
<b>Persons on Board:</b>	Crew - 14 Passengers - 317
<b>Injuries:</b>	Crew - Nil Passengers - Nil
<b>Nature of Damage:</b>	Minor Damage to Right Main Wheel Tyres
<b>Commanders Licence:</b>	Airline Transport Pilot (FAA)
<b>Commanders Age:</b>	52 years
<b>Commanders Flying Experience:</b>	8307 hours (incl 2672 hours as Captain on type) Last 90 days - 150 hours Last 28 days - 78 hours Last 24 hours - 5.3 hours
<b>Information Source</b>	ATC Watch Manager, Shannon Airport. AAIU Field Investigation.

## **SYNOPSIS**

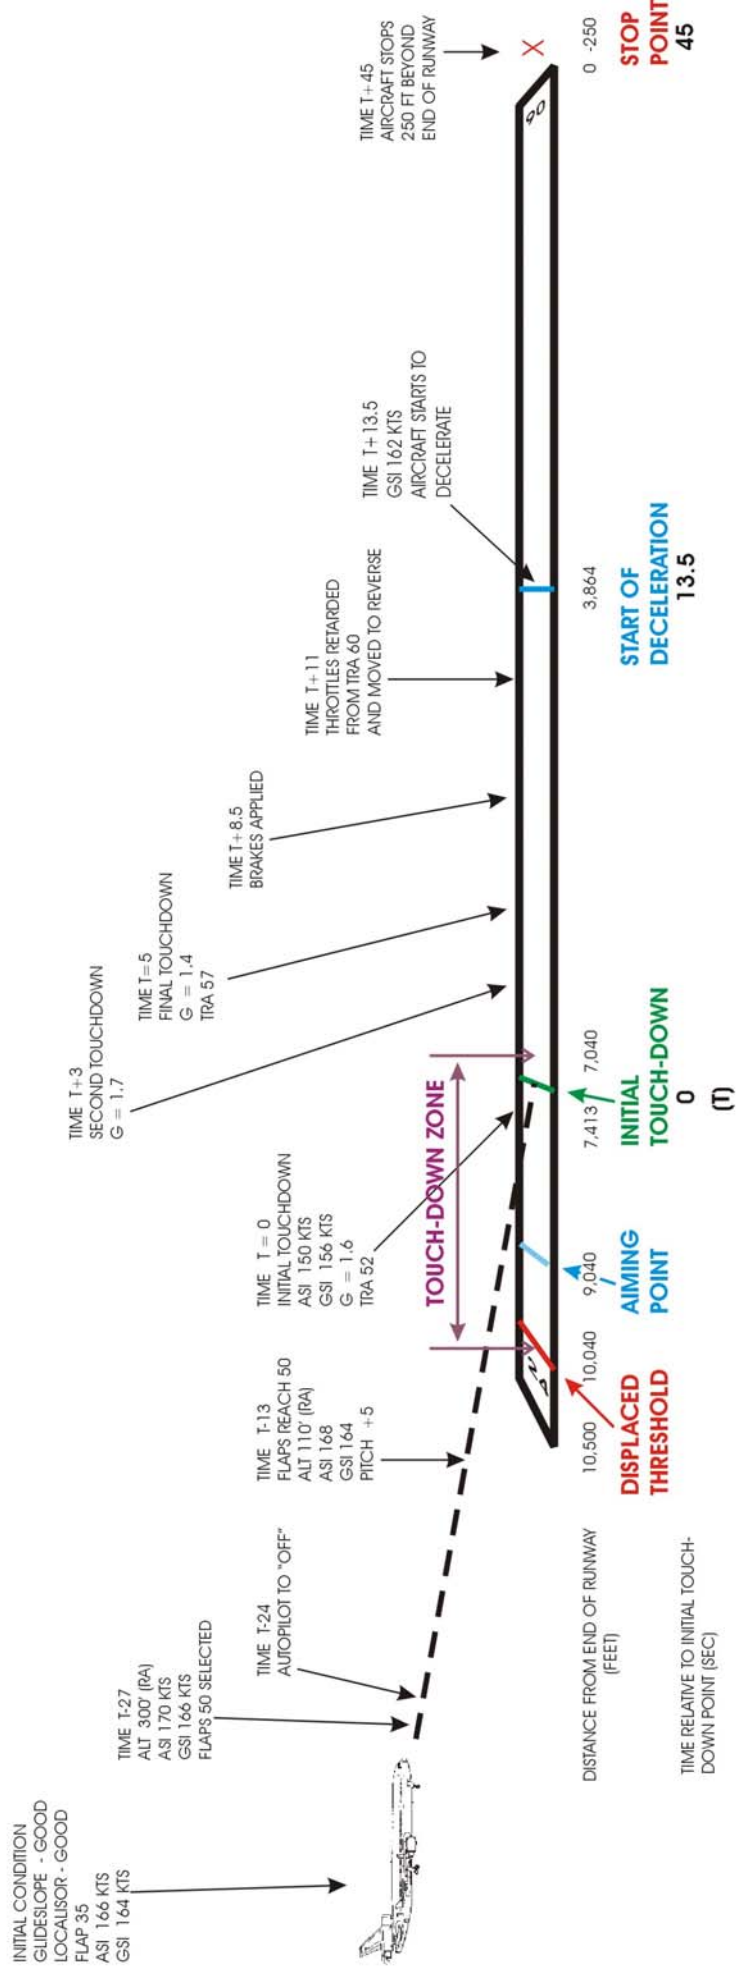
## VISUAL REPRESENTATION OF LANDING OF MD-11 N-272WA ON RUNWAY 24/06 AT SHANNON 18 SEPT 1999

- a. the late selection of 50° flap,
- b. the threshold airspeed of 162 kt
- c. touchdown 1,600 ft past the normal 1000 ft touch down point
- d. application of power during the initial touchdown and landing roll; and
- e. the non-deployment of the ground spoilers which, in turn, precluded the use of the autobrakes.

The late selection of 50° flap destabilized what had otherwise been a stabilized approach, placing the aircraft in a position from which a normal touchdown and landing roll-out could not be effected within the remaining landing distance available.

The Operator reviews its flight training programme to re-emphasize the following points;

- a. The stabilized approach concept, definition and requirements,

The importance of executing a missed approach if the approach becomes destabilized; and
- b. The PNF's role in assuring that ground spoilers are deployed after touchdown. **(SR 13 of 2001)**
