FINAL REPORT

AAIU Synoptic Report No: 2004-018

Aircraft Type and Registration:	Boeing 737-2T5 EI-CKS
No. and Type of Engines:	2 x Pratt & Whitney JT8D-15A
Aircraft Serial Number:	52990
Year of Manufacture:	1980
Date and Time (UTC):	3 February 2003 @ 13.00 hrs
Location:	Dublin Airport (EIDW)
Type of Flight:	Public Transport - Scheduled
Persons on Board:	Crew - 5 Passengers - 122 ¹
Injuries:	Crew - 0 Passengers - 0
Nature of Damage:	Minor damage to pressurisation system
Commander's Licence:	Air Transport Pilot's Licence
Commander's Details:	Male, aged 35 years
Commander's Flying Experience:	6,864 hours of which 6,284 were on type
Information Source:	AAIU Field Investigation

SYNOPSIS

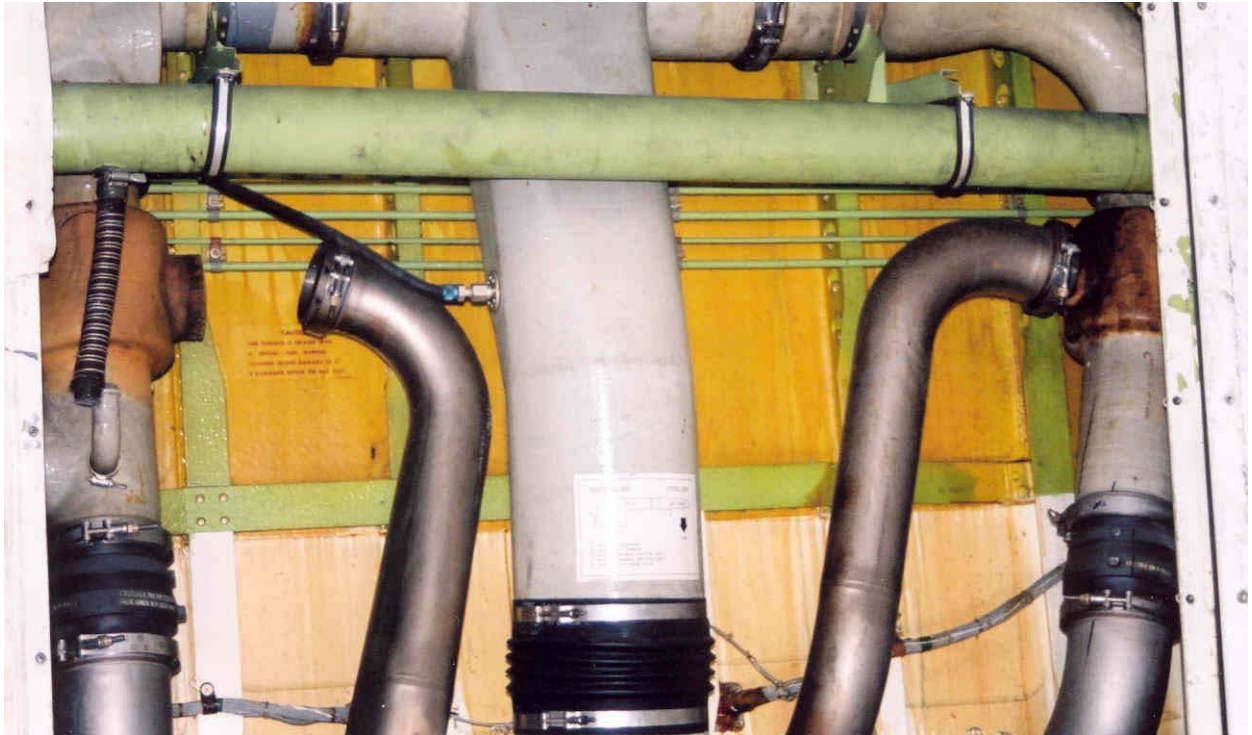
Photo 1

Subsequent inspection of the aircraft found that a duct, of approximately 100 mm diameter, which carries engine bleed air from the right engine to the right air conditioning mix chamber, had separated from the mix chamber (**Appendix A, Photo 1**). The mix chambers are located in the main cabin under-floor area, immediately aft of the forward cargo bay, in an area known as the “snake pit”. This area is underneath Row 10. When the duct separated, large volumes of engine bleed air, at a pressure, above ambient, of approximately 1 to 3 PSI (0.07 to 0.21 bar) and a temperature of approximately 320°F (160°C) entered the snake pit. This hot air then entered the main cabin area through the grill vents at the bottom of the sidewalls on both sides of the cabin fuselage. There was no evidence of burning or charring, and no obvious source of smoke generation. However, it was noted that the ducts behind the grills were heavily covered with a fine grey dust and lint (**Appendix A, Photo 2**).

This photo shows the “snake pit”, as viewed from the forward cargo hold, looking aft with the rear screen removed. It shows the failed joint on the left. The mix chamber can be seen on the extreme left. The intact LH system can be seen on the right of the photo.

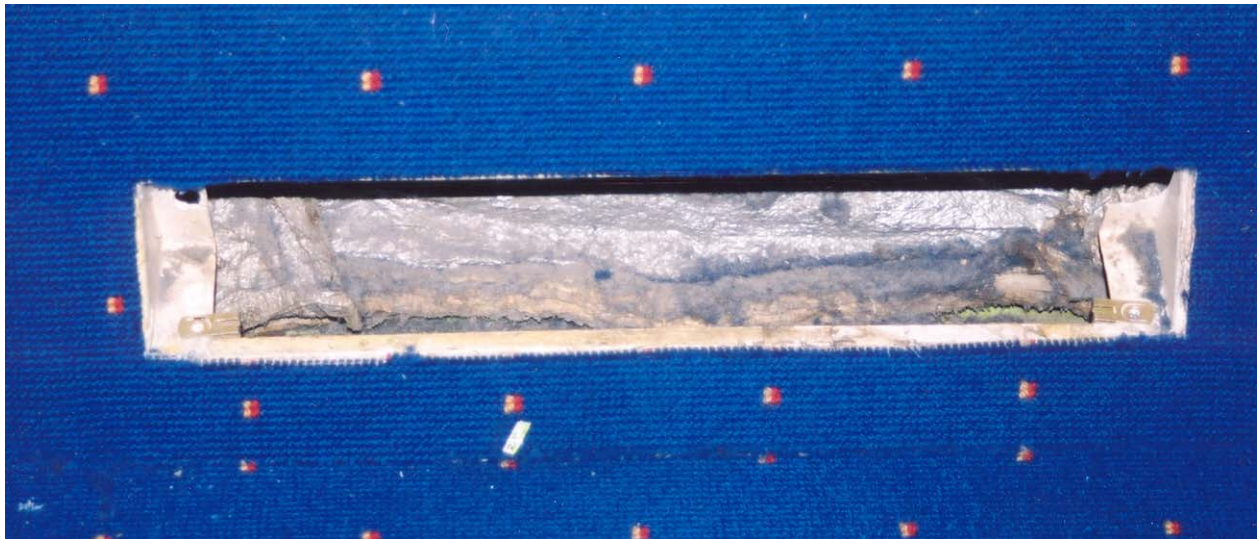
Photo 2

2.1.4 The blast of pressurised bleed air from the failed joint, rushing through the sidewall ducts and grills in the opposite direction to the normal air flow, dislodged the dust that had accumulated in these ducts and then carried the dust into the cabin, where it was mistaken for smoke. Given the presence of very hot air in the cabin, it was reasonable to confuse this visual dust with smoke.

This shows one of the sidewall ducts with the grill removed. The dust and lint that caused the smoke effect can be seen in the duct.

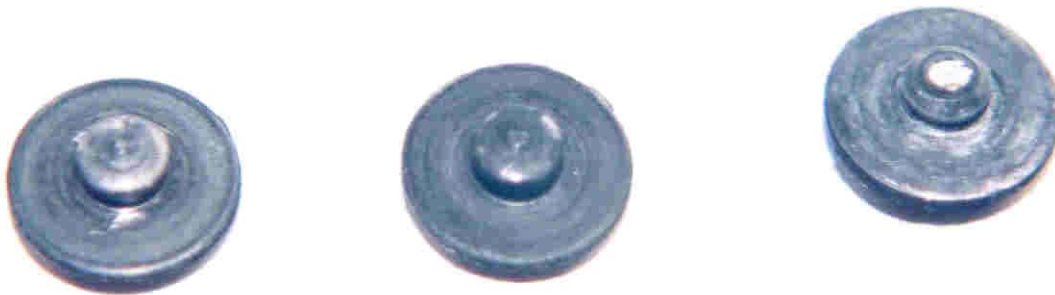
Photo 4

2.1.3 The rivet shanks were worn away by the sharp edges of the countersunk hole of the flange. Eventually the loss of material in the rivets was sufficient to cause some to fail

This shows the clenched end of the recovered rivets, with the washers still attached. The parallel shank section can be seen. The worn section is visible at the top of each rivet.

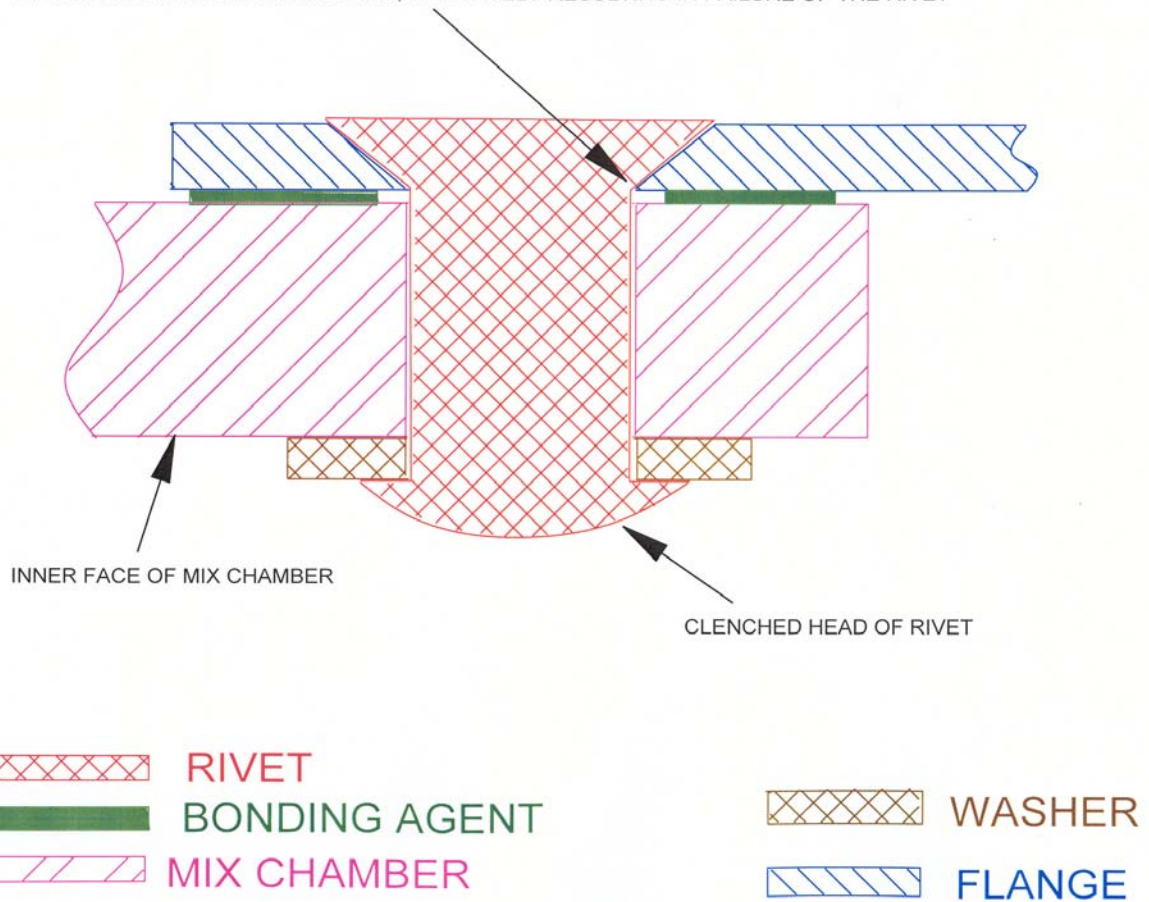
Appendix B

A total of 8 countersunk rivets are used to secure the flange to the mix chamber. The rivets are 1/8" (approximately 3 mm) diameter. The flange, which fits over the inlet of the mix chamber, is countersunk on the outer surface. The rivets pass through the ring and the composite material of the inlet. The rivets are clenched on the inner face of the inlet. In order to prevent crushing of the composite material by the axial loads of the riveting clenching process, a 5/16" (8 mm) diameter washer is inserted underneath the rivet clench (**Appendix B**).

MOVEMENT OF THE RIVETS AT THIS POINT CAUSED SEVERE WEAR AND A GROSS REDUCTION OF THE RIVET CROSS-SECTIONAL AREA, ULTIMATELY RESULTING IN FAILURE OF THE RIVET

This is a schematic drawing of the area where the failure occurred (not drawn to scale).

by simple overload. This, in turn, led to overload of the adjacent worn rivets and ended in cascade failure of all the rivets. The Investigation is of the opinion that dome head rivets would have been more suitable in this application. This would have done away with the need to countersink the rivet holes and the consequent creation of the sharp edges that bore on the rivets. A possible remedy of this problem would be to replace the flange with a new design using dome head rivets without a countersink in the flange.

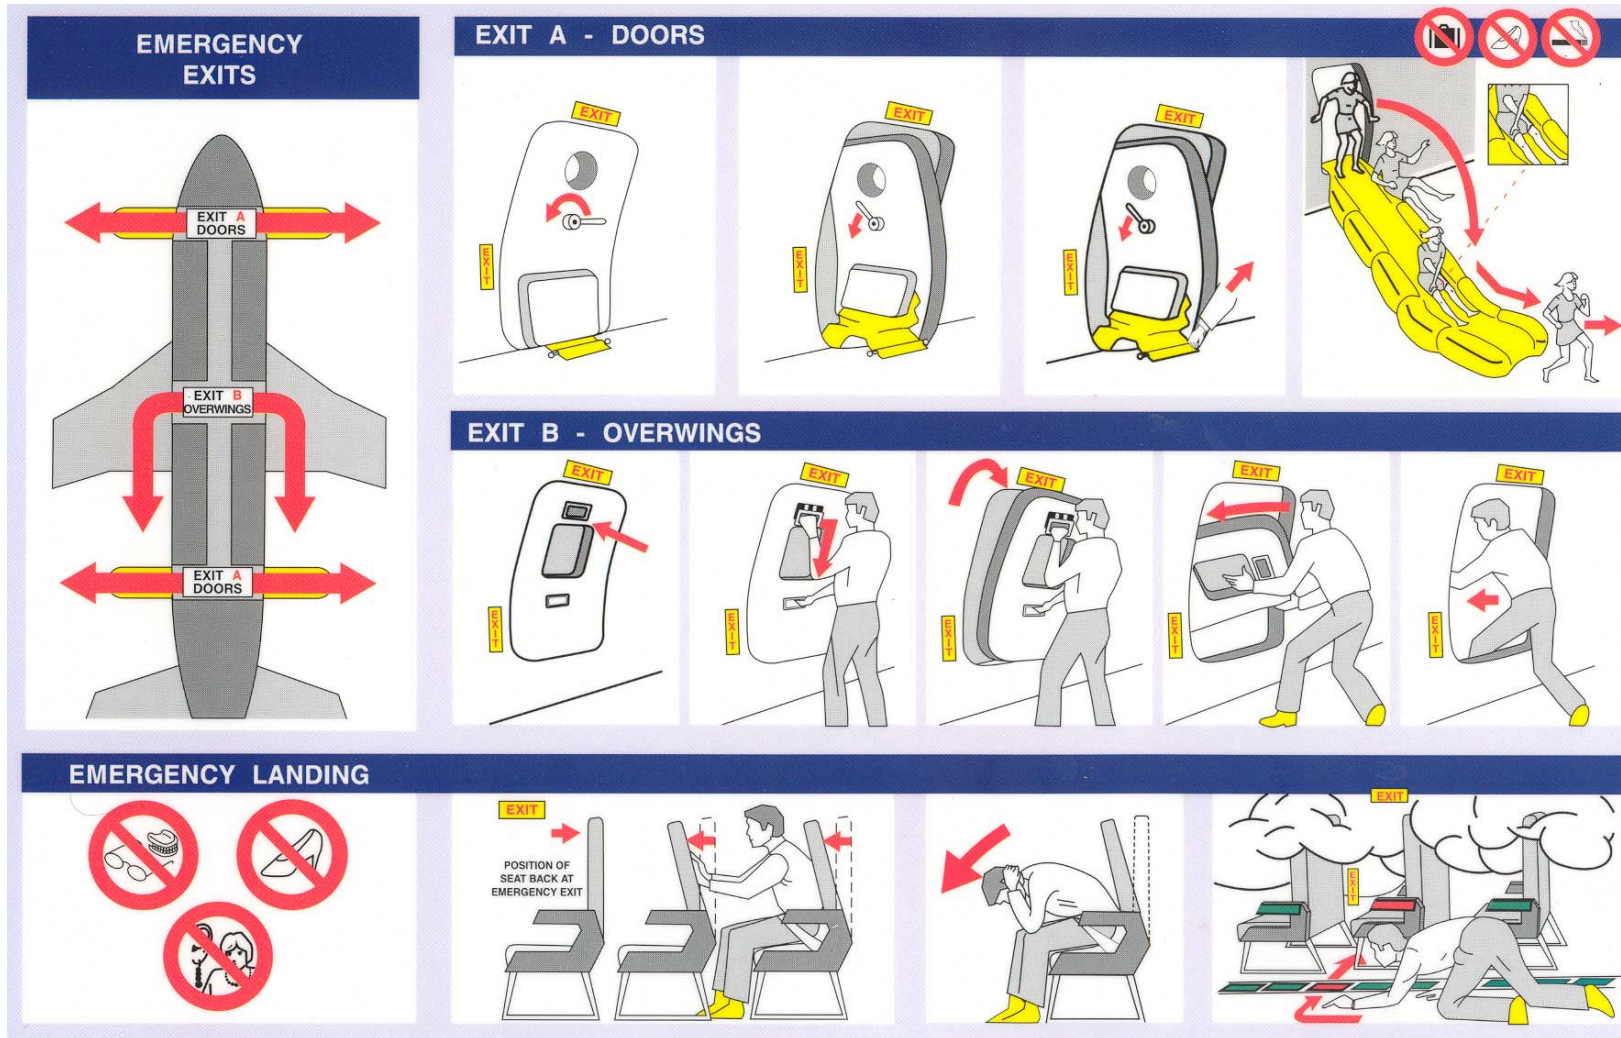
Appendix C

- Some passengers, having made their way through the over-wing exit, were unsure as to where they should go next and in particular how they should get down off the wing. The absence of information in the Safety Card, as to how to get off the wing, may have been a factor in this confusion.

This is the Operator's Safety Card dealing with emergency evacuation procedures. It does not give obvious directions as to how passenger should get down off the wing.

- 4.2 The Operator should review their Safety Card to ensure that the card clarifies how passengers should get down from the aircraft wing, when using the over-wing exits in an emergency evacuation. ([SR 36 of 2004](#))

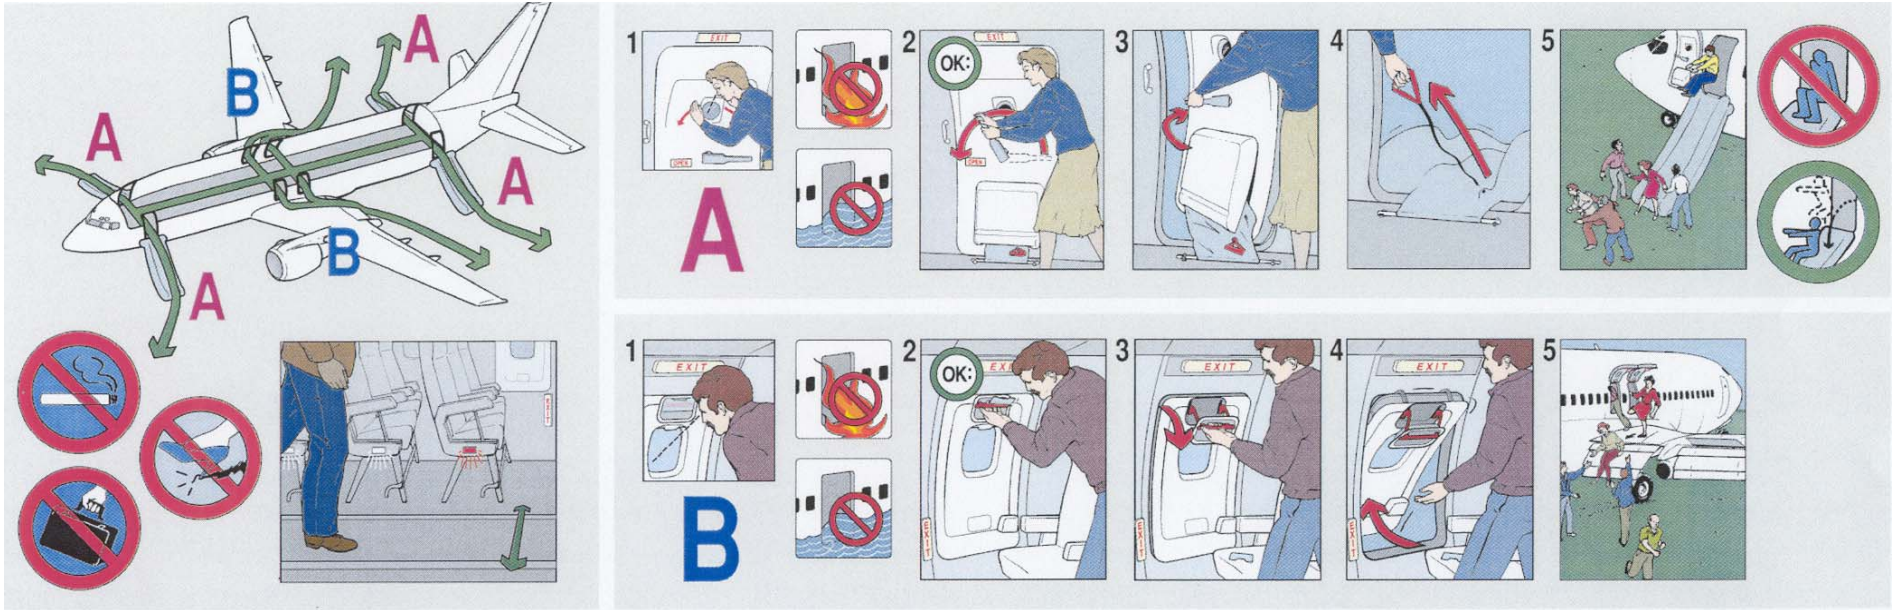
Appendix D

2.2.2 There is no doubt that in this evacuation, some passengers, who had exited onto the wing, were unsure as to how to get from the wing onto the ground. The Investigation considers that an average passenger would more easily and more completely understand the pictorial information, as presented in **Appendix D**. This in turn would reduce the potential for confusion, such as arose in this evacuation.

This is a Safety Card, used by another operator for a later version of the B737, for using the over-wing exits in an emergency evacuation. Note that it shows, pictorially, the path that passengers using the over-wing exit should take (upper left), and how they should get down off the wing (lower right).
