Air Accident Investigation Unit Ireland

SYNOPTIC REPORT

Boeing 737-8AS, EI-DPA

24 October 2011

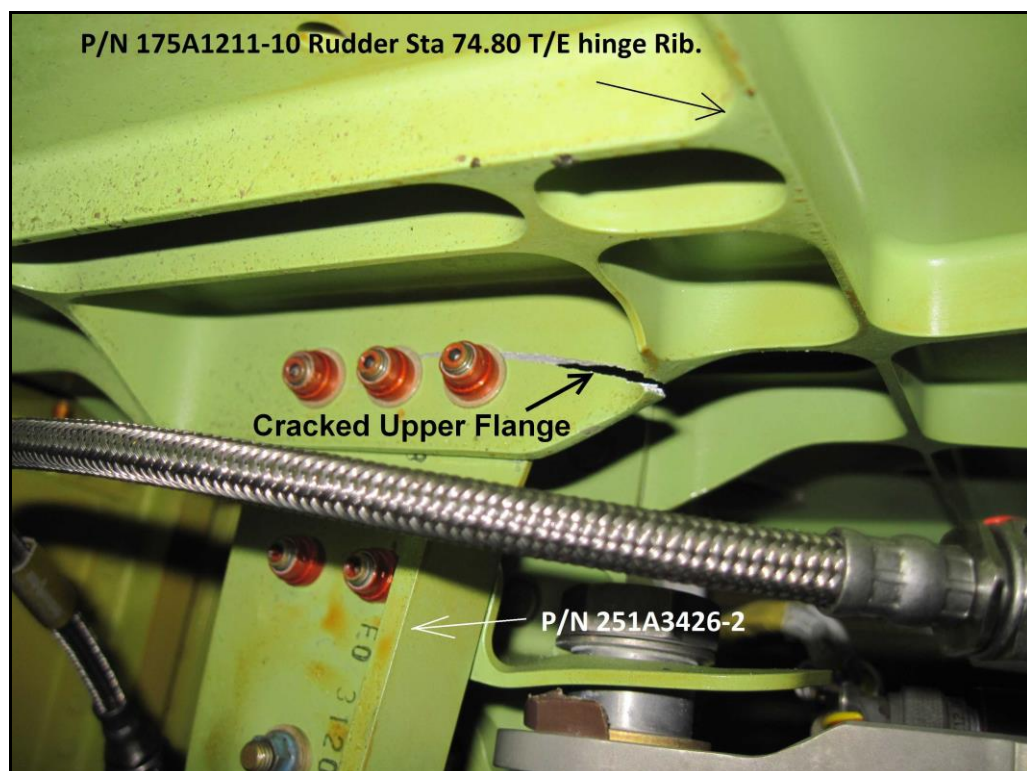
The support brackets for both PCUs were seen to have sustained damage, such as cracking, fracturing and displacement. The Operator provided photographs of the damaged areas to the Investigation and to the aircraft Manufacturer. The Manufacturer proposed that they would send an engineering team to LPFR to examine the damage and this was agreed with the Investigation and the Operator. The Investigation arranged for the examination to be overseen by an investigator from the GPIAA.

The rudder was found to be moving freely but with more travel to the right than to the left. Its aerodynamic surface was clean and showed no signs of buckling or any other deformation. They found that at the tailstock¹² of the Standby PCU, the upper and lower flanges attached to the support brackets securing the forward part of the PCU were cracked, see **Photo No. 1**. A lug fitting, also part of the securing mechanism of the Standby PCU, was found to have pulled away from one of the support brackets. In addition, one of the brackets exhibited gaps where it had pulled away from the adjacent flange.

Photo No. 1: Damage to Standby PCU Support Bracket

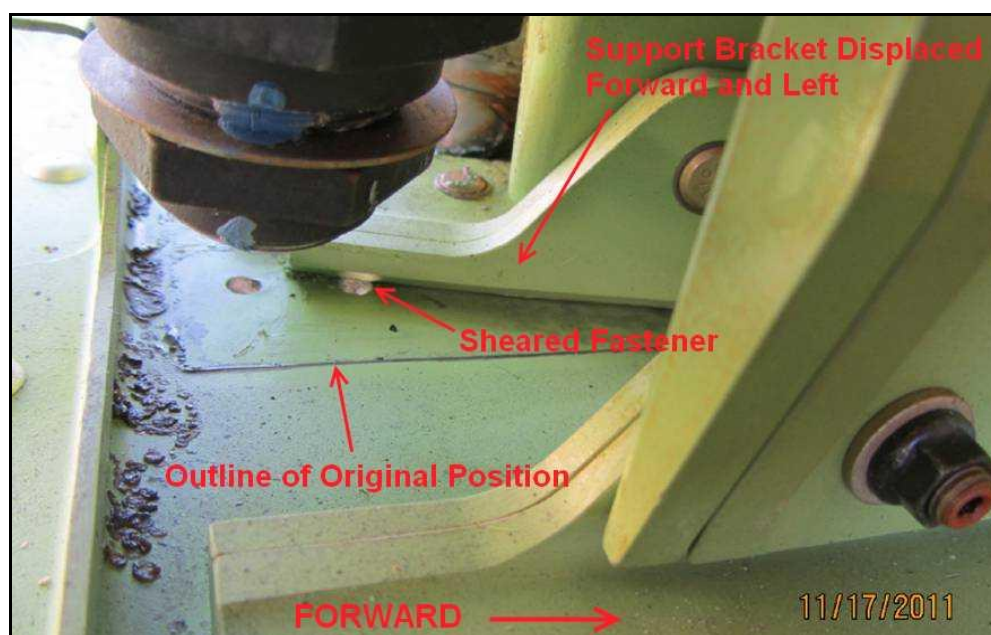
At the Main PCU tailstock, four fasteners securing the left hand support bracket to the adjacent structure had sheared and the bracket had been displaced significantly forward and left, see **Photo No. 2**.

The right hand support bracket fasteners remained intact but the bracket itself was deformed. A gap was found to have developed between the lug fitting and the right hand support bracket.

Photo No. 2: Displacement of Main PCU Support Bracket

Significant damage was caused to the mounting brackets at both PCUs' tailstocks as well as to parts of the aircraft structure to which the brackets were attached. Four fasteners securing the left hand support bracket of the Main PCU had sheared allowing the support bracket to become significantly displaced forward and left. The Main PCU right hand support bracket fasteners were intact and the support bracket itself was not displaced but was permanently deformed. A gap was created between a lug fitting and the bracket.

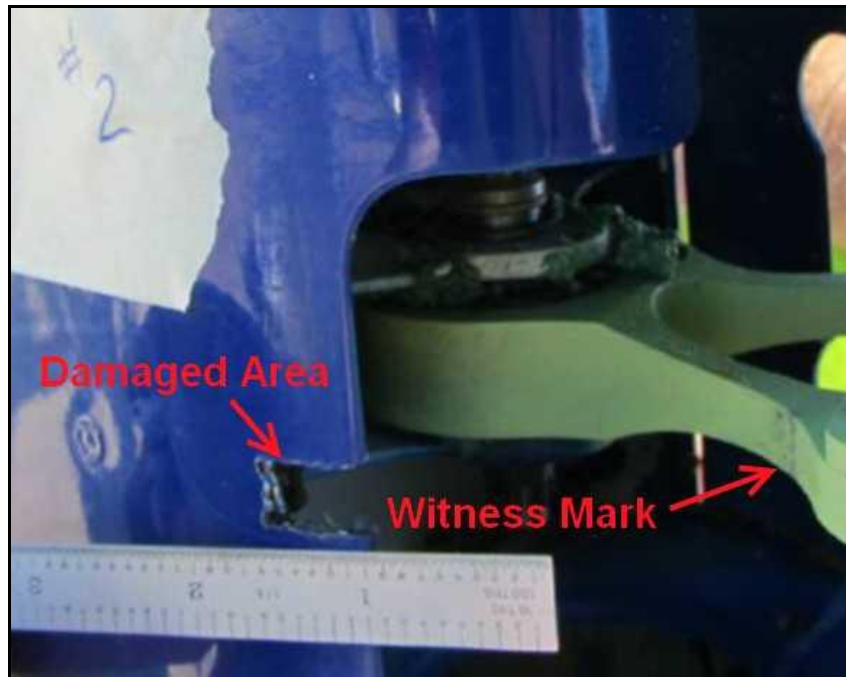
When the blade seals¹³ were removed from the stabiliser, visual examination of the right side of the leading edge of the rudder revealed damage at various hinge points. The damage in the area of No. 2 hinge is shown in **Photo No. 3**. Similar damage was documented at hinges Nos. 5, 7, 8 and 9.

Photo No. 3: Damage to Rudder Leading Edge at Hinge No. 2

This damage exhibited evidence that the rudder had over-travelled with the trailing edge moving to the right. The skin of the rudder leading edge had come into contact with the hinge mechanism structure, which perforated the rudder skin leaving impact marks on the hinge mechanism. The GPIAA Investigator who oversaw the inspection stated that the damage in the area of the hinges could not be seen when the blade seals were in place, and in particular was not visible from the ground during what he termed a “*normal inspection*.” He also reported that the hinges and balance panels were found to be in good condition.

EI-DPA was parked on an approximately northerly heading on Stand 18 at LPFR when the microburst, approaching from the southwest, struck the airport. The orientation of the airport, with the ramp and runway to the south of the terminal buildings, is such that the ramp area is open to weather approaching from a southwesterly direction. It is probable that the severe wind gusts impacted on the left hand side and rear of the aircraft and as a consequence the rudder control surface moved rapidly, trailing edge to the right, which is consistent with the damage shown in **Photo No. 3** in **Section 1.2**.

The leading edge of the rudder was damaged by contact with the rudder attachment hinges at several hinge points. This damage demonstrated that the entire rudder control surface had over travelled to the right and its leading edge had come into contact with the hinges, which perforated the rudder skin at several locations. Otherwise the rudder surface was undamaged and exhibited no signs of buckling or deformation.

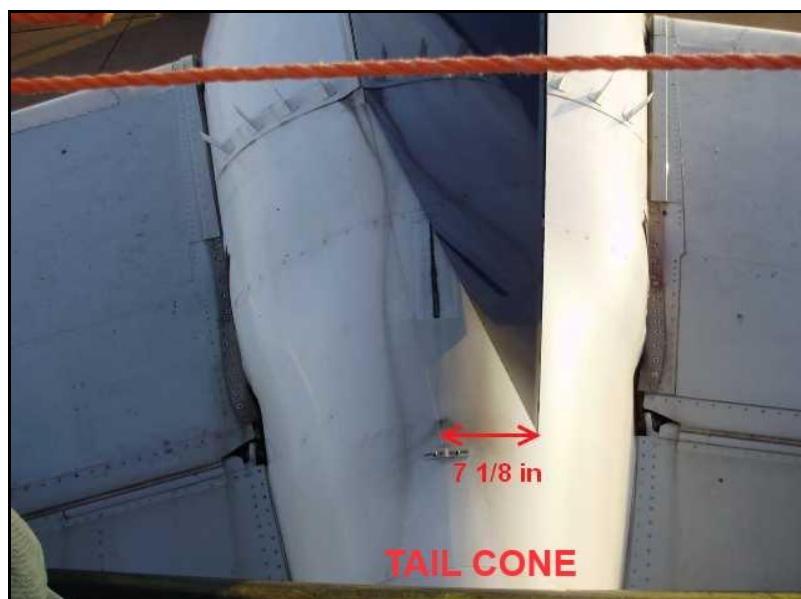
Hydraulic power was turned on, the rudder pedals were centred and the rudder trim was set at zero. It was found that the offset between the rudder trailing edge and the index plate which is used as a reference point to centralise the rudder was 7 1/8 inches to the right (**Photo No. 4**).

Photo No. 4: Rudder Trailing Edge Offset from Neutral

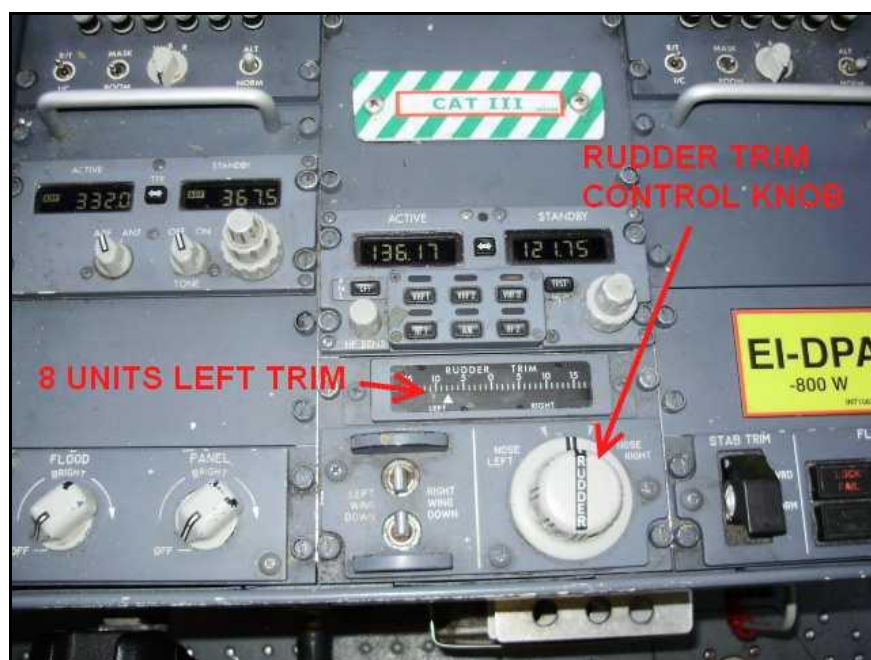
The rudder trailing edge was aligned onto the index plate by the application of approximately 8 units of left rudder trim (**Photo No. 5**).

Photo No. 5: Rudder Trim with Rudder Centred

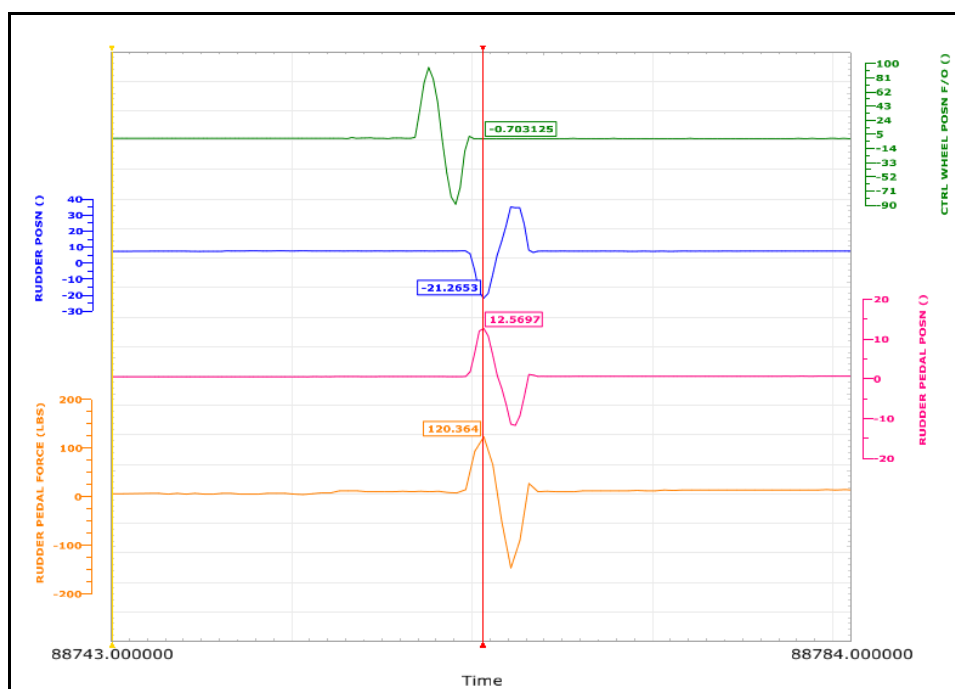
Figure No. 5: Rudder Data - Controls Check on Occurrence Flight

On the check carried out on the flight preceding the occurrence flight, the rudder movement was recorded between -29° (negative figures indicate trailing edge left) and $+29.7^{\circ}$ (trailing edge right). The rudder position was recorded at approximately 0° while the rudder pedals were at 0° and there was minimal force being applied to the pedals. On a similar check carried out immediately before the departure of the occurrence flight, the rudder movement was recorded between -21° and $+35^{\circ}$.

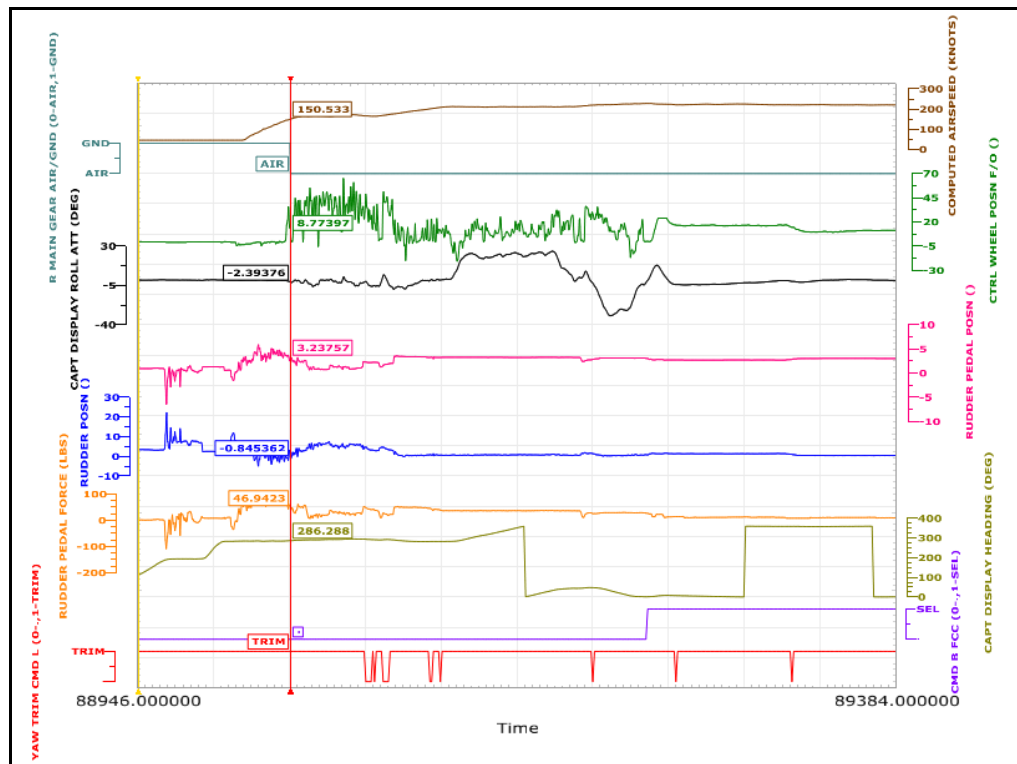
Figure No. 6 shows relevant recorded data for a period of 438 seconds¹⁵ (7 mins 18 secs) immediately before and after the take-off on the occurrence flight. The uppermost trace shows the airspeed increasing from zero to approximately 220 knots as the aircraft accelerates along the runway, takes off and climbs away from the runway. The second trace from the top shows the ground/air parameter changing from ground (GND) to air (AIR) as the main landing gear lifts off the runway at take-off. The red vertical cursor is set at this point.

Figure No. 6: DFDR Parameters Before and After Take-off

The rudder remained at a recorded deflection of 8° right until the aircraft commenced its taxi to the take-off runway. During the taxi, the rudder pedals moved both left and right of the neutral 0° position. Simultaneously the rudder position moved left and right around a “central” deflection of approximately 8° to 10° trailing edge right. As the aircraft accelerated along the runway but before the ground/air parameter changed from GND to AIR, the rudder pedal position was recorded at values up to approximately 5° left. The rudder responded by moving to positions centred around 0°.

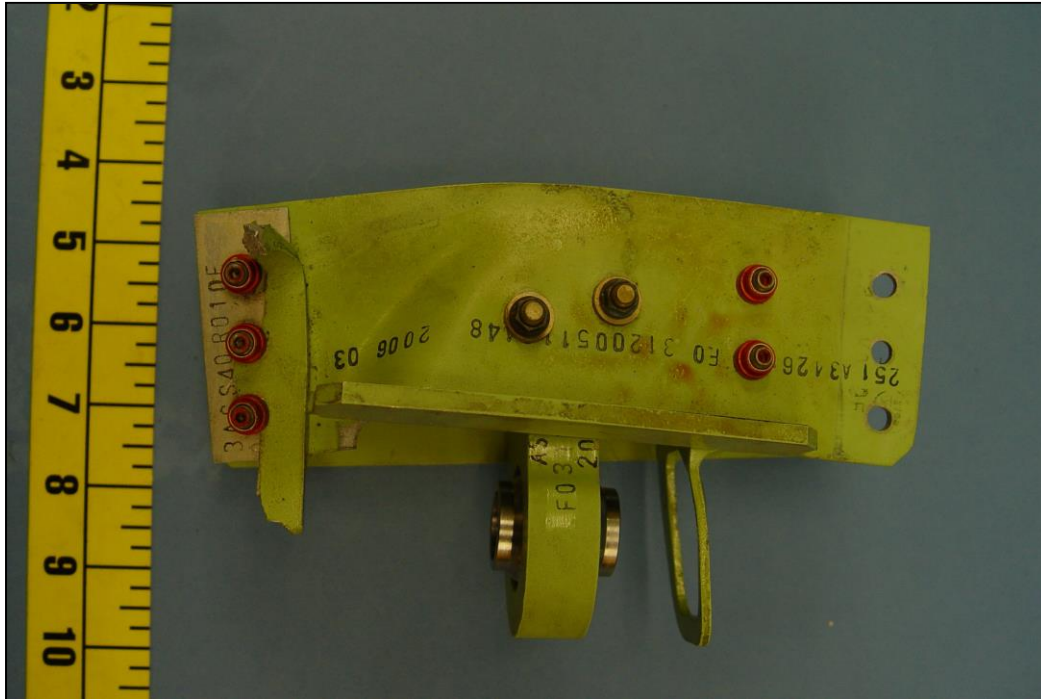
Examination of the Standby PCU tailstock attach hardware revealed that the brackets exhibited deformation, fractures and overload shear. Several of the attachment holes were elongated.

Photo No. C1: Standby PCU Tailstock (Left Side) *(NTSB)*

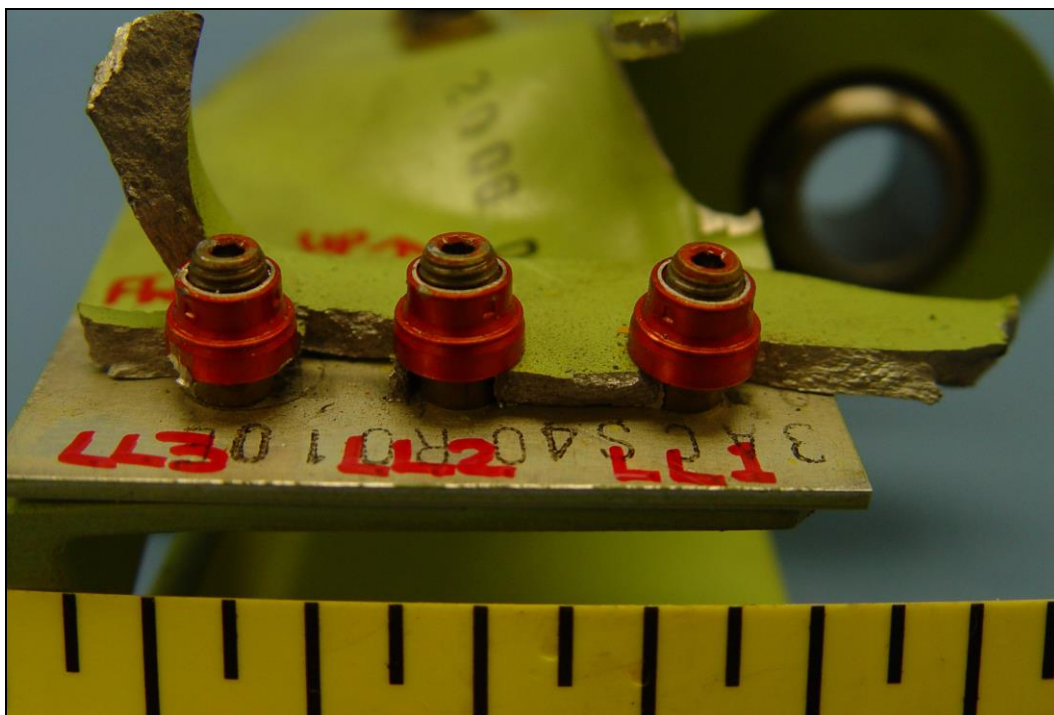
Examination of the main trailing edge hinge ribs revealed that both the upper and lower ribs had mating damage consistent with that noted for the Main and Standby PCU tailstocks' attach hardware. The NTSB characterised the overall damage as being consistent with an overload event.

Photo No. C2: Overload stress fracture and shear detail *(NTSB)*

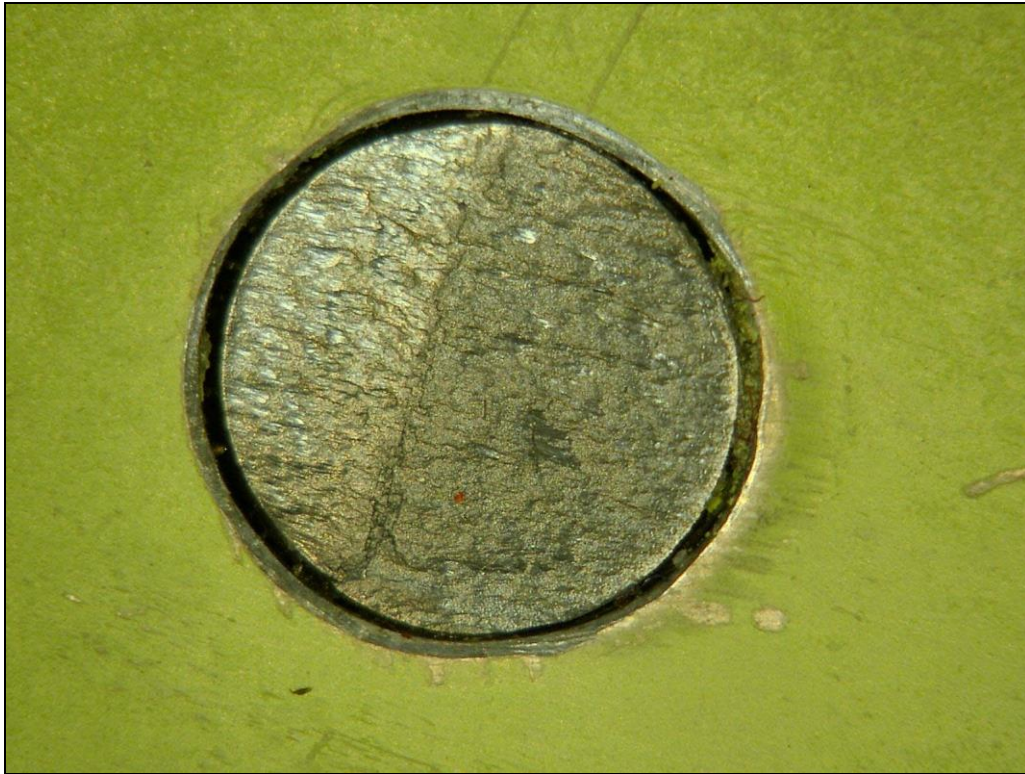
Photo No. C3: Main PCU lower bracket fastener shear (*NTSB*)

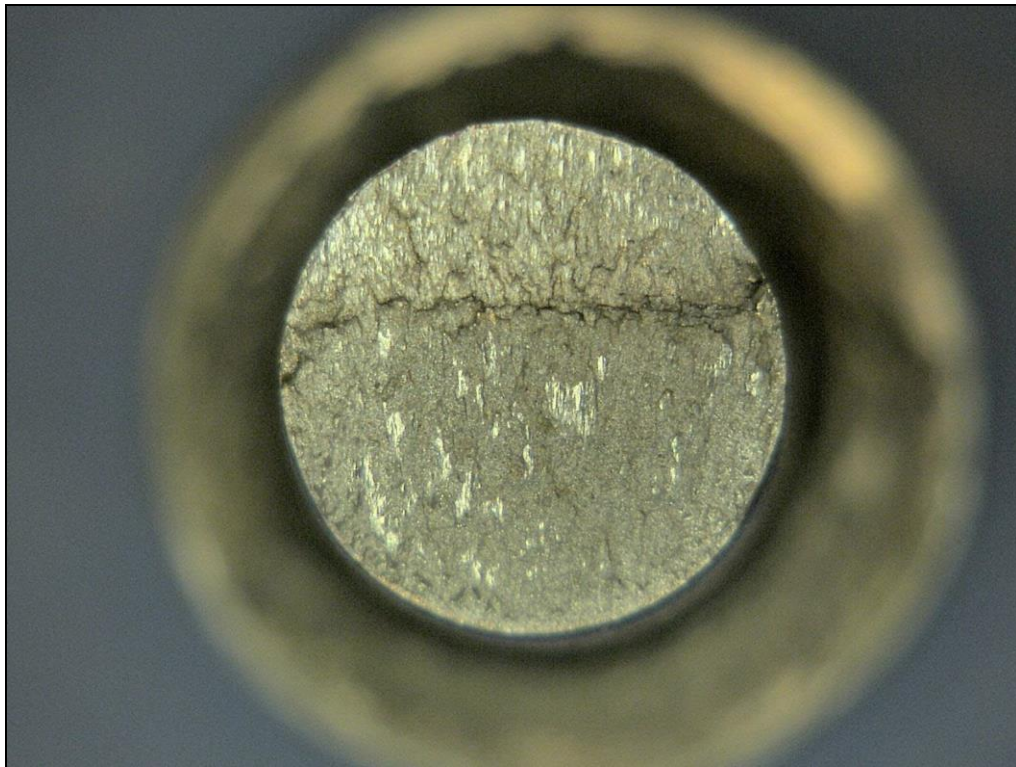
Photo No. C4: Main PCU lower bracket fastener shear (*NTSB*)
