# Air Accident Investigation Unit Ireland

**PRELIMINARY REPORT**

**Cessna 208B, G-KNYS**

**Near Clonbullogue, Co. Offaly**

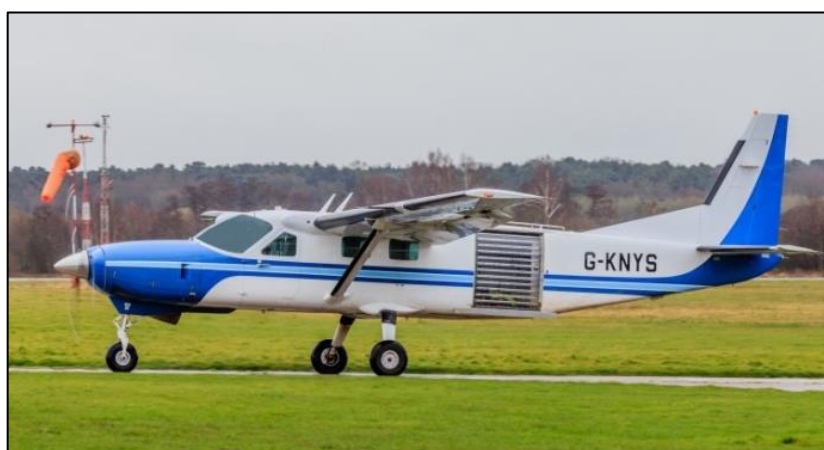
**Photo No. 1:** G-KNYS - Cessna 208B Grand Caravan (*David Reeves*)

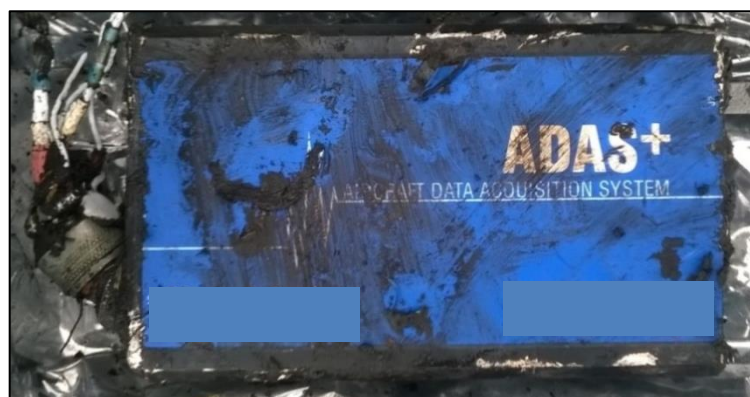
The ADAS unit from the accident aircraft was found at the site when the front section of the aircraft was lifted from the bog. It was damaged, but intact (**Photo No. 2**), and was shipped to the engine manufacturer’s Norwood facility in the USA on 15 May 2018 for examination under the supervision of the National Transportation Safety Board (NTSB)/Federal Aviation Administration (FAA). Following extensive preparatory work by the engine manufacturer, the unit was successfully downloaded on 23 May 2018.

**Photo No. 2:** ADAS unit recovered from the wreckage

The ADAS unit from G-KNYS was capable of recording 30 minutes of data on a continuous loop. The engine manufacturer advised that ADAS units contain a built-in battery with a 10-year life, which is used to power the unit's internal clock. The battery life had expired in the ADAS unit from G-KNYS. Consequently, the actual date and time were not recorded. However, the data obtained correlated with the ATC radar data for the accident flight. Several parameters were recorded, including Engine Inter-Turbine Temperature (ITT), Outside Air Temperature (OAT), Engine Torque, Static Pressure, Engine Speed (Ng), Propeller Speed (Np), Fuel Flow (Wf), Airspeed and Altitude. Analysis of the ADAS data is ongoing. However, the data indicates that the engine was providing power to the propeller until the end of the data recording.
