## FINAL REPORT

**AAIU Report No: 2010-003**  
**State File No: IRL00909076**  
**Published: 29/04/10**

<b>Aircraft Type and Registration:</b>	Colomban Cri-Cri MC-15, G-CDNJ
<b>No. and Type of Engines:</b>	2 x JPX PUL-212
<b>Aircraft Serial Number:</b>	69
<b>Year of Manufacture:</b>	1991
<b>Date and Time (UTC):</b>	17 August 2009 @ 15.40 hrs
<b>Location:</b>	Coonagh Airfield (EICN), Co. Limerick
<b>Type of Flight:</b>	Private
<b>Persons on Board:</b>	Crew - 1          Passengers - 0
<b>Injuries:</b>	Crew - Nil          Passengers - Nil
<b>Nature of Damage:</b>	Substantial
<b>Commander's Licence:</b>	ATPL issued by the UK Civil Aviation Authority (CAA)
<b>Commander's Details:</b>	Male, aged 34 years
<b>Commander's Flying Experience:</b>	6,214 hours, of which 1 hour was on type
<b>Notification Source:</b>	Duty Manager, Shannon Airport Air Traffic Control (ATC)
<b>Information Source:</b>	AAIU Accident Report Form submitted by Pilot, AAIU Field Inspection

During circuit flying, just before levelling from a descent, the left engine stopped. The Pilot carried out a forced landing into a field adjacent to the airfield. The aircraft suffered substantial damage. The engine stoppage was p

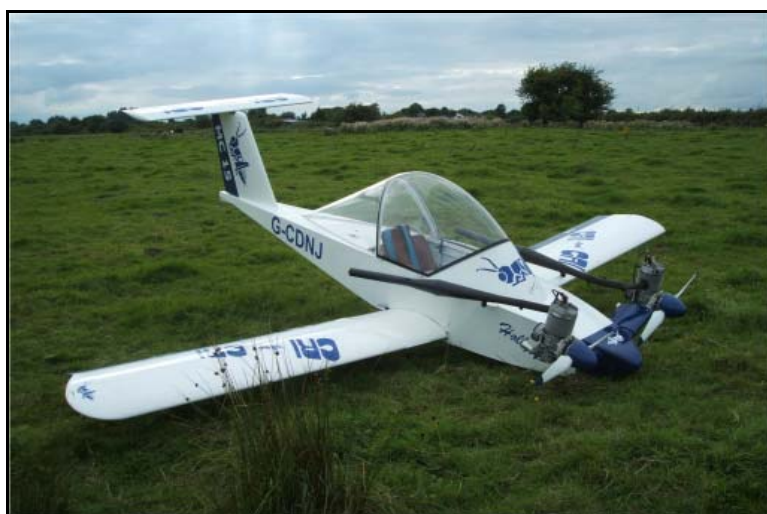
The aircraft suffered substantial damage, which included broken nose and right undercarriage legs, and extensive damage to the left wing tip, the right wing and flaperon, lower right hand side of the fuselage, the nose cone area and the right hand propeller. (**Photo No. 1**)

**Photo No. 1: Aircraft as it came to rest following the accident**

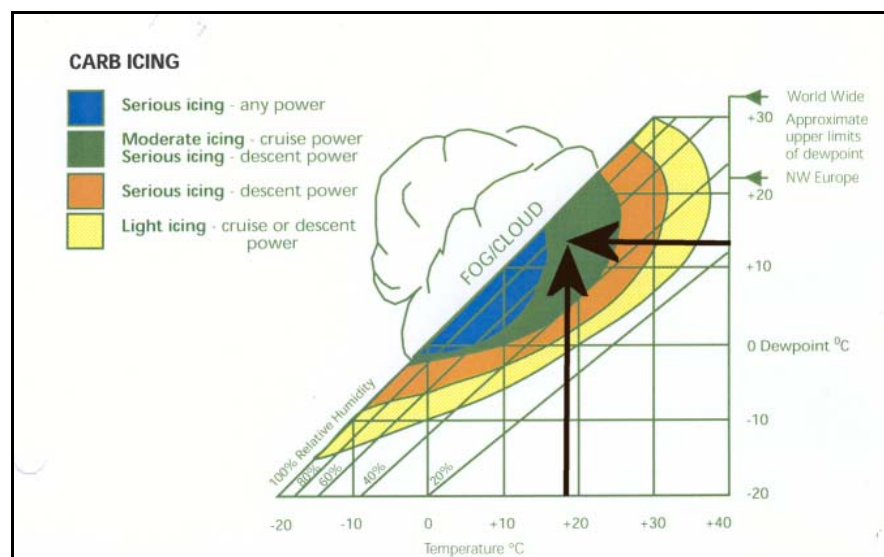
However TC notes “*In severe cases, ice may form at OATs<sup>1</sup> up to 20° C higher than with Avgas*”. **Figure No. 1** shows a version of this (Avgas) chart, with the temperature and dew point for the accident flight plotted.

**Figure No. 1: AVGAS carburettor icing chart for accident flight**

Despite the presence of some foreign matter in the bottom of the fuel tank, the facts that examination of the in-line filters revealed no contamination and the engine started and ran easily on the day following the accident, suggest that the foreign matter was not a factor in the accident. For an Avgas operated aircraft the prevailing conditions (temperature and dew point) were conducive to the formation of moderate carburettor icing at cruise power and serious carburettor icing at descent power. Factoring for the use of Mogas suggests that there was a serious risk of carburettor icing at any power setting. Evidence of carburettor icing is perishable and carburettor icing is usually diagnosed by exclusion i.e. by ruling out other potential causes such as mechanical failure. In this case, the fact that the failed engine started and ran on the day after the accident, indicates that the aircraft had sufficient fuel and a viable ignition system; allied to the prevailing temperature and dew point (**Figure No. 1**), this suggests a diagnosis of carburettor icing, particularly when cognisance is taken of TC’s warning in relation to the (Avgas) chart, that “*the risk areas would be larger*” for Mogas.
