## FINAL REPORT

AAIU Report No: 2010-018  
State File No: IRL00910076  
Published: 4/11/2010

<b>Aircraft Type and Registration:</b>	Mooney M20J, D-EKGL
<b>No. and Type of Engines:</b>	1 x Lycoming IO-360-A3B6D
<b>Aircraft Serial Number:</b>	24-3232
<b>Year of Manufacture:</b>	1991
<b>Date and Time (UTC):</b>	12 August 2010 @ 14.56 hrs
<b>Location:</b>	Kerry Airport, Co. Kerry
<b>Type of Flight:</b>	Private
<b>Persons on Board:</b>	Crew – 2      Passengers – 0
<b>Injuries:</b>	Crew – Nil      Passengers – Nil
<b>Nature of Damage:</b>	Significant
<b>Commander's Licence:</b>	JAA Private Pilot Licence (Germany)
<b>Commander's Details:</b>	Male, aged 62 years
<b>Commander's Flying Experience:</b>	570 hours, of which 250 were on type
<b>Notification Source:</b>	Kerry Air Traffic Services
<b>Information Source:</b>	AAIU Field Investigation and Accident Report Forms

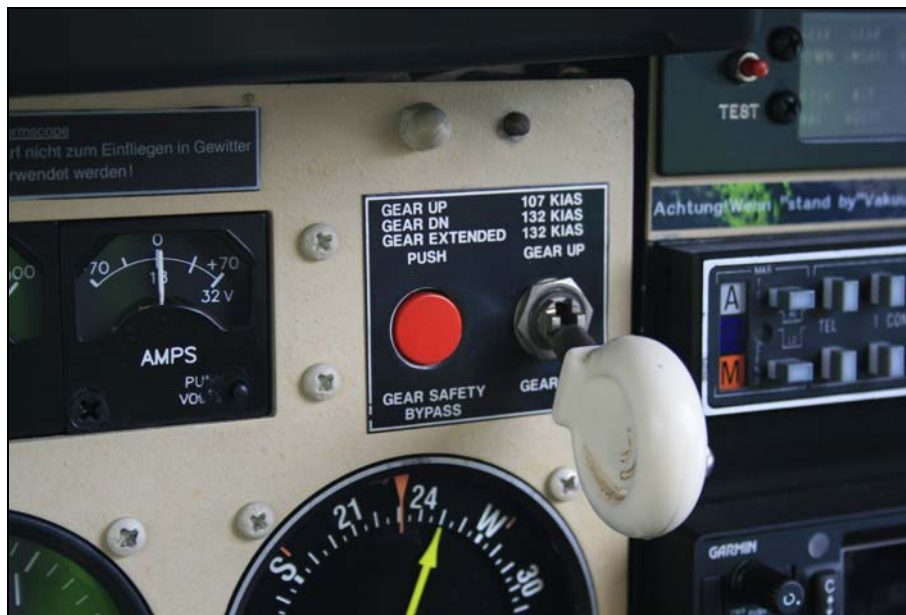
Moving the landing gear selector switch (**Photo No. 1**) to the lower detent operates the landing gear actuator relay and lowers the landing gear. A down limit switch stops the gear actuating motor when sufficient force has been exerted to hold the landing gear down. Bungee springs preload the retraction mechanism in an overcentre position to assist in holding the landing gear in the down position. The green 'Gear Down' light will illuminate on the annunciator panel and the landing gear position indicator (on the floorboard) will indicate a green decal. The green annunciator light illuminates continuously when the landing gear is fully extended.

**Photo No. 1:** Landing Gear selector switch and Gear Safety Bypass switch

A landing gear safety bypass switch is positioned next to the landing gear selector lever, to be used in case the landing gear fails to retract. Depressing and holding the switch bypasses the airspeed safety switch and allows the landing gear to retract (**Photo No. 1**).

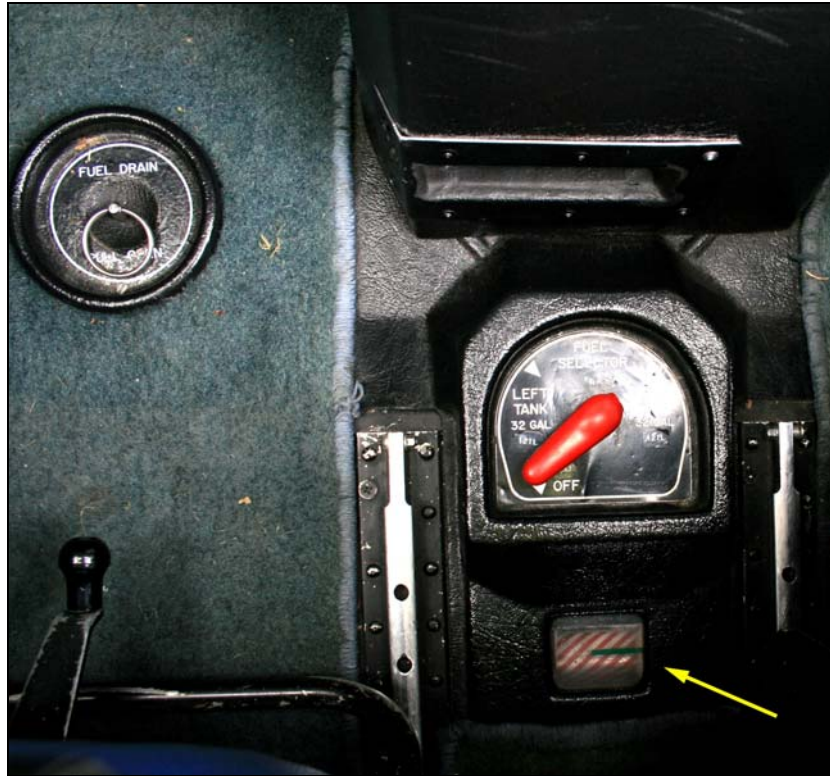
Moving the landing gear selector switch to the upper detent will raise the landing gear. However, an airspeed safety switch is incorporated to prevent landing gear retraction while on the ground and until a safe take-off speed is reached (approximately 60 kts indicated airspeed). An up limit switch stops the landing gear actuating motor when the landing gear is in the retracted position. When the landing gear is retracting, the red 'Gear Unsafe' light will illuminate on the annunciator panel. When the landing gear has fully retracted, the red 'Gear Unsafe' light extinguishes and the landing gear position indicator will indicate a red/white decal (**Photo No. 2**).

**Photo No. 2:** Gear Position Indicator (shows retracted position)

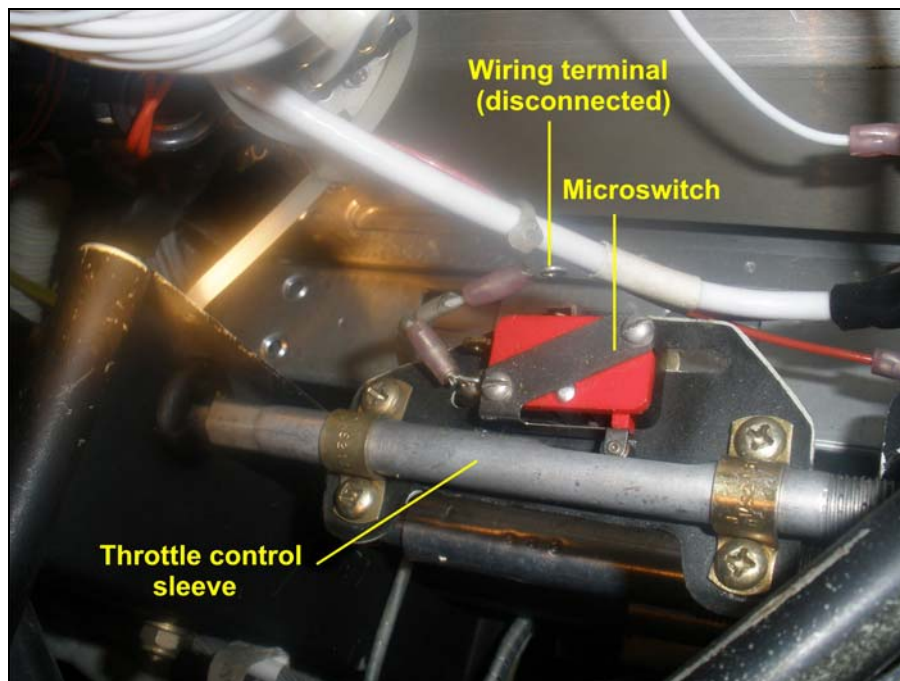
Manual activation of the stall warning vane did not produce an audible warning from the horn. An inspection was made of the landing warning horn circuit. The microswitch positioned above the throttle control was found to have the common (COM) terminal disconnected from the wiring (**Photo No. 3**).

**Photo No. 3:** Landing Gear warning system microswitch

The attachment screw was not recovered. The stall warning/landing gear warning horn was tested using a voltmeter with manual activation of the stall warning vane; although a voltage was observed across the horn terminals, no tone was produced.

The landing gear warning system had developed two separate faults. The microswitch had been open-circuited due to a wiring terminal lug becoming detached from the switch (COM) connection. It is possible that the fixing screw may have worked loose over time due to vibration. This fault rendered the circuit permanently open, and the microswitch function inoperative. This function is to provide the aural warning if the throttle is closed to near idle and the landing gear is not fully down. The aural warning horn itself was also unserviceable and as the two systems use a common warning device, it also made the stall warning system inoperative. With the Battery switched to 'ON' it is possible to test the stall warning manually during the pre-flight checks. The Pilot subsequently stated to the Investigation that the horn functioned during the preflight inspection prior to flight. However, as there is no facility to check the landing gear warning system on the ground, the wiring disconnection fault and the unserviceability of the landing gear warning system would not have been apparent to the PIC.
