# Air Accident Investigation Unit Ireland

**ACCIDENT REPORT**  
**SCHLEICHER - ASK 21 (Glider), EI-GLB**  
**Gowran Grange Airfield (EIGN), Co. Kildare**  
**24 October 2010**

AAIU Draft Final Report No: 2012-002

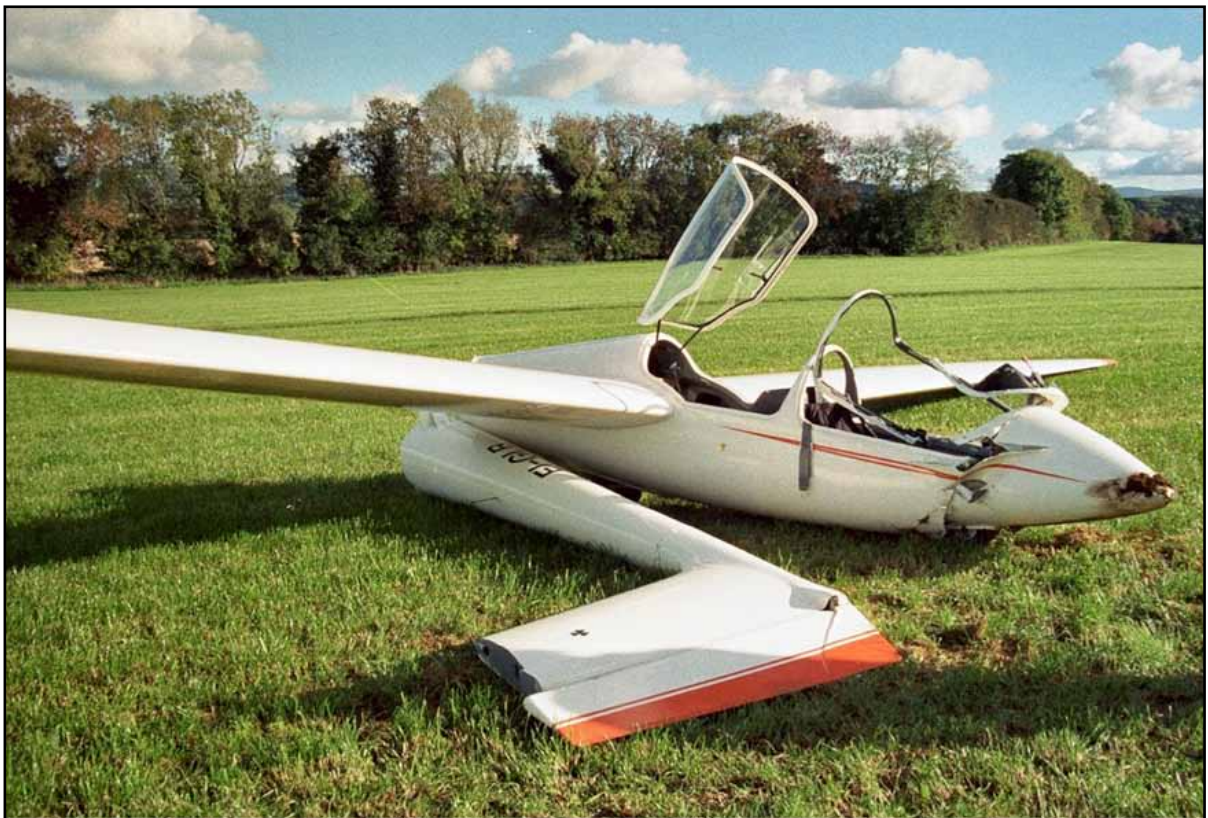
RWY 03 at EIGN is a grass strip 475 metres long. A heavy single wheel indentation was found in the grass in the touchdown area of RWY 03, 150 metres from the threshold. An impact mark was found at a further 57 metres to the right of the runway. The glider stopped 30 metres from that impact, pointing back towards the threshold of RWY03, consistent with a ground loop.

The glider was substantially damaged. The tail section had severed behind the wings (**Photo No. 1**), but remained attached to the fuselage by control cables. The horizontal tail plane had detached and the nose area was crushed. Mud was found on the right wingtip. A technical inspection of the glider established continuity for flight controls and did not find evidence of any pre-existing defect that might have contributed to the cause of the accident.

Photo No. 1: Final resting position of EI-GLB
