FINAL REPORT

AAIU Synoptic Report No: 2005-004

Aircraft Type and Registration:	Piper PA 28, EI-BSO
No. and Type of Engines:	1x Lycoming 0-320-E2A
Aircraft Serial Number:	28-25449
Year of Manufacture:	1969
Date and Time (UTC):	24 January 2004 @ 13.20 hrs
Location:	Ramsgrange, Co. Wexford 52° 12' N 6° 53' W
Type of Flight:	Private
Persons on Board:	Crew - one Passengers - one
Injuries:	Crew - Nil Passengers - Nil
Nature of Damage:	Minor damage to engine air intake
Commander's Licence:	Irish CPL
Commander's Details:	Male, aged 36 years
Commander's Flying Experience:	1,412 hours, of which 1,200 were on type
Information Source:	Station Manager, Shannon Airport and An Garda Síochána at New Ross.

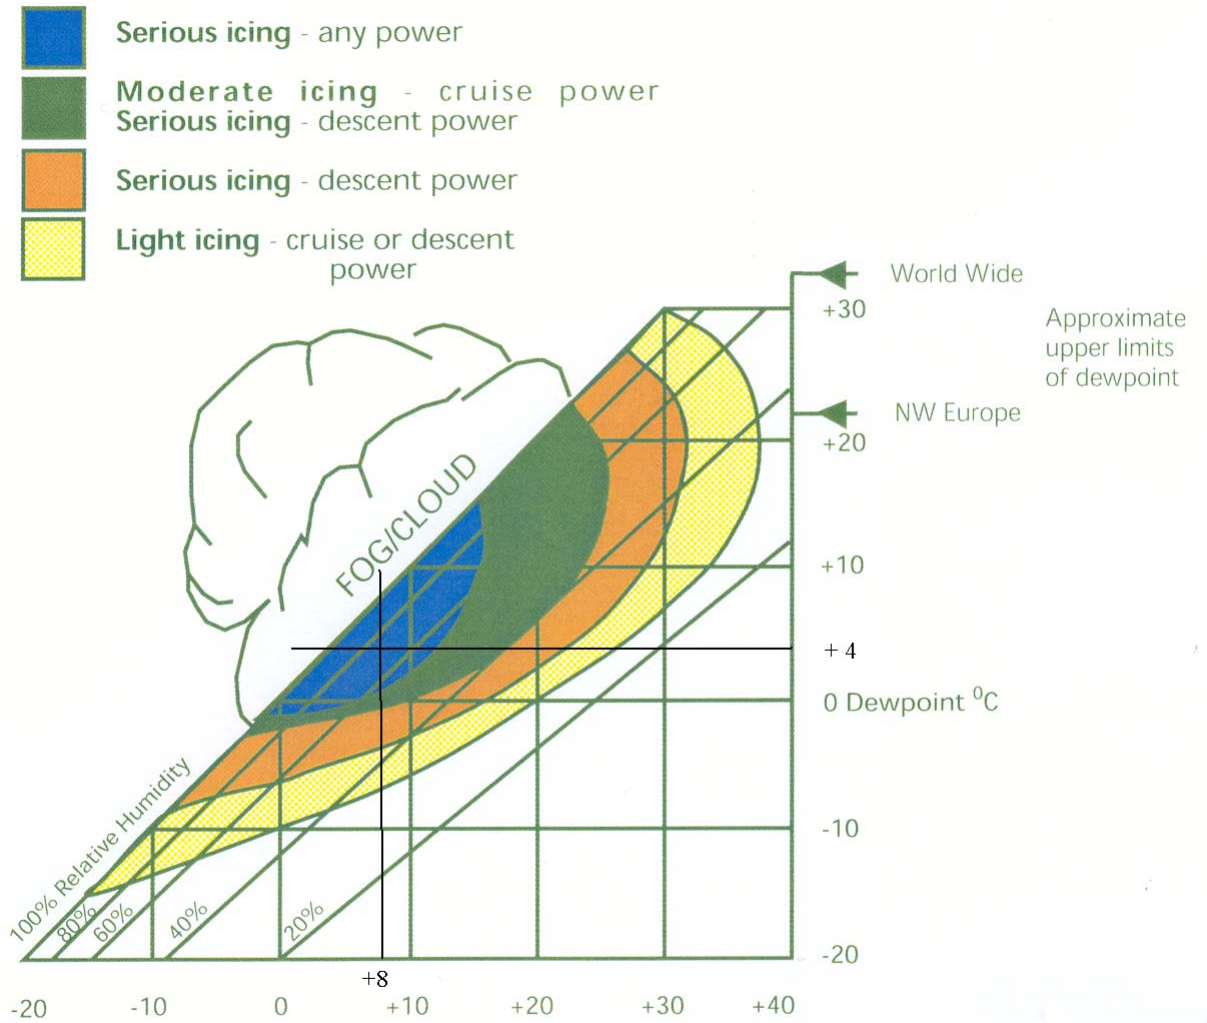
Appendix A

In 1979 the IAA issued an Aeronautical Information Circular (AIC) pointing out in graphical form the likelihood of carburettor icing at various levels of ambient temperature and dewpoint. (See graph Appendix A)

At a temperature of 8° C and a dewpoint temperature of 4° C there is a possibility of serious carburettor icing at any power setting. However, if the pilot has switched on carburettor heat, and switched it on in time, then carburettor icing could be prevented.
