Air Accident Investigation Unit Ireland

ACCIDENT REPORT
Snowden, Avid Flyer, G-BTKG
Near Trevet Airfield, Co Meath, Ireland
2 July 2011 @ 16.30 hrs

AAIU Final Report No: 2012-005

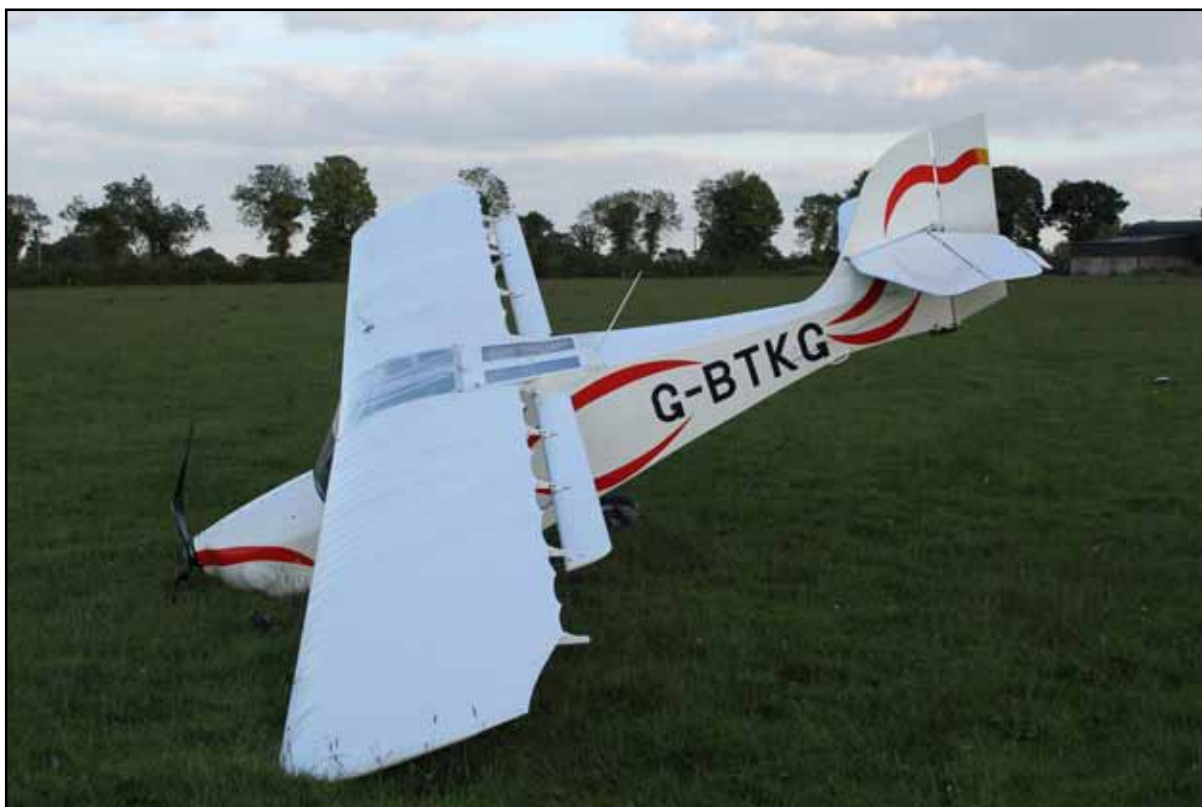
The Investigation examined the aircraft shortly after the accident (**Photo No. 1**). No pre-accident defect was observed. Clean uncontaminated fuel was found in the float chambers of both carburettors.

Photo No. 1: Final resting position of G-BTKG.

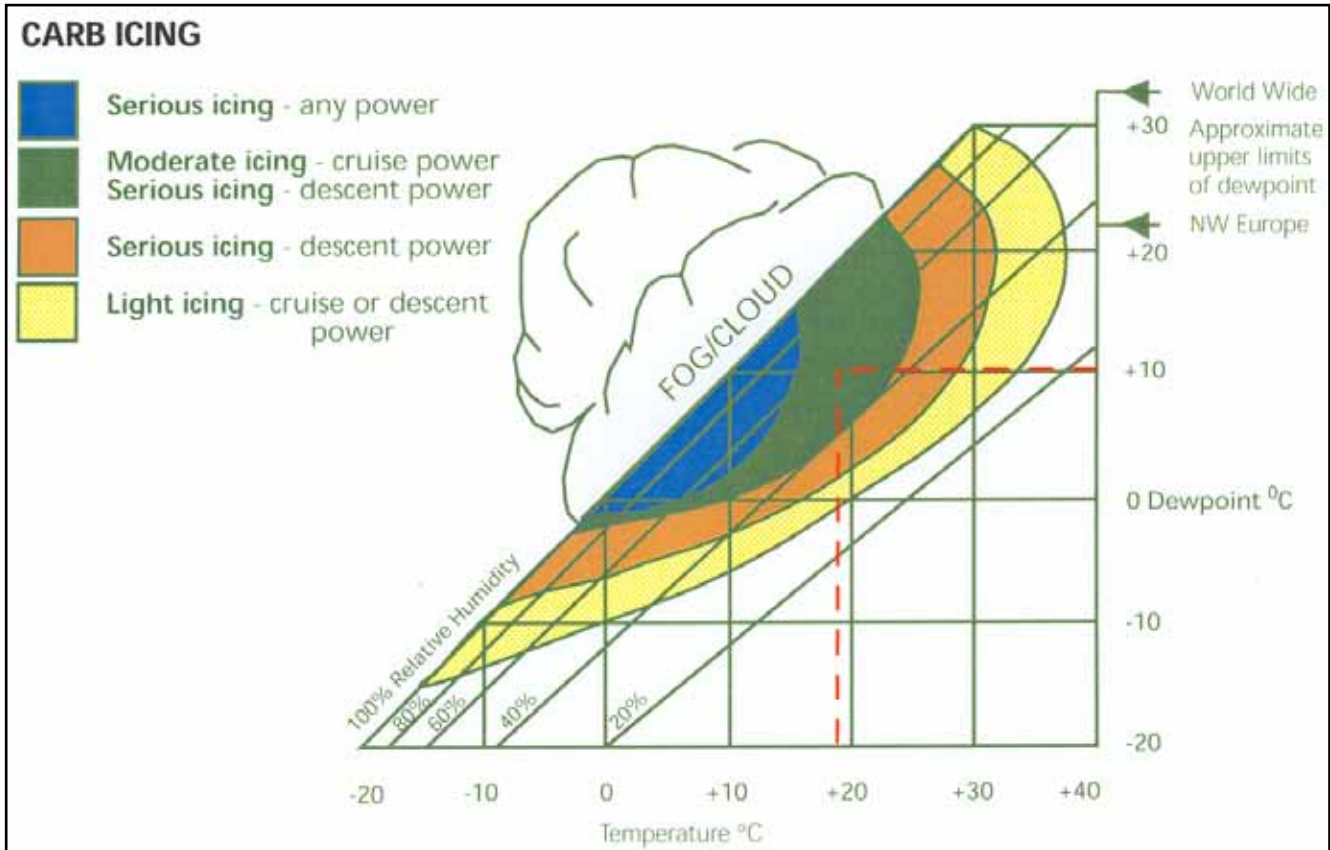
The Investigation found no fault with the engine or its fuel system when they were examined shortly after the accident. Although this unintentional flight was of short duration, the engine had been run for some time at various power settings while on the ground. Interpolation of the carburettor icing graphic in **Appendix 1** shows that, for a temperature of 18°C and a dew point of 10°C, moderate icing was likely at cruise power settings and serious icing at a descent power setting. It is therefore possible that the cause of the engine problems reported was carburettor icing, although this could not be confirmed. Nevertheless, the occurrence was an unwanted distraction for the Pilot in the highly pressurised situation that he found himself.

Figure No. 1: Carburettor icing

Note: This graphic displays the likelihood of carburettor icing when AVGAS³ 100LL is used. A similar graphic is not available for MOGAS but empirical evidence indicates that MOGAS is more susceptible to carburettor icing than AVGAS.
