Air Accident Investigation Unit Ireland

FACTUAL REPORT

ACCIDENT

**ICP Savannah S, EI-GHR
Craughwell Airfield, Co. Galway**

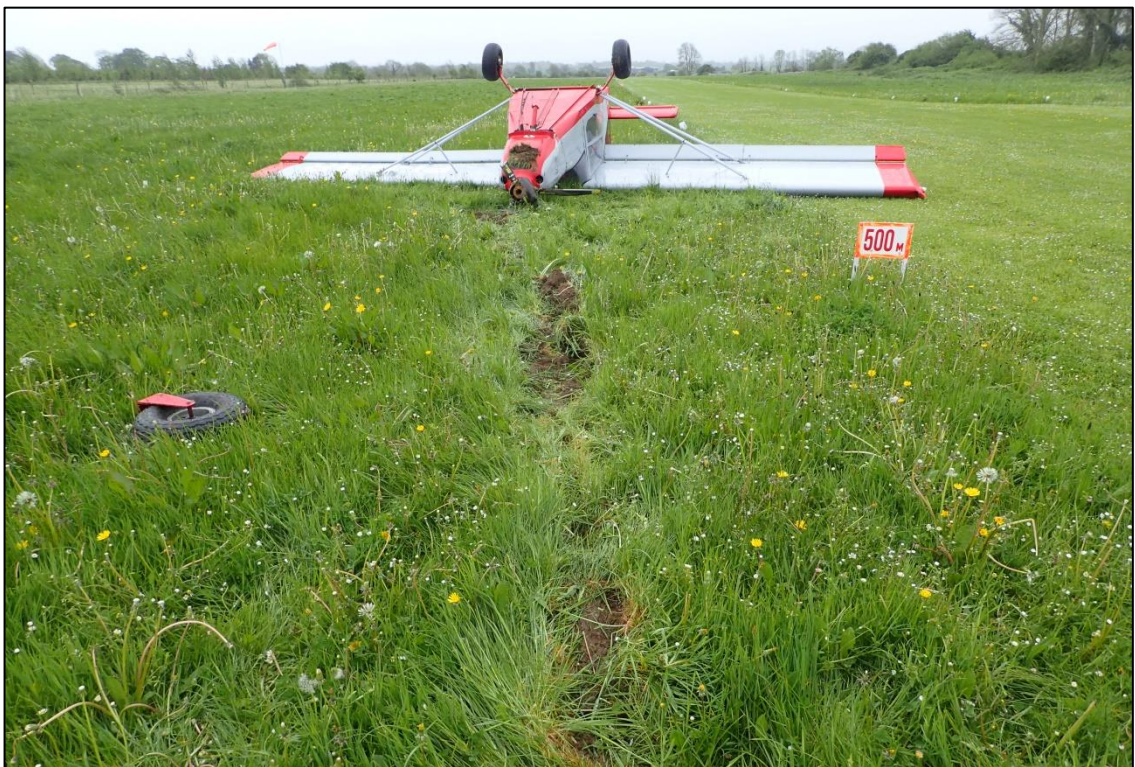
On examination of the aircraft, it was noted that the nosewheel had sheared from its leg early in the impact sequence. The nosewheel leg was bent rearwards and there was grass and soil embedded in the air inlet on the bottom of the engine cowling. Two of the propeller's three blades had fractured and separated, while the third had fractured but not separated. The propeller spinner sustained significant damage and much of it had separated. There was buckling on the underside of the aircraft aft of the firewall. There was distortion of both door frames and significant crumpling and distortion, circumferentially in the area aft of the cabin structure. The fairing on the top of the rudder was shattered and the leading edge of the fin had crumpling damage. The tip of the leading edge of the right wing was also damaged.

Photo No. 1: Aircraft position following the accident
