Air Accident Investigation Unit Ireland

FACTUAL REPORT

**Piper PA-28-181 (Archer II), G-BHNO
Milltownpass Airstrip, Co. Westmeath**

28 June 2022

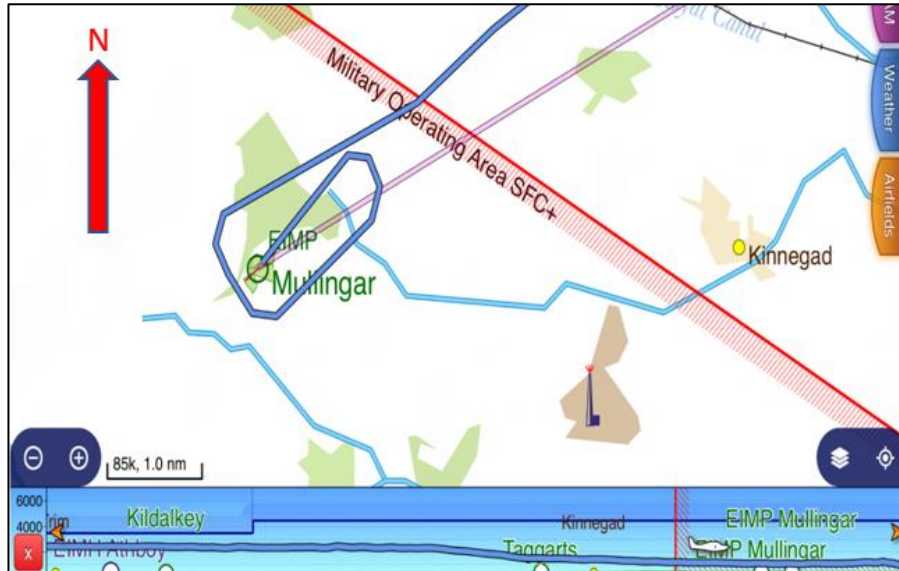
Figure No. 1: Aircraft approach to Milltownpass (as recorded by Pilot's navigation app)

As the Pilot turned onto final approach, he noticed that the wind was stronger than expected and that the aircraft had drifted to the right of the extended centreline and was slightly above the ideal approach path. To regain the centreline and approach path, the Pilot said he performed a side slip manoeuvre⁸ before crabbing the aircraft into wind during the latter stage of the approach.

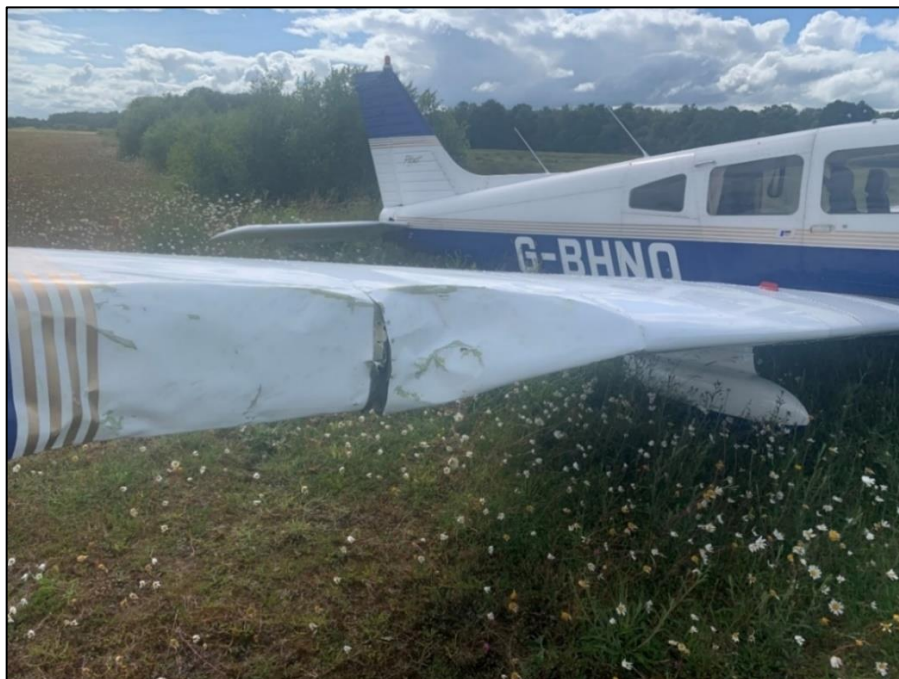
The aircraft touched down to the right of the centreline approximately 105 m after the threshold of RWY 24. The Pilot informed the Investigation that during the landing roll, the aircraft departed the right-hand edge of the runway, and entered rough ground where its right wing struck a wooden post; and that the aircraft came to rest having rotated approximately 180 degrees from its original direction of travel. **Photo No. 1** shows the damage to the right wing and the final position of the aircraft which was approximately 261 m from the runway threshold. The Pilot, who was the sole occupant of the aircraft, was uninjured and he exited the aircraft unaided. There was no fire.

Photo No. 1: Final position of G-BHNO (image provided by the Pilot)

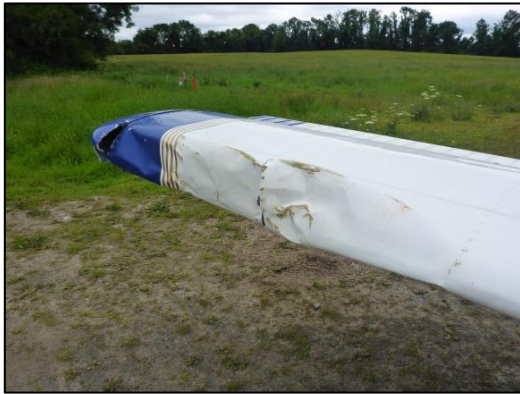
Following the accident and prior to notifying the AAIU, the aircraft was removed to another location on the airstrip. The AAIU inspected the aircraft at this location. The leading edge of the right wing sustained significant damage (**Photo No. 2**). The right wing had partially separated from the wing root (**Photo No. 3**). The anti-servo tab on the left elevator sustained significant crush damage (**Photo No. 4**). There was damage observed to the right trailing edge flap and adjacent fuselage due to the rearward movement of the right wing during the accident (**Photo No. 5**).

Photo No. 2: Damage to right wing

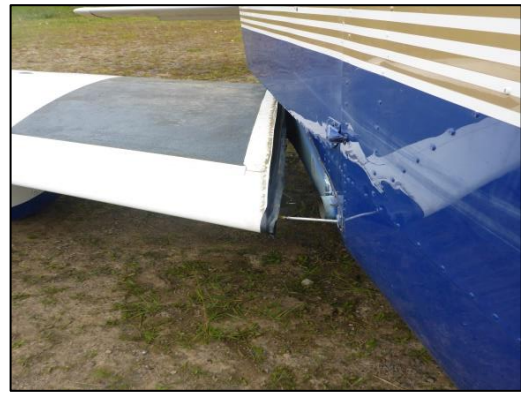
Photo No. 3: Damage at wing root

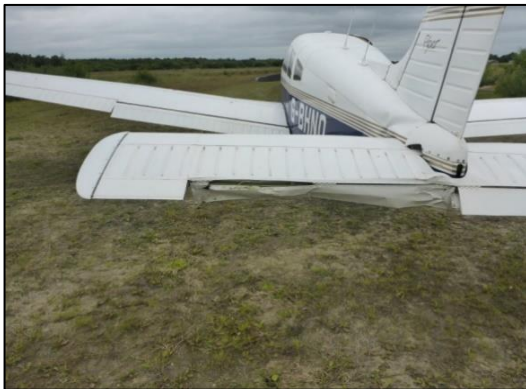
Photo No. 4: Damage to left anti-servo tab

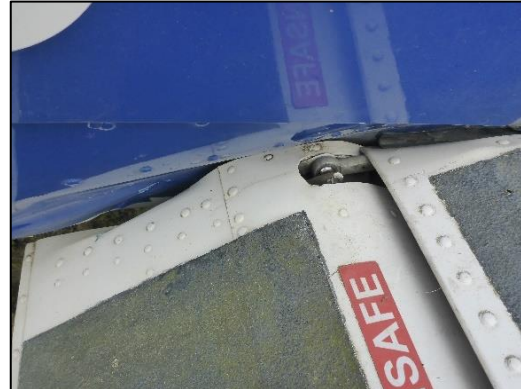
Photo No. 5: Damage to flap and fuselage

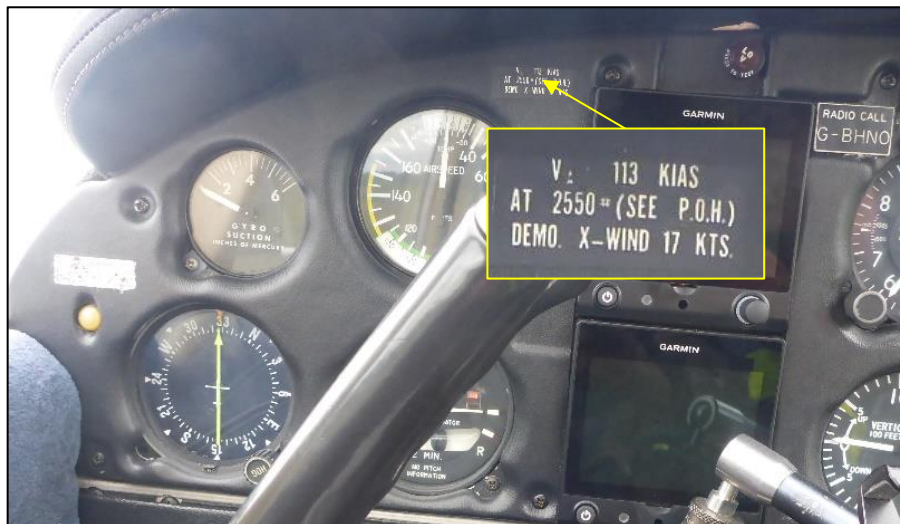
Figure No. 2: Instrument panel of G-BHNO with placard

The aircraft has a maximum take off weight of 1,157 kgs with a maximum demonstrated crosswind¹⁰ of 17 knots. In accordance with the Pilot's Operating Handbook (POH), this was placarded in the cockpit of the subject aircraft above and to the right of the airspeed indicator (Figure No. 2).

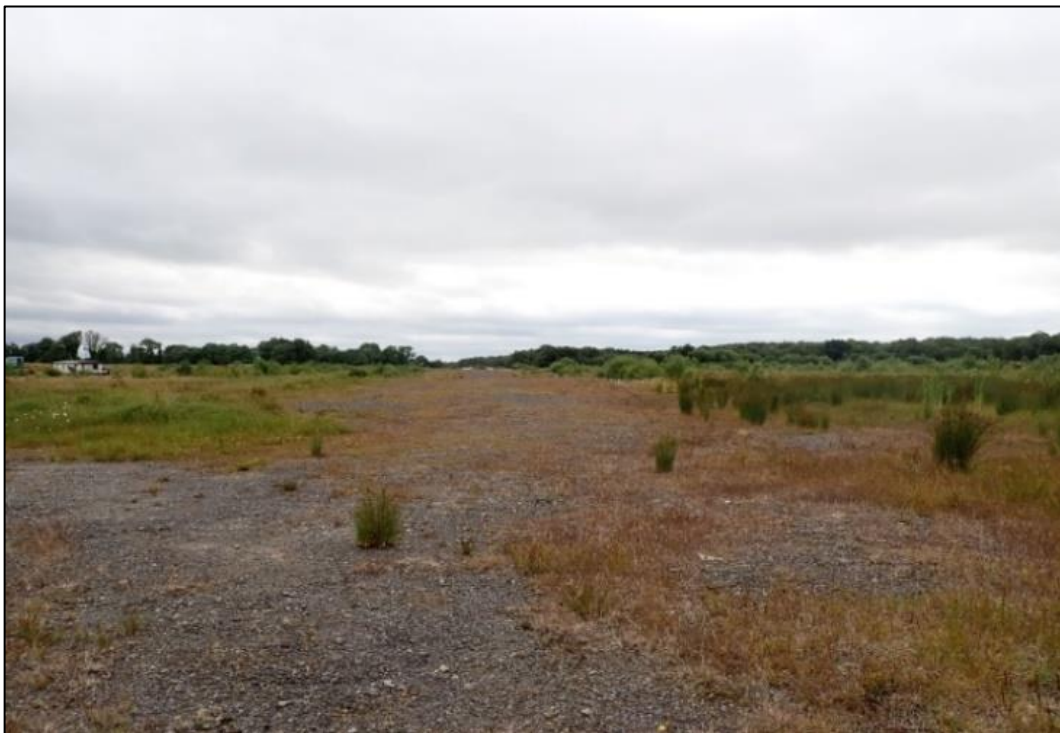
Accurate measuring of RWY 24 in both length and width proved difficult for the Investigation as there were no runway markings and the edges were ill-defined. In addition, the surface was covered in loose stones/gravel, and there were weeds and other vegetation encroaching from both sides and ends of the runway (**Photo No. 6**). The Investigation located the approximate final position of the aircraft following the accident (**Photo No. 7**). A broken fence post was also found. The Investigation's site survey of the airstrip had difficulty locating the other runway, RWY 27, due to an abundance of foliage resulting in the runway being essentially overgrown.

Photo No. 6: View of RWY 24

RWY 24 at the airstrip was unmarked and its edges were ill-defined. This would have made it difficult for the Pilot to identify the runway centreline. In addition, the surface was covered in loose stones/gravel. Based on data from the meteorological aftercast, the wind at the time of the accident may have exceeded the maximum demonstrated crosswind of the aircraft, and this, combined with the condition of the runway, left little margin for error. The aircraft touched down in gusty conditions, veered off the runway and entered rough ground at the right-hand side of the runway. The Pilot reported that the aircraft's right wing struck a wooden post, and that the aircraft came to rest approximately 180 degrees from its original direction of travel. The extent of the damage to the aircraft suggests that the impact sequence was quite dynamic and involved significant forces. The Pilot was uninjured and notified the AAIU of the accident two days later, after the aircraft had been moved.

The airstrip was unlicensed, and therefore was not subject to regulatory oversight. Unlicensed airstrips are not required to meet a defined standard and conditions at such airstrips may vary widely. The IAA's Safety Promotion Leaflet, AED 1, provides helpful guidance to airstrip owners on how to mitigate the risks posed by obstacles in the vicinity of a runway. However, although the leaflet does not give guidance regarding aspects such as adequate surface conditions on non-grass runways, clear definition of runway thresholds and edges, or the presence of windsocks, these are obvious requirements. Following the accident, the airstrip owner informed the Investigation that he closed the runway until such time as remedial works could be completed.
