Air Accident Investigation Unit Ireland

FACTUAL REPORT

**Sud Aviation SE 313B, Alouette II, N577AG
Newcastle Airfield, Co. Wicklow**

16 July 2022

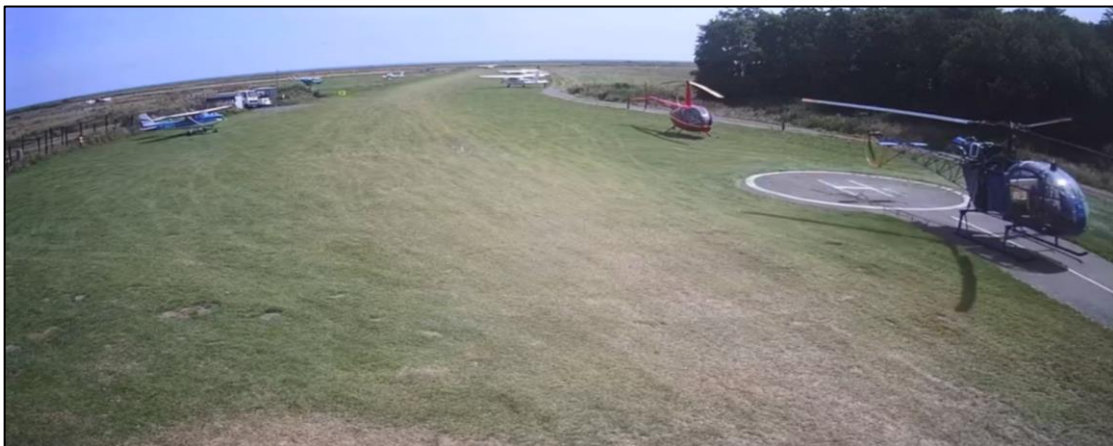
Figure. No 1: CCTV image of helicopter on tarmac surface prior to lift-off (blue helicopter in foreground, image looking east)

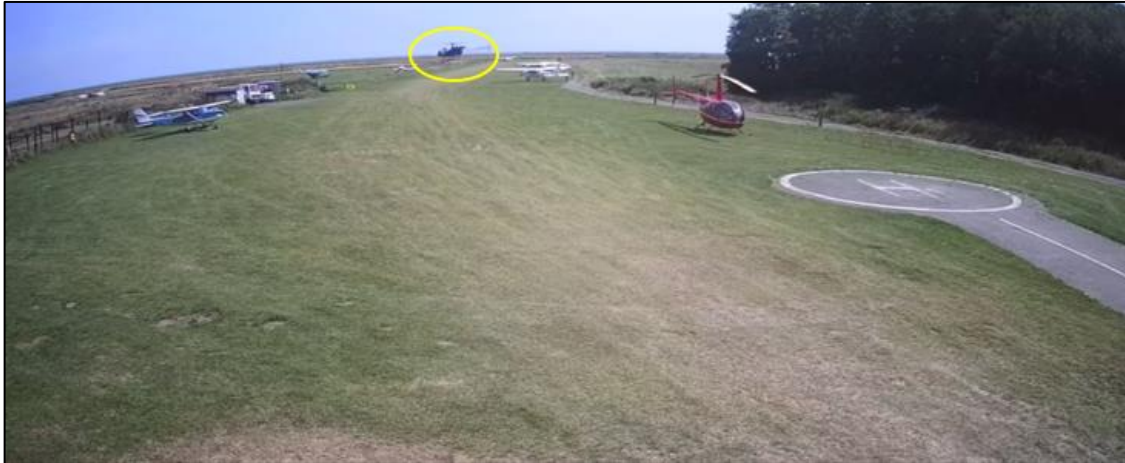
The CCTV recording shows the helicopter lifting off in a controlled manner and commencing a slow right turn to establish on an easterly heading at a height of approximately 20 feet. Approximately 33 seconds after lift-off, the helicopter yawed to the left and descended (**Figure No. 2**). The rate of yaw increased, and the helicopter commenced a rolling motion to the right from which the Pilot was unable to recover.

Figure. No 2: Helicopter yawing to the left and descending

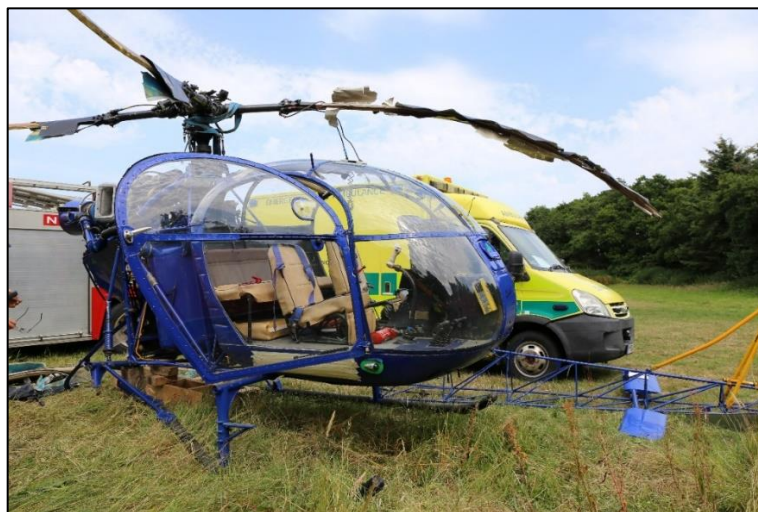
The helicopter had come to rest in a nose up attitude. There was buckling of the right-hand skid consistent with impact. The cockpit was mostly intact, with some of the plexiglas panels having shattered during the accident sequence. No significant damage was observed to the control cables connecting the control quadrant to the tail rotor pitch change mechanism; however, some of the pulleys on which these cables ran were not rotating freely and exhibited some damage. All three main rotor blades sustained substantial damage consistent with ground strikes during the accident sequence.

Photo. No 1: Damage to helicopter (photo taken following recovery at airfield)

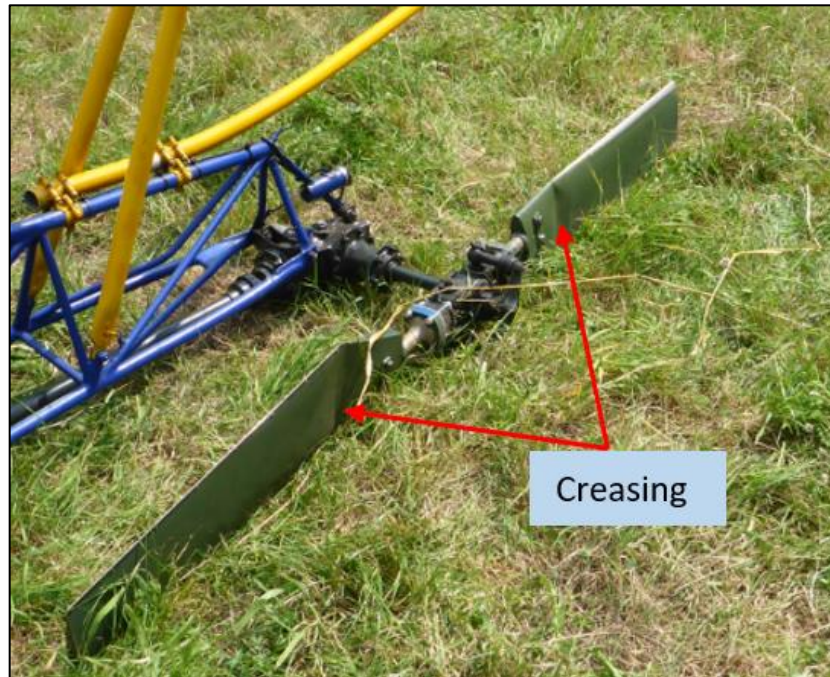
The tail rotor blades exhibited chordwise creasing at the roots (**Photo. No 2**), however, the tips and leading edges of both blades did not show any damage. The tail boom had separated from the main body of the helicopter and the tail rotor drive shaft was bent and had separated from the intermediate driveshaft. The centrifugal clutch, which transfers power from the engine to the main gear box, exhibited heat damage and there was molten metal visible on its surface. The Investigation noted that a number of fasteners on the airframe and main gearbox were not secured by split pins and were loose.

Photo No. 2: Chordwise creasing of tail rotor

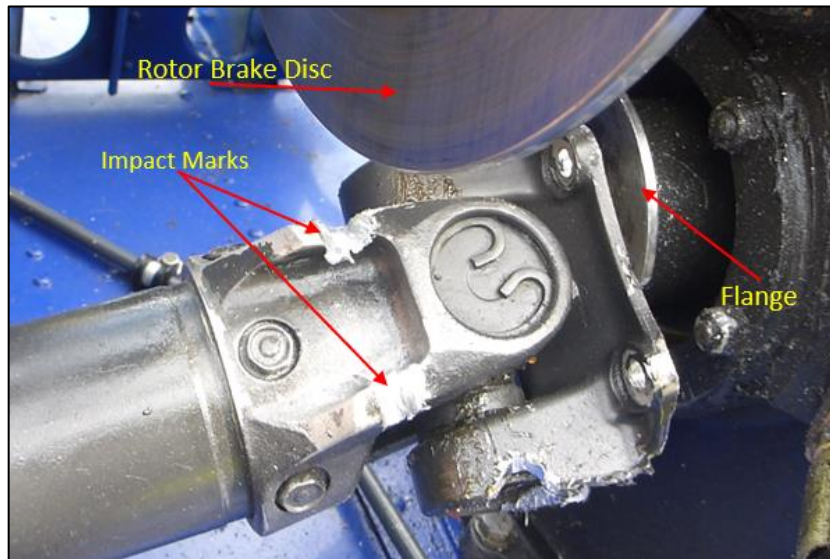
The tail rotor inclined drive shaft (**Figure No. 3**) is part of the tail rotor transmission system and is connected to the main gearbox output flange via a universal joint. This universal joint is secured to the flange by four bolts and associated nuts, washers, and split pins. The universal joint was found to have completely separated from the main gearbox output flange and all four bolts were missing. The universal joint exhibited impact marks consistent with it having separated from the main gear box output flange and coming into contact with the main rotor brake disc at high rpm (**Photo No. 3**). The mating surface of the universal joint was deeply scored. Rotational witness marks were observed on the inclined drive shaft where it made contact with the airframe following the separation.

Photo. No 3: Damage to universal joint

The Investigation notes that the Pilot flew the helicopter on two previous occasions in July 2022. The Pilot reported no issues with the flight controls or other anomalies on these two flights. On the day of the accident, the Pilot decided to move the helicopter to another location on the airfield. Shortly after lift-off, the Pilot heard a loud bang followed by an uncommanded yawing motion to the left, which is consistent with a loss of drive to the tail rotor as observed by one of the witnesses to the accident. The Pilot was unable to recover from this yawing motion and the helicopter impacted with terrain on a grass taxiway in close proximity to other aircraft. The nuts and bolts that secure the universal joint to the main gearbox output flange were not found following the accident. The loss of drive was likely the result of these becoming loose and eventually failing or migrating.
