Air Accident Investigation Unit Ireland

FACTUAL REPORT

**Cessna 150M, EI-HJX
Ballingen, Co. Wexford**

AAIU Report No: 2023-014

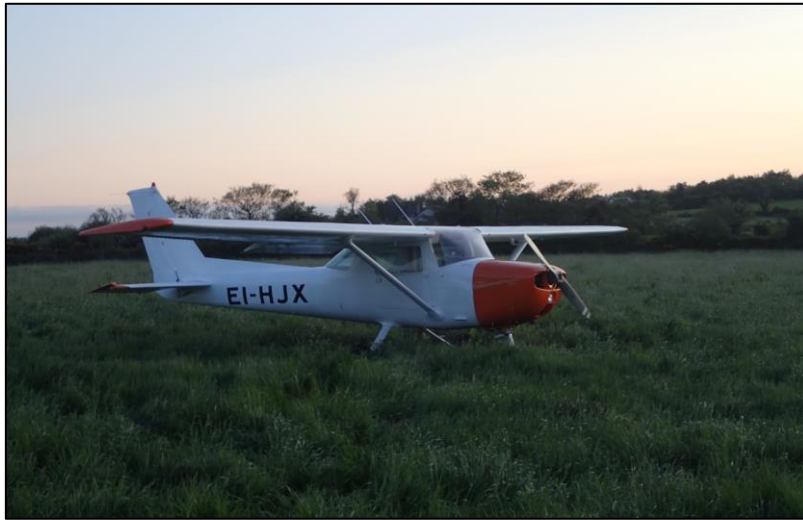
The aircraft was not damaged during the landing, and came to rest in an agricultural field, the surface of which was covered in long grass (**Photo No. 1**).

Photo No. 1: Position of EI-HJX following landing

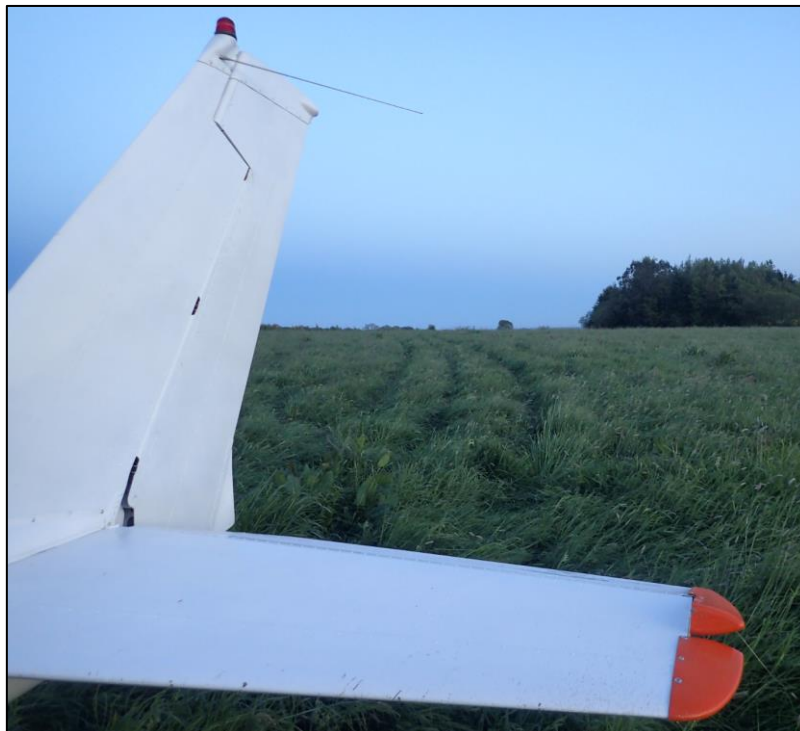
The aircraft wheels made curved track marks (approximately 55 metres (m) in length) on the grass surface before the aircraft came to rest on a magnetic heading of approximately 350 degrees (**Photo No. 2**).

Photo No. 2: Curved ground track made by the aircraft wheels

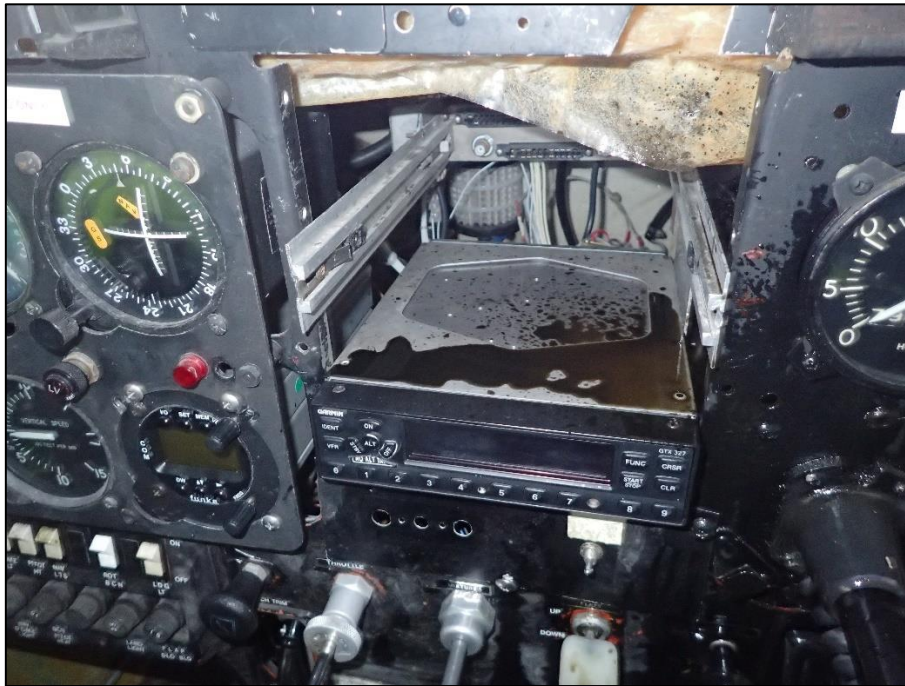
When inspected in the field, the Investigation noted that the instrument panel was open and that oil had pooled on top of the aircraft's transponder unit (**Photo No. 3**).

Photo No. 3: Open instrument panel with oil pooled on transponder unit

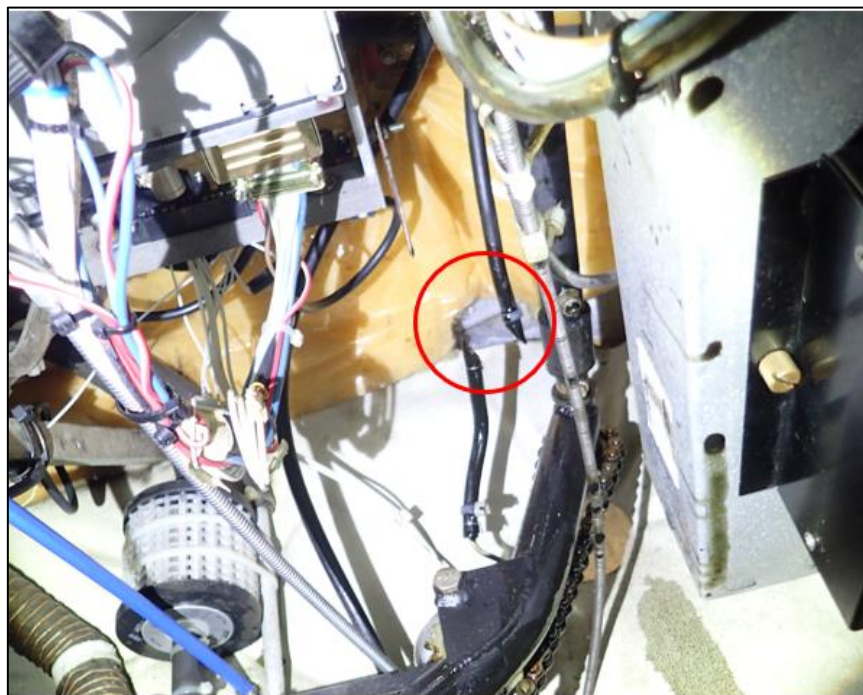
Examination of the area behind the instrument panel identified that a pipe supplying engine oil from the engine to the oil pressure gauge had fractured and allowed engine oil to discharge into the aircraft cockpit (**Photo No. 4**).

Photo No. 4: Fractured pipe (ringed in red) behind instrument panel (as viewed from below)

The Investigation identified that the cause of the oil leak was the failure of an unapproved repair that had joined two sections of metal pipe butted together using a plastic sleeve secured with tie-wraps and locking wire.

While the provenance of the unapproved repair could not be determined from the available maintenance records, this incident demonstrates the importance of only using correct parts and repair schemes whenever maintenance is being carried out on an aircraft.

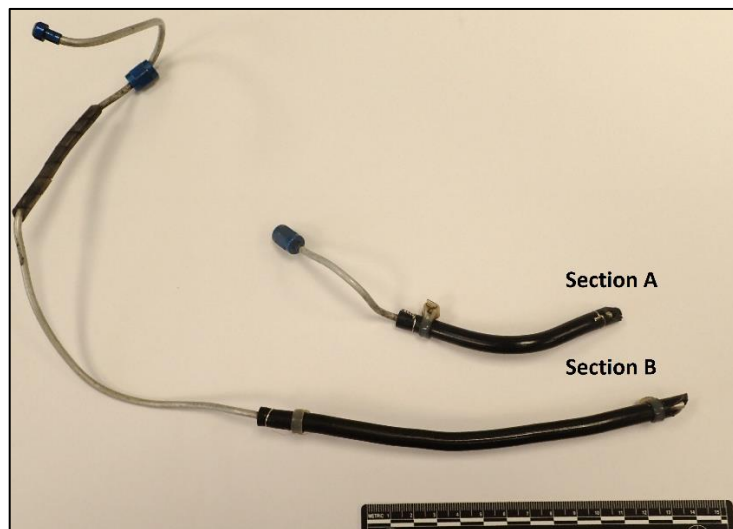
The two sections of the fractured pipe (designated Section A and Section B for the purposes of this Report) were removed from the aircraft in the field, under the supervision of the Investigation, by one of the Operator's technical personnel (**Photo No. 5**).

Photo No. 5: The two sections of the fractured pipe

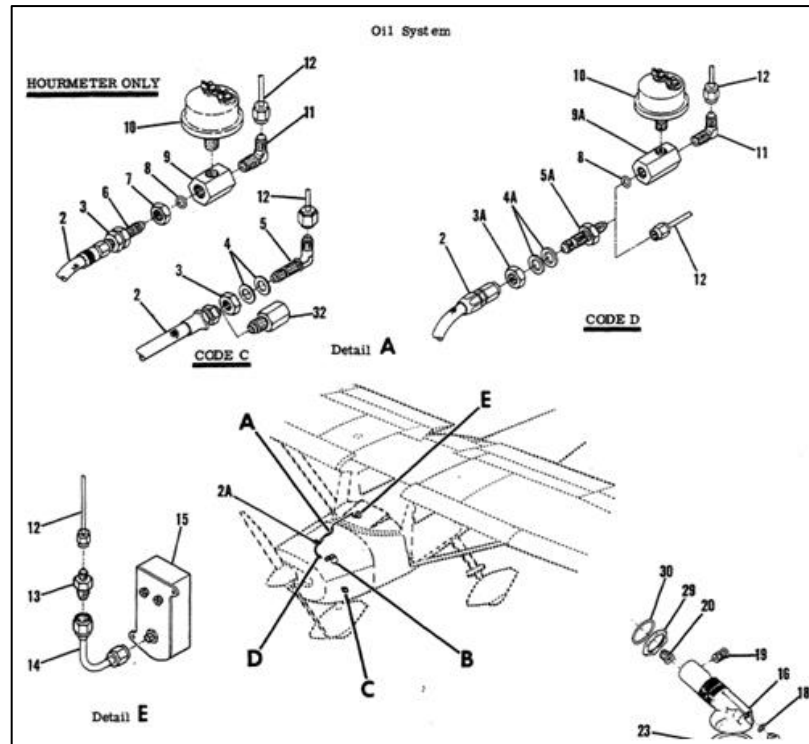
The pipe in question, part number 0400311-78, was designated as Item 12 in the Oil System Schematic provided in the Cessna 150/A150 (1970-1977), manual number P691-12, dated March 1, 1996 (**Figure No. 1**). Detail E in **Figure No. 1** shows that item 12 connects to a union and then another tube with larger fittings (Item 14) which connects to the oil pressure gauge.

Figure No. 1: Oil system schematic from the aircraft manual

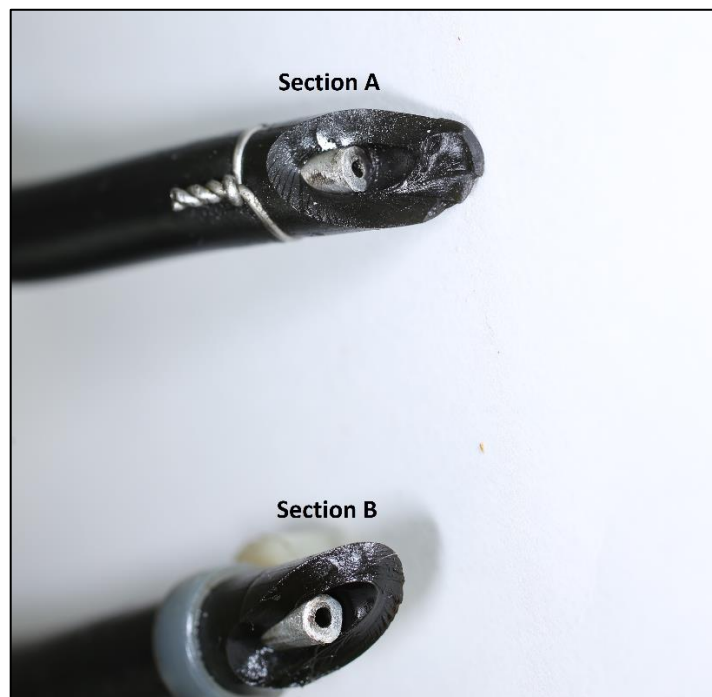
On examination of the removed sections, it was noted that the pipe which had been fitted to the aircraft comprised two separate metal pipe sections whose ends had been cut square. During examination it was noted that square-cut ends exhibited roughness and marking similar to that which would be seen if the pipe had been cut with a hack saw (**Photo No. 6**).

Photo No. 6: Square-cut ends of metal pipe and the failed plastic sleeve

It appears that the two square-cut metal pipes were then inserted into a plastic sleeve that was approximately 27 centimetres (cm) in length. The section of the pipe that was attached to the pressure gauge (Section A) was pushed into the sleeve to a depth of approximately 10 cm, while the section of pipe that was attached to the engine (Section B) was pushed into the sleeve to a depth of approximately 17 cm. The plastic sleeve was secured at each end (i.e. on each section of pipe) with a plastic tie-wrap and a section of locking wire. At the region of the plastic sleeve where the metal pipes met, there was a section of locking wire on the cockpit side (Section A) and a tie-wrap on the engine side (Section B). The plastic sleeve had broken at the point where the two square-cut sections of pipe met, and this was the cause of the oil leak.

The AAIU found no evidence that the practice of joining two metal pipes with a plastic sleeve, secured with tie-wraps and locking wire was, or is, an approved method of repair.
