# Air Accident Investigation Unit Ireland

**FACTUAL REPORT**

**Reims Aviation SA, Cessna F172N, EI-GWU  
Birr Airfield, Co. Offaly**

**19 February 2023**

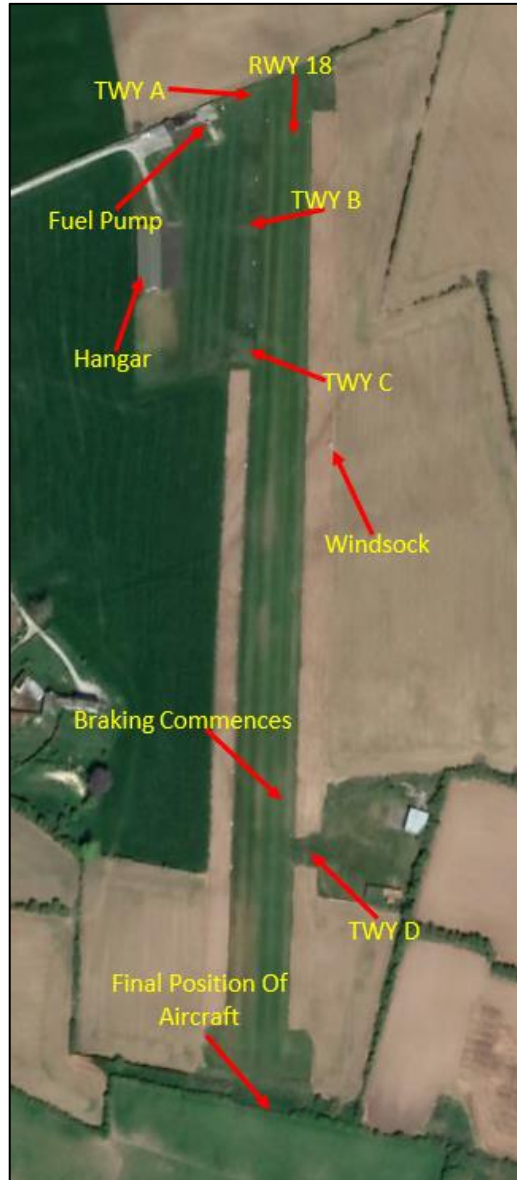
The Instructor reported that the engine was started without any issues and that the temperatures and pressures were observed to be in the normal ranges. The aircraft was taxied on the grass surface to a point abeam Taxiway (TWY) B (Bravo) and positioned on a southerly heading to conduct power checks (**Figure No. 1**).

**Figure No.1:** Birr Airfield (*Google Earth*)

During the site survey of the airfield, the Investigation located the approximate position where the brakes were applied on EI-GWU (**Figure No. 1**).

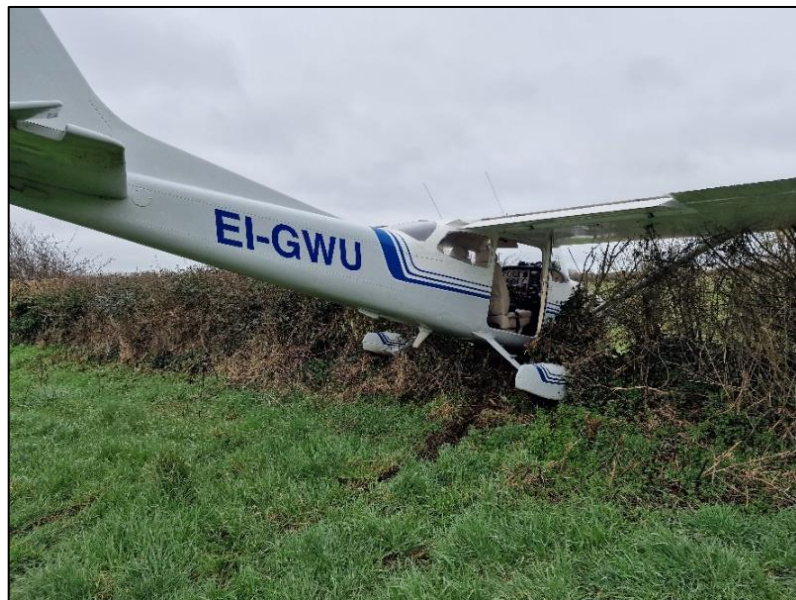
**Photo No 1:** Final position of EI-GWU (with flaps extended)

In a photograph taken shortly after the occurrence, the Investigation notes that the flaps were in the extended position. Section 3 of the POH for the aircraft states that in the event of an engine failure during the take-off run, the flaps should be retracted which increases weight on wheels and improves braking effectiveness. Whilst EI-GWU did not experience a total engine failure, the Investigation considers the actions as described in Section 3 of the POH to be appropriate when abandoning a take-off.

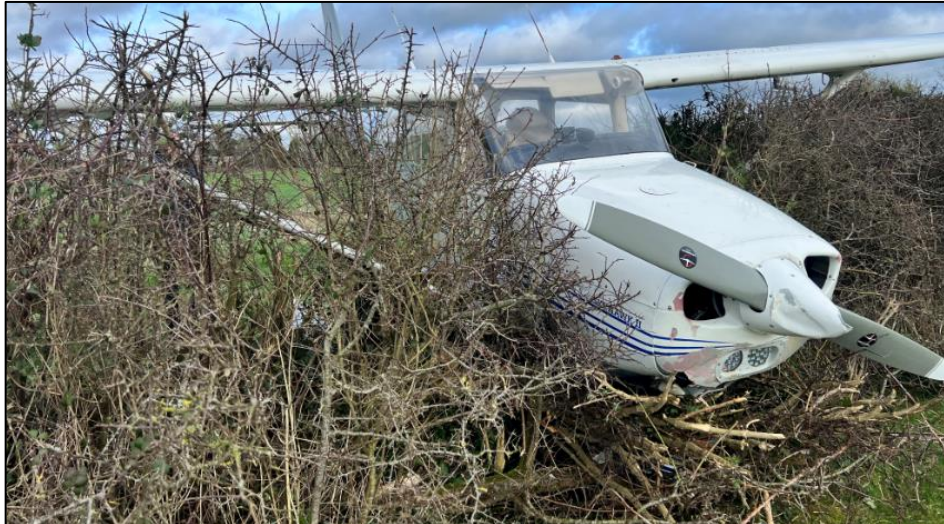
The aircraft was damaged during the runway excursion and subsequent impact with the boundary hedge. The propeller spinner was deformed and there was minor scuffing of the propeller itself (**Photo No. 2**). The engine cowling was damaged and the lower section of the exhaust had bent rearwards. The nose wheel spat had partially disintegrated during the impact sequence.

**Photo No. 2:** Final position of EI-GWU showing aircraft damage

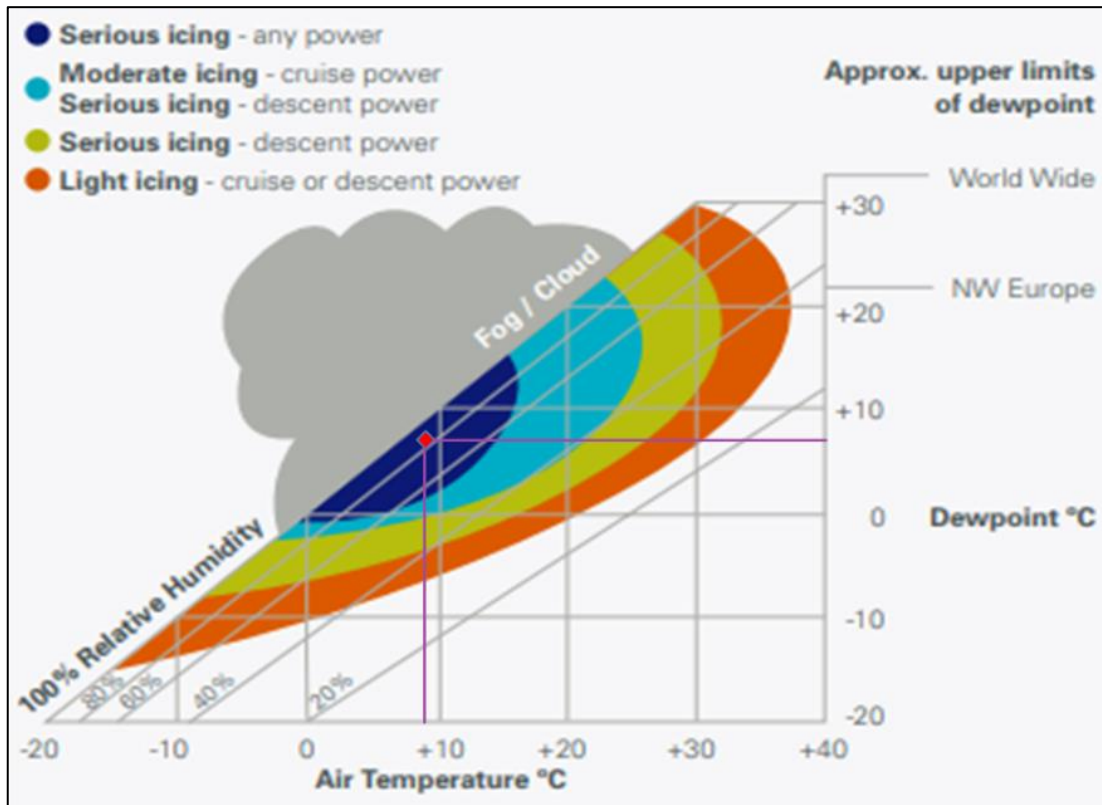
As stated in previous investigations conducted by the AAIU, numerous charts have been produced indicating the probability of carburettor ice forming. **Figure No. 2** is extracted from SSL No. 14 and has been annotated by the Investigation using the meteorological conditions on the day of the occurrence. When the temperature of 9°C and dew point of 7°C are plotted, the chart indicates that there is a probability of serious icing in the carburettor at any power setting.

**Figure No. 2:** Carburettor icing chart (modified)
