# Air Accident Investigation Unit Ireland

**FACTUAL REPORT**

**Boeing 767-322ER, N675UA  
Shanwick Oceanic Airspace**

**28 March 2022**

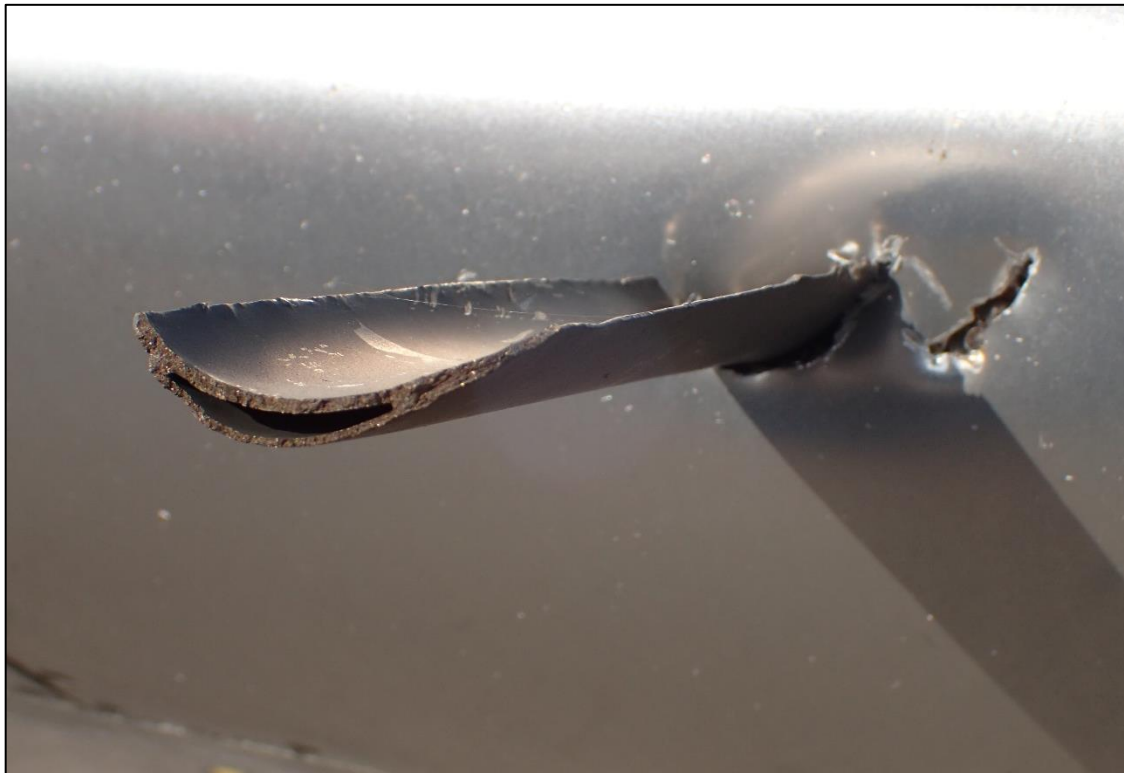
The aircraft's right engine was substantially damaged (**Section 1.8**). The horizontal stabiliser sustained minor damage due to the impact of a low-pressure turbine blade that had been ejected from the exhaust of the right engine (**Photo No. 1**). The right engine containment system remained intact.

**Photo No. 1:** Turbine blade impact with horizontal stabiliser

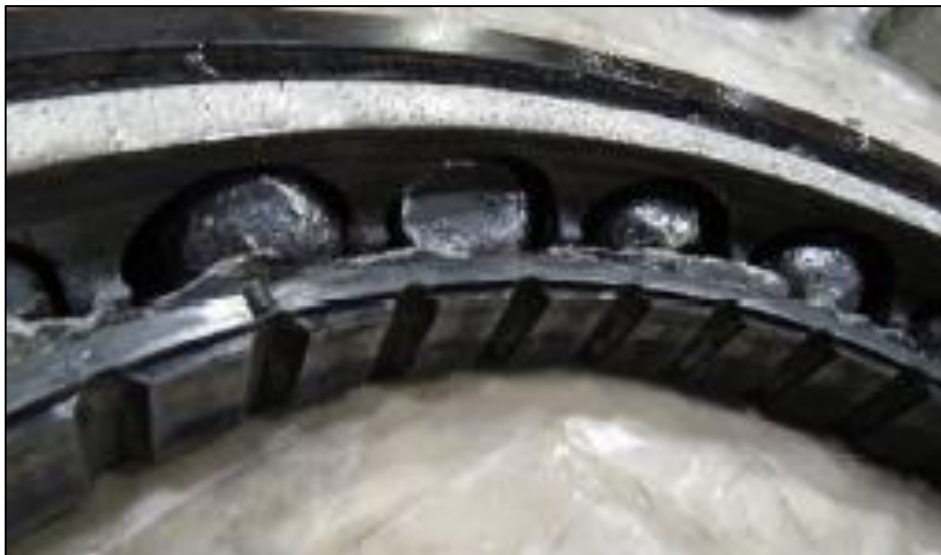
Teardown of the right engine No. 1 bearing assembly revealed that multiple parts within the assembly had sustained significant damage. There was evidence of overheating and some of the rolling elements had been compressed and had lost their spherical profile (**Photo No. 2**).

**Photo No. 2:** Engine No. 1 Bearing post Occurrence (*Courtesy of Engine Manufacturer*)

A metallurgical analysis of the disassembled bearing components indicated likely spalling<sup>19</sup> on the bearing outer race. Examination of debris found in the main oil filter determined it to be bearing material. The Engine Manufacturer deemed it likely that spalling was also present on the inner race of the bearing; however, due to the level of damage on the bearing it was not possible to confirm this.

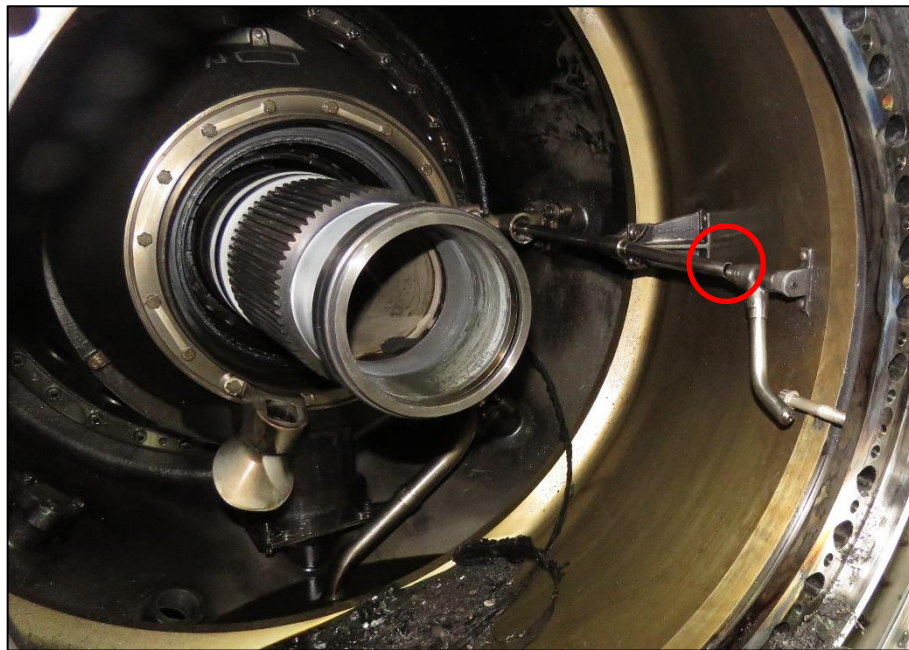
Metallurgical analysis of the fractured No. 1 oil tube did not identify any material or manufacturing abnormalities. Analysis of the fracture surface indicated that the oil tube failed in High Cycle Fatigue (HCF)<sup>20</sup>. **Photo No. 3** shows the location of the oil tube fracture.

**Photo No. 3:** Location of oil tube fracture indicated by red circle (*courtesy of Operator*)

The Engine Manufacturer carried out a modal analysis<sup>21</sup> for the No.1 oil supply tube. This showed that the frequency response of a No.1 bearing with a defect in the inner race could excite the first (fundamental) frequency mode of the oil tube. In addition, the fracture of the oil tube was found to be in the location where the stress due to the fundamental frequency mode wave form was greatest.

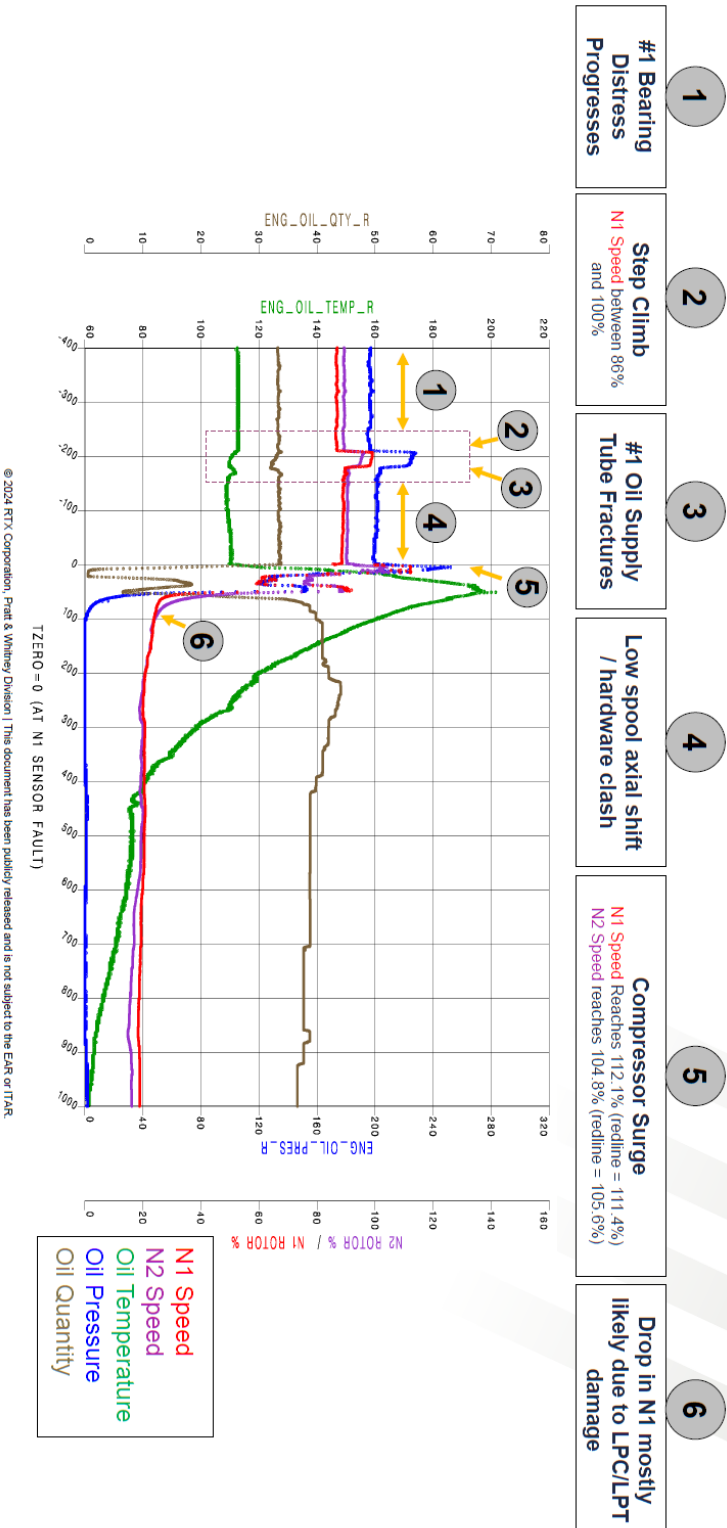
Flight data consistent with hardware observations

**Figure No. 1:** Relevant parameters recorded during failure progression (Produced by Engine Manufacturer)
