Technical report

IN-031/2022

Incident on 29 April 2022 involving an Airbus 320 aircraft operated by Vueling, registration EC-KLT, and a Boeing 737 aircraft operated by Ryanair, registration EI-EPA, at Josep Tarradellas Barcelona-El Prat Airport (Barcelona, Spain)

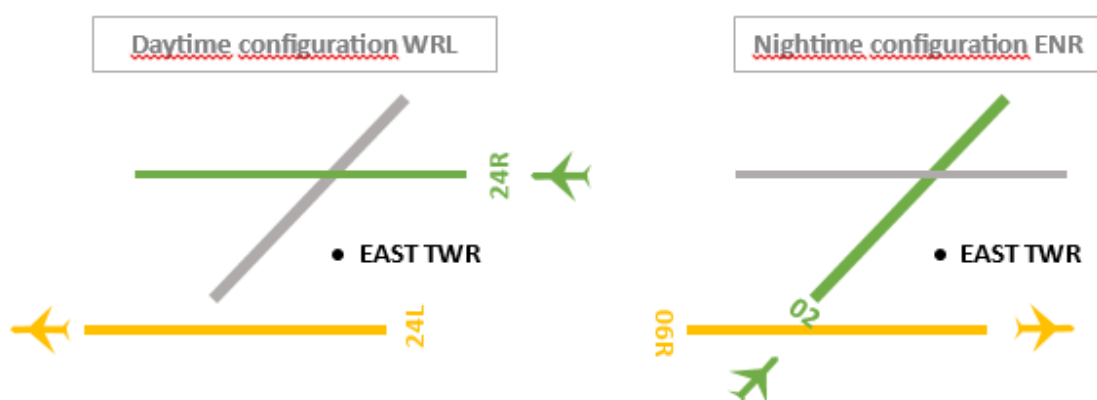
Figure 1. Change of configuration at 21:28 (12 minutes before the incident)

The airport had changed its operating configuration 12 minutes before the event, from operating in the WRL daytime preferred configuration with parallel runways (24R for arrivals and 24L for take-offs) to the ENR² night-time preferred configuration with intersecting runways (landings on runway 02 and take-offs on runway 06R). The new configuration affected the local controller for runway 24L in position 2 of the east tower, who, previously in charge of take-offs on 24L, became the single local controller responsible for take-offs on 06R and arrivals on 02.

The configuration change required manual modifications to the information display system to be made by each controller at their position³, which, in this case, were not completed at position 2. Specifically, the arrival runway selected (in green in Figure 1) in the general information window (VIG) was not changed. Consequently, the times and distances to the threshold for the inbound traffic that the local controller saw on his screen⁴ were longer than the actual times and distances because the system's calculations were based on using runway 24R rather than runway 02. In this context, at 21:39:09, the local controller cleared the aircraft that was taxiing to take off from runway 06R, thinking that the approaching aircraft was further away than it was.

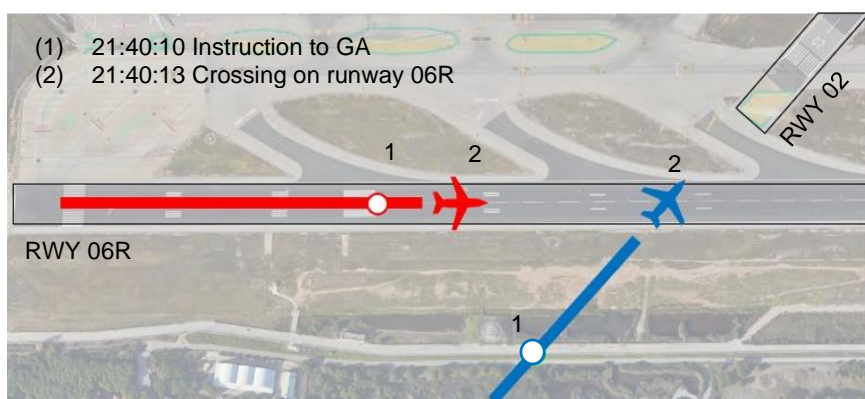
Figure 2. Crossing of the two aircraft on the runway 06R at 21:40:13

The two aircraft crossed paths on runway 06R at 21:40:13, with a horizontal separation of 285 m and a vertical separation of 59 ft (18 m). The approaching aircraft was flying over the runway at

148 kt IAS and 59 ft (18 m) altitude, while the aircraft on take-off was accelerating at 97 kt GS but had not yet executed the rotation.

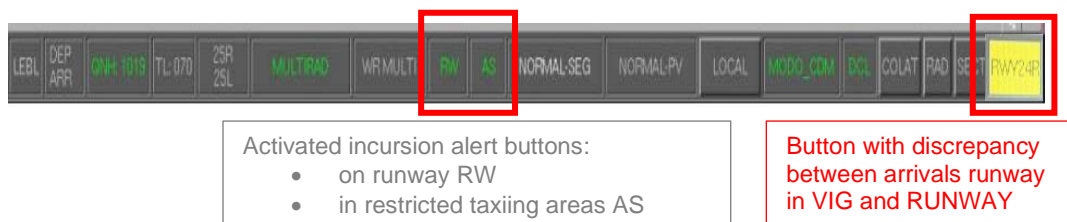
Figure 6. VIG of position 2 in the east tower

The number 2 control position in the east tower was enabled to carry out the function of single local controller LCL, which meant the controller seated there, previously in charge of take-offs on runway 24L, became responsible for take-offs on 06R and arrivals on 02. This change implied several actions on the part of the controller, one of which was not carried out: the selection, in the general information window (VIG), of the new arrivals runway for the calculation of times and distances to the threshold (DFTI) (the previous runway, 24R, was left as the selected runway). As a consequence, in the VIG, the arrivals runway button remained in yellow and would remain so until after the event.

The presence of the visual warning was not detected by the controller at the position, who was responsible for the task, nor by the two supervisors (the one on the afternoon/evening shift and the one covering the night shift), although it should be noted that this was not one of their duties.

REC 51/23: It is recommended that ENAIRE, as the ATC service provider for the Barcelona control tower, assess the possibility of implementing in the SACTA system an automated change of arrival runway in the VIG each time a change of arrival runway is made in the RUNWAY USAGE menu.

REC 52/23: It is recommended that ENAIRE, as the ATC service provider for the Barcelona control tower, increase the robustness of the current information systems with regard to discrepancies between the runway selected in the RUNWAY USAGE menu and the runway selected in the VIG.

REC 53/23: It is recommended that ENAIRE, as the ATC service provider for the Barcelona control tower, draft a control position checklist to facilitate the detection of any oversights during configuration changes. This checklist should include checking the arrivals runway in the VIG after a change of configuration, particularly for the local controller responsible for arriving traffic.

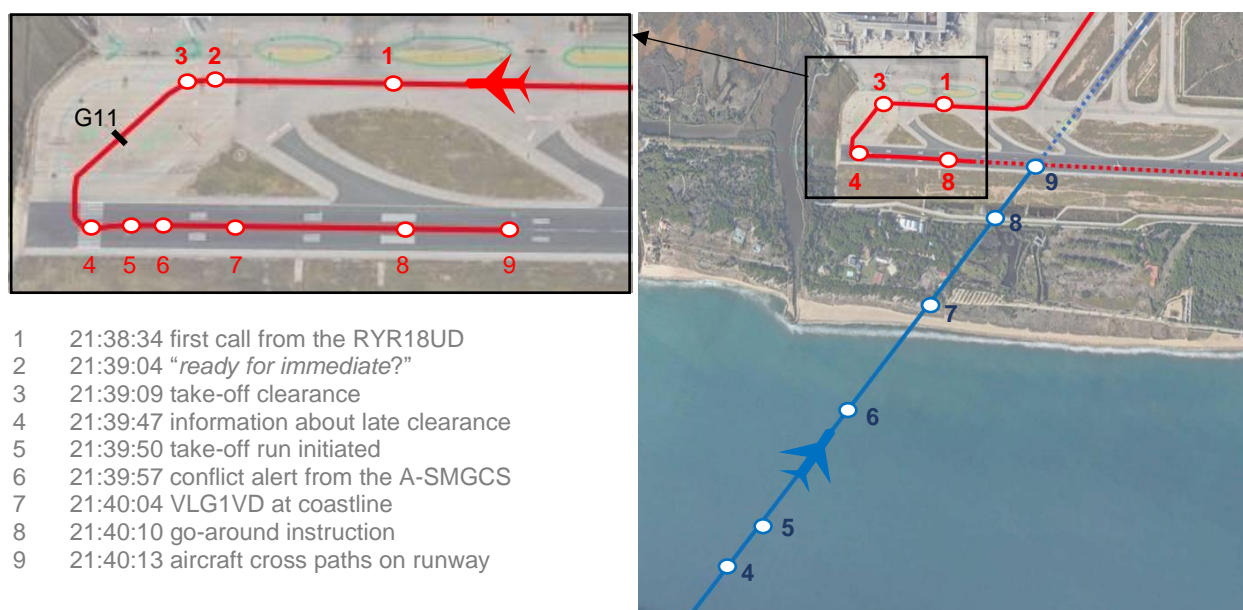
Figure 7. Trajectory prior to the crossing

21:39:15 The taxiing aircraft was reading back the take-off instruction at 13 kt GS.
 21:39:25 The taxiing aircraft was crossing holding point G11 with the approaching aircraft at 2.2 NM actual (2 NM from the intersection¹²). This point is the D1 distance of the A-SMGCS alert activation (see section 1.16.1).

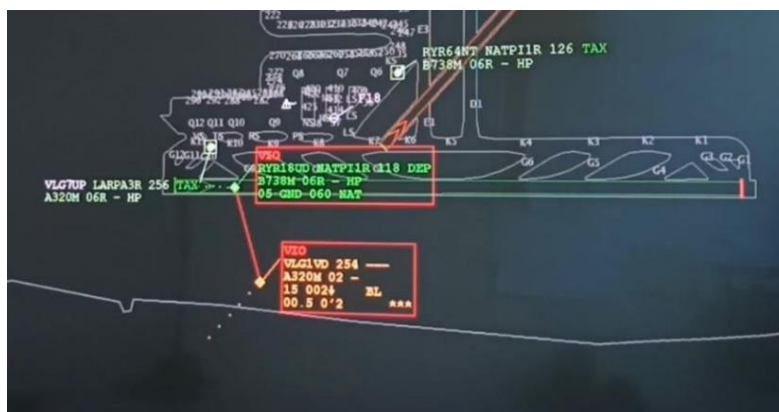
Figure 8. Activation of the VIO warnings on the controller's screen

- 21:39:57 Activation of the A-SMGCS Level 2 conflict alert (VIO). The aircraft on approach was 0.9 NM from runway 02 (2.1 NM for the controller) and 0.7 NM from the crossing point. The aircraft on take-off was on the take-off run at 26 kt GS, having travelled 100 m from the threshold.

The warning was acknowledged by the controller at 21:40:04 and remained active for 16 seconds until the approaching aircraft passed the crossing point.

After the VIO violation warning appeared on the controller's display, the reaction times were 7 seconds to acknowledge it and 13 seconds to issue a resolution instruction. These values are abnormally high and far exceed the usual reaction times to stimuli.

The investigation has been able to establish, as stated in sections 1.16.6 and 1.16.10, that these reaction times are the result of a lack of confidence in the alert system. The system regularly gives false warnings of conflict alerts, so there is a perception – in this case a well-founded one – among all personnel, that the system is unreliable.

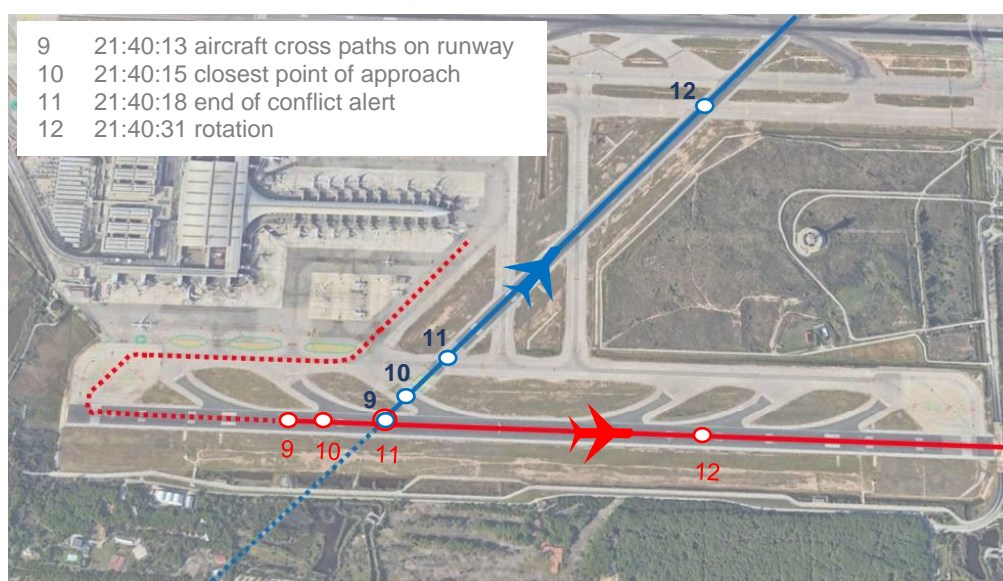
Figure 9. Trajectory after the crossing

21:40:13 VLG1VD was flying over runway 06R at 59 ft (18 m) altitude, 148 kt IAS and -340 fpm while reading back the instruction and changing the autothrottle mode to TOGA. The traffic on take-off was on his left, accelerating at 97 kt GS without having rotated and at a distance of 285 m from VLG1UD, having travelled 550 m from the threshold markings.

After the crossing, by system definition, the conflict alert (VIO) disappeared from the local controller's screen, having been active for 16 seconds.

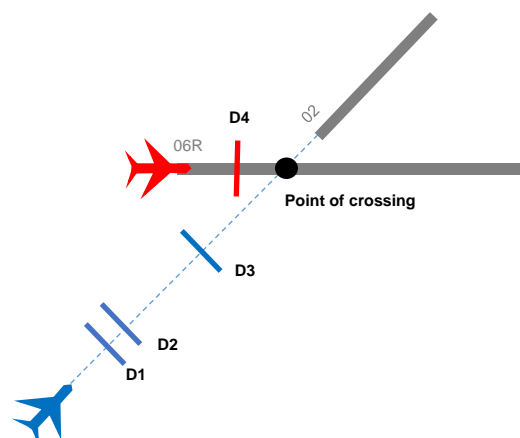
Figure 10. Alert activation geometry

In this event (intersecting runways with take-offs and arrivals), the system skipped the first alert (WRN) and moved straight to the second. Which alert is triggered depends on the combination of four predefined distances to the crossing point, as shown in Figure 10, and on the progress of the aircraft on take-off. For this event, the defined distances were as follows: D1= 3704 m (2 NM), D2=D3=1852 m (1NM) and D4=1 m. As far as the aircraft on take-off is concerned, in addition to being on the runway, it must be travelling at a speed of over 20 kt.

This data explains why, even though the approaching aircraft had exceeded the D1 distance at 21:39:25, no WARNING or VIOLATION alert was triggered until 32 seconds later because during this period, the other aircraft was not on the runway during take-off and when it did enter the runway it was below 20 kt GS. This rules out system malfunctions.
