Air Accident Investigation Unit Ireland

FACTUAL REPORT

**Raj Hamsa X Air, 582(11), EI-CXC
Near Limetree Airfield**

7 September 2023

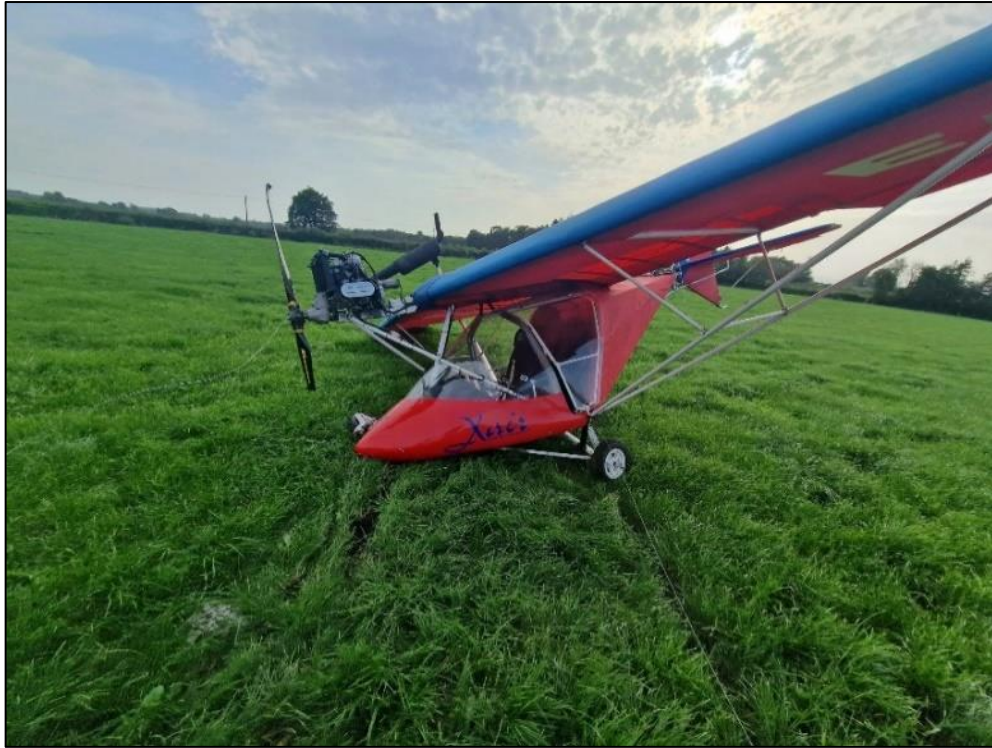
Although the wreckage had been removed from the accident site, it was possible for the Investigation to identify and survey prominent aspects of the aircraft's ground track from its point of landing to its final resting position. This survey revealed that the aircraft travelled approximately 50 m before the right-hand wing strut struck a vertical stake, and another 20 m approximately before it came to rest in an adjacent field (**Photo No. 1**).

Photo No. 1: Aircraft as it came to rest following the accident

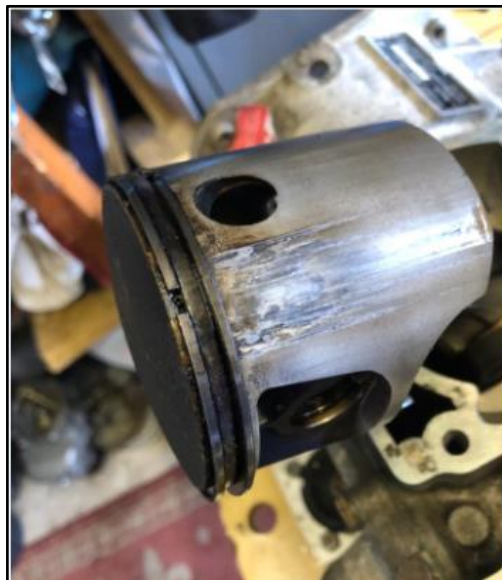
- When the engine was stripped it was observed that the front piston had seized. The piston and rings were unserviceable (**Photo No. 2**). There was some light scoring on the barrel, but these were not deep.
- The rear cylinder had not seized, but there was evidence of the piston & bore clearance coming close to zero (**Photo No. 3**).
- The B gearbox had to be stripped for removal from the engine crankcase. There were no defects and all looked normal.
- The carbs [carburettors] and the jets were free of any blockages, the floats looked satisfactory and the rubber carb sockets had no splits in them.
- The ignition timing was checked with a dial gauge and again this was set to the correct advance.

Photo No. 2: Damaged forward piston

The engine specialist opined that in the case of the subject engine, five minutes idling at 2,200 rpm was not sufficient and that when full power was applied for take-off, the aluminium piston expanded faster than the steel liner in the barrel, causing the front cylinder to seize (a condition known as a cold seizure) and the piston/bore clearance in the rear cylinder to come close to zero.

Subsequently, the engine was dismantled, and it was found that a cold seizure had occurred in the forward cylinder with the piston expanding faster than the cylinder liner, resulting in contact between the piston and the cylinder wall. There was also evidence of a loss of clearance between the piston and the cylinder liner in the rear piston.

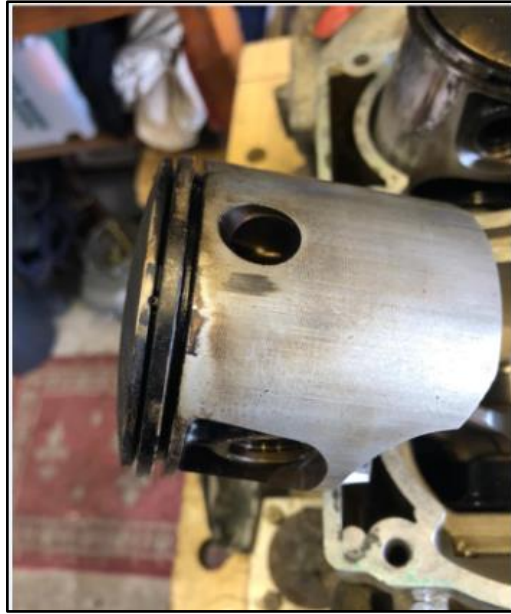
Photo No. 3: Rear piston exhibiting loss of clearance damage
