Air Accident Investigation Unit Ireland

ACCIDENT

**Robinson R44 Raven II, N999RL
Kennycourt, Co. Kildare, Ireland**

AAIU Report No: 2024-007

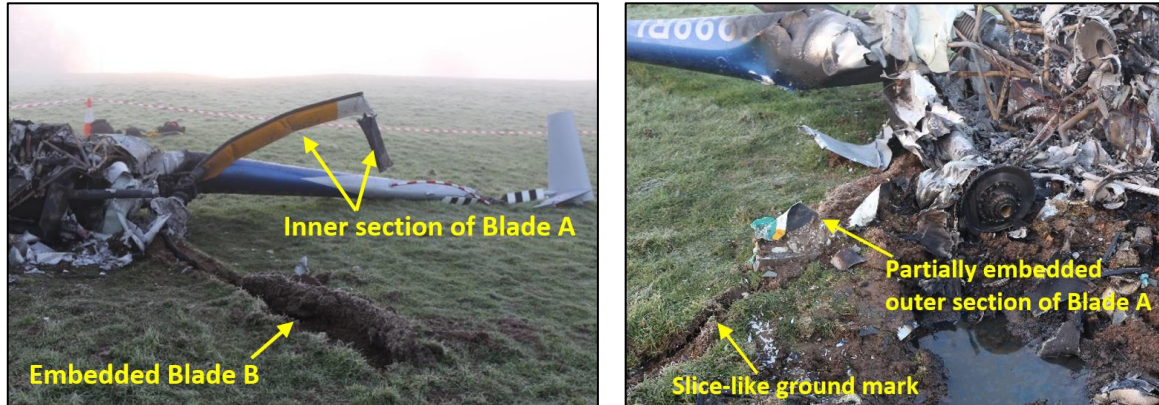
The other blade (annotated as **Blade B** in **Photo No. 5**) remained attached to the rotor head. It had sustained significant fracture damage, approximately 1.25 m from the blade root, but remained in one piece. The outer portion of this blade, approximately 3.5 m long, was embedded along its length, leading edge down, in the surface of the field.

Photo No. 5 (left) and **Photo No.6** (right): Damage to main rotor blades and surface of field (Photos taken on the morning after the accident)

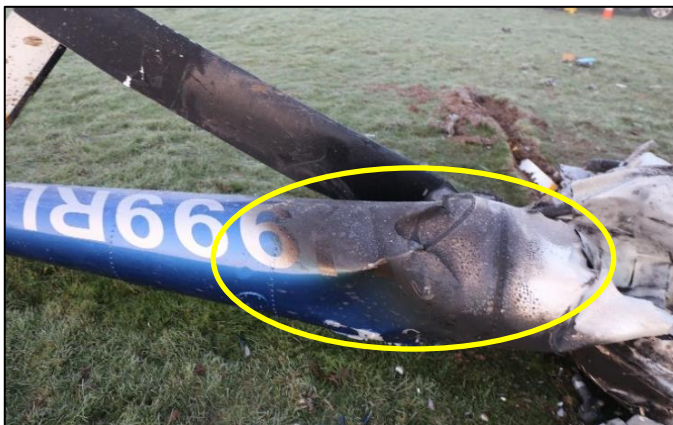
The tailcone sustained fire damage adjacent to where it attached to the fuselage and exhibited crumpling damage along its length (**Photo No. 7**). The empennage had separated from the tailcone (**Photo No. 8**). There was no evidence of main rotor blade contact with the tail cone or empennage. The two tail rotor blades sustained bending damage close to the roots of the blades. One blade was partially fractured at the bending damage. The leading edge of each blade was undamaged.

Photo No. 7: Fire damage and crumpling to tailcone (highlighted) (Photo taken on the morning after the accident)

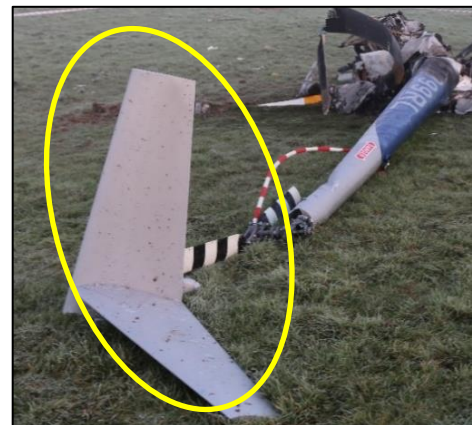
Photo No. 8: Separated empennage (highlighted) (Photo taken on the morning after the accident)

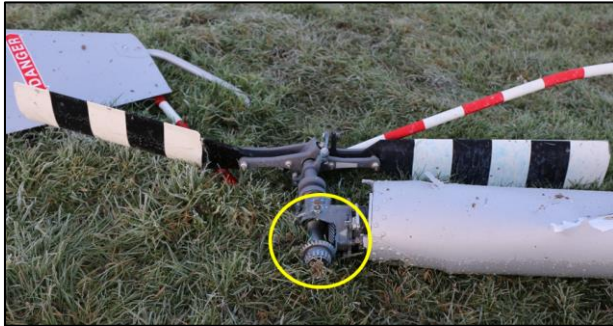
The tail rotor gearbox housing was broken (**Photo No. 9**). The tail rotor pitch control rod in the tailcone had fractured close to the where it connected to the pitch change lever at the tail rotor gearbox housing (**Photo No. 10**); there was evidence of soil and grass where the rod connects to the pitch change lever. The fracture surfaces were inclined on approximately 45° shear planes, consistent with instantaneous overload fracture.

Photo No. 9: Broken tail rotor gearbox (circled) (Photo taken on the morning after the accident)

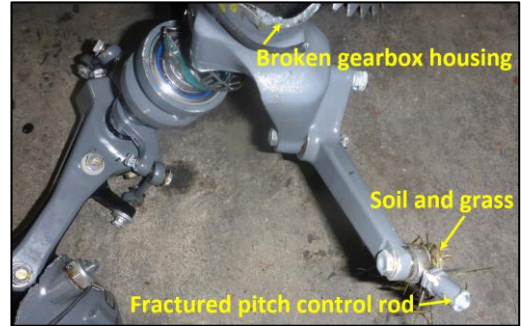
Photo No. 10: Fractured pitch change control rod (Photo taken during subsequent examination)

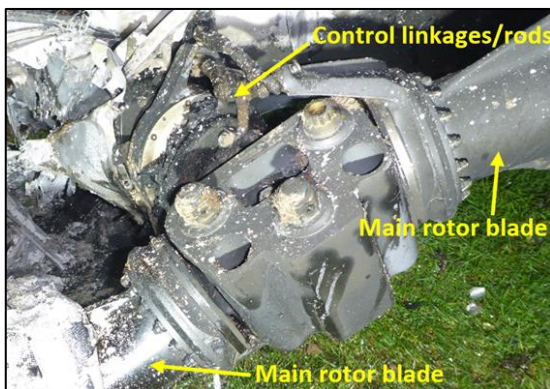
Due to the extent of the Helicopter damage, it was not possible to verify the continuity of the main rotor and tail rotor control systems. However, the flight control linkages/rods at the main rotor head were found to be connected/intact (**Photo No. 11**). The linkages/rods at the tail rotor pitch change mechanism were also intact (**Photo No. 12**).

Photo No. 11: Main rotor head (Photos taken on the morning after the accident)

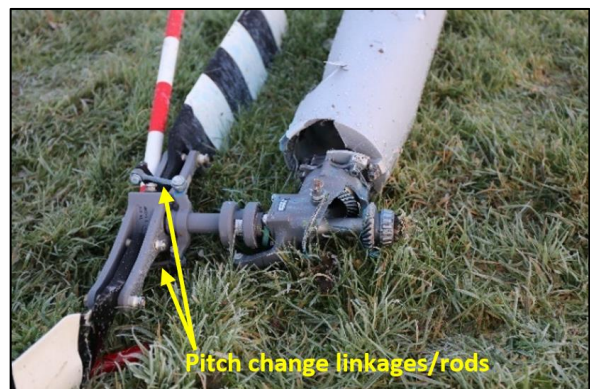
Photo No. 12: Tail rotor head /gearbox (Photos taken on the morning after the accident)

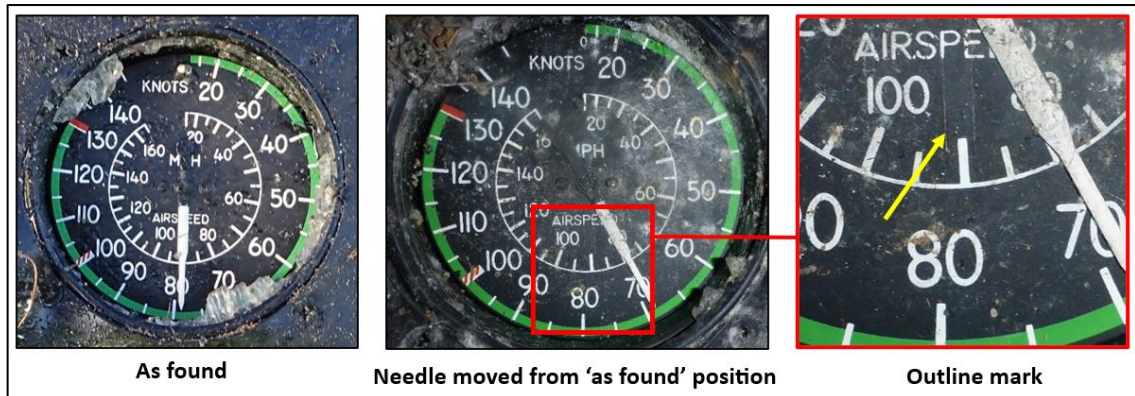
The remains of the Helicopter's instrument panel, which included the airspeed indicator (ASI), were recovered at the accident site. The ASI's indicator needle was close to the 80 kt position (**Figure No. 9**)³⁷. When the indicator needle was moved, an outline mark, which was similar in shape and size to the indicator needle, was visible on the dial of the ASI at the position the needle was found in.

Figure No. 9: ASI indicator needle position and outline mark

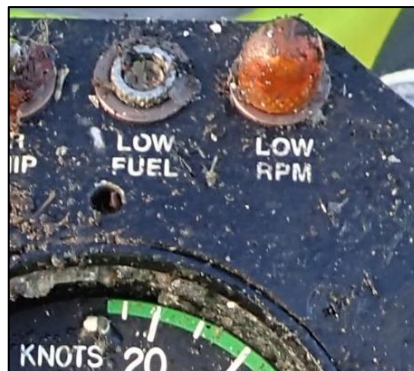
The panel also contained several warning light assemblies, including the *LOW RPM* (main rotor) and the *LOW FUEL* warning light assemblies (**Photo No. 13**).

Photo No. 13: Instrument panel with warning light assemblies

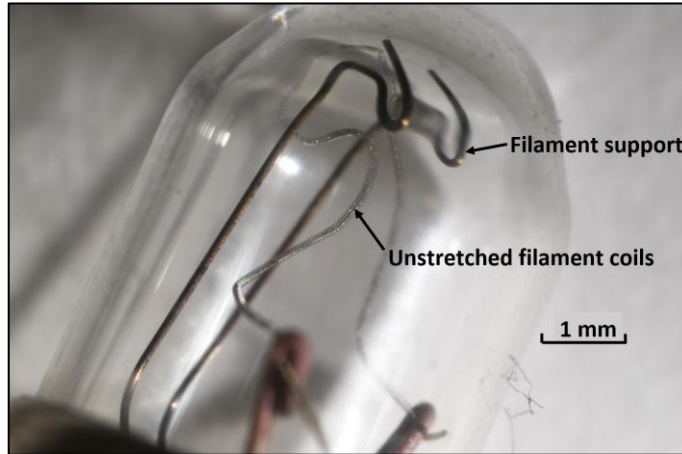
The analysis of light bulbs following an accident may provide an indication regarding whether or not a particular bulb was illuminated (lit) at the time of impact. If an impact occurs when a bulb is illuminated, its (hot) filament may stretch and fail, whereas, if an impact occurs when a bulb is not illuminated, its (cold) filament may remain intact or may shatter or break in an unstretched condition.

Photo No. 14: Bulb from LOW (main rotor) RPM warning light

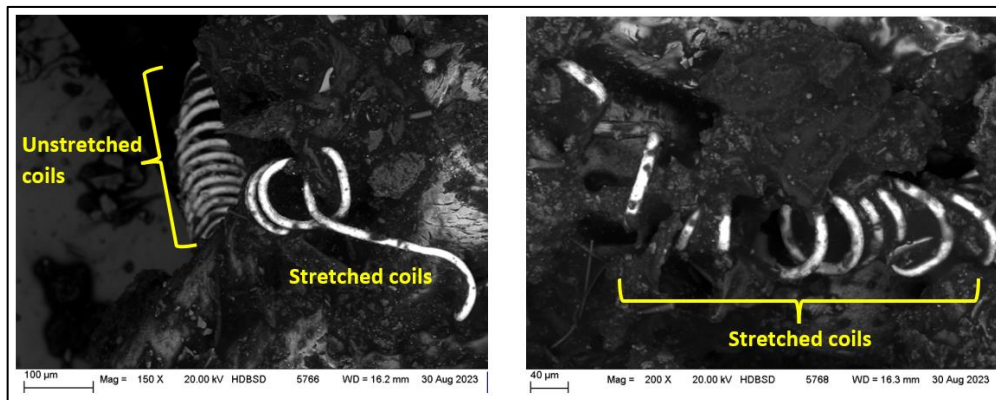
The LOW FUEL warning light assembly sustained significant damage in the accident. When examined visually, it was not possible to identify any remaining filament. To conduct further examination, the Investigation sought the assistance of a laboratory equipped with a Scanning Electron Microscope (SEM). The SEM images showed some remaining sections of filament located within the cap of the bulb. Some areas of the coils showed evidence of what appeared to be stretching. However, others appeared unstretched (**Figure No. 10**).

Figure No. 10: SEM images of bulb from LOW FUEL warning light

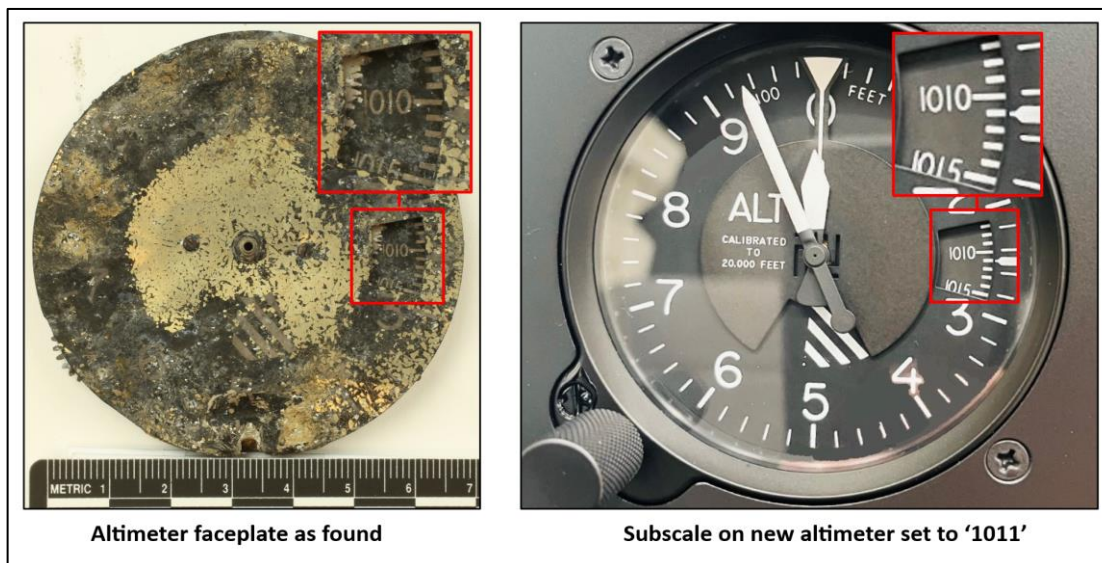
The faceplate of an altimeter, which included its subscale, was found in the debris recovered from the accident site. Before flight, a pilot will normally adjust the altimeter's subscale to the local sea level air pressure (QNH), if known. This ensures that the altimeter accurately indicates height above sea-level. Adjusting the altimeter before flight, so that it indicates the local elevation has the same effect; when the altimeter is set to the local elevation, the QNH subscale will reflect the local QNH. The subscale aligns with an indicator mark in the centre of the subscale window. For every 1 hPa adjustment of the subscale, the altimeter needle moves by approximately 30 ft (27.1 ft). The recovered faceplate and subscale had sustained significant impact and fire damage. However, the subscale remained legible. When compared to a new altimeter, it appeared to be set to 1011 (**Figure No. 11**). This was the QNH that was advised by Shannon FIS to the Pilot on departure from Ballygarret on the day of the accident.

Figure No. 11: Altimeter subscale setting

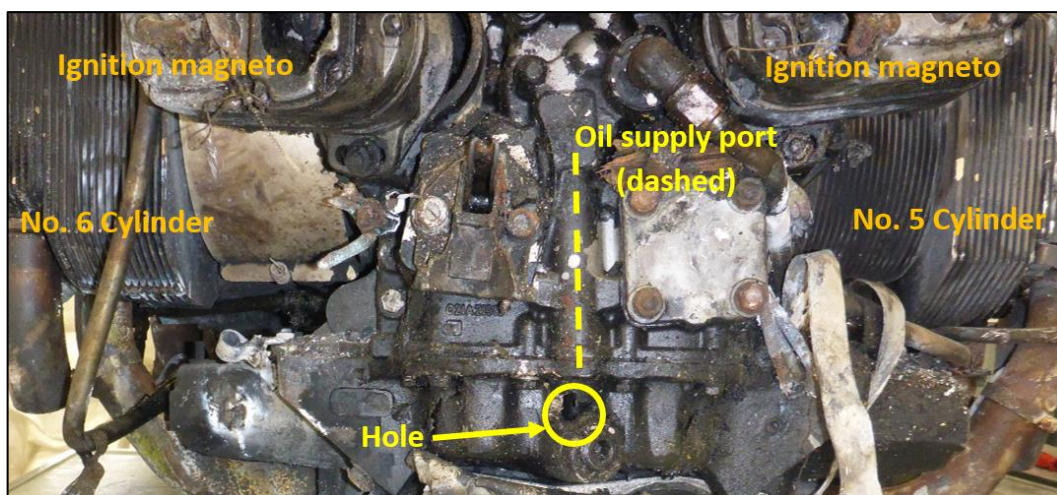
It was noted that the forward-facing section of the engine oil sump sustained impact damage, resulting in a hole in the outer wall of an integral oil supply port that supplies engine lubrication oil from the main oil screen in the oil sump to the inlet of the oil pump (Photo No. 15). The tubular oil screen was removed from its housing in the sump and was found to be intact and clean. The oil pump was removed from the engine. Debris, in the form of metallic chips, was found at the gears within the oil pump (Photo No. 16).

Photo No. 15: Hole in oil pump supply port at front of engine

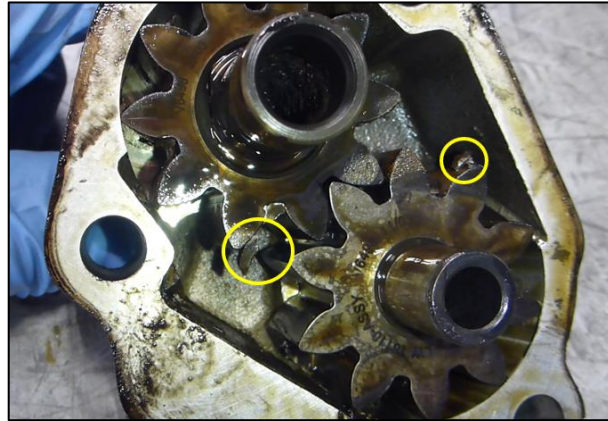
Photo No. 16: Metallic chips in the engine oil pump (circled)

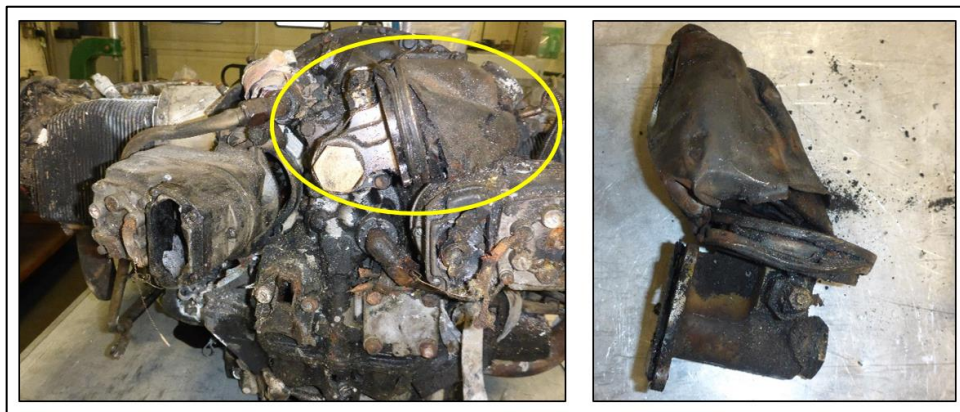
Pressurised oil from the oil pump is filtered by the main oil filter before it is supplied to other components for lubrication and cooling purposes. The main oil filter and its mount, which are located on the forward-facing section of the engine, sustained significant impact and fire damage (**Figure No. 12**). Due to the extent of the damage, further examination was not performed as results would not have been meaningful.

Figure No. 12: Oil filter and mount in-situ (circled in left image) and removed (right image)
