Air Accident Investigation Unit Ireland

FACTUAL REPORT

**SERIOUS INCIDENT
TECNAM P2006T, EI-WST
Weston Airport, Co. Dublin**

22 August 2023

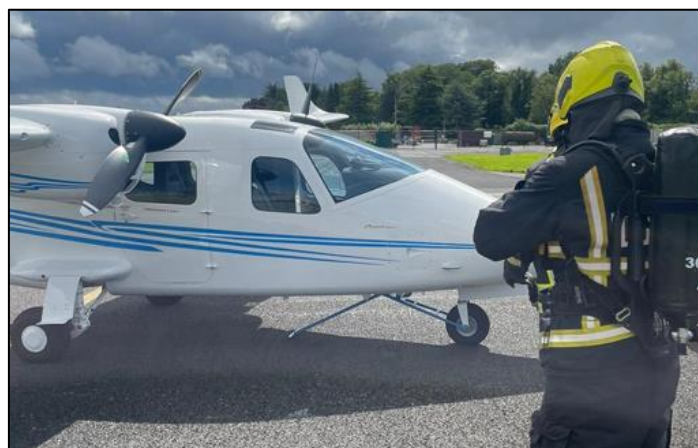
The Instructor took control of the aircraft from the Student and requested landing clearance. ATC offered a choice of runways with the Instructor electing to land on RWY 25. The Instructor performed a left-hand circuit during which he was advised by ATC that the towbar was still hanging from the nose landing gear. The Student stated that during the landing, the Instructor held the nose wheel off the ground longer than normal and that he (the Student) only noticed unusual noises during the latter stage of the ground roll. The aircraft came to a stop abeam TWY J (**Photo No 1**), where they were met by the Airport Fire and Rescue Service (AFRS) that had positioned at TWY F.

Photo No. 1: Aircraft stopped abeam TWY J (*image provided by the AFRS*)

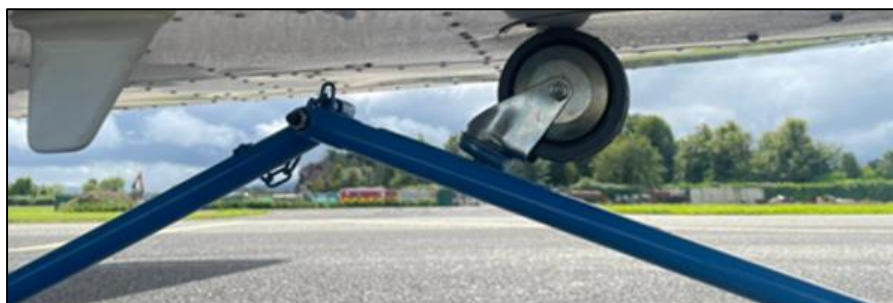
Following recovery of the aircraft to the Operator's hangar, a visual inspection of the nose landing gear was conducted in conjunction with landing gear retraction and extension tests. An inspection panel aft of the nose landing gear bay doors was dented by the towbar's wheel as the aircraft landed. The impact geometry of the towbar with the fuselage is shown in **Photo No. 2**.

Photo No. 2: Towbar's wheel in contact with inspection panel (*image provided by AFRS*)

Shortly after becoming airborne, the ATCO observed the towbar hanging from the aircraft and advised the Crew, who elected to complete a circuit of the airport and land on RWY 25. During the landing, it is likely that the handle of the towbar contacted the runway first and then swung rearwards with the wheel of the towbar striking the aircraft. This caused minor damage to the fuselage.

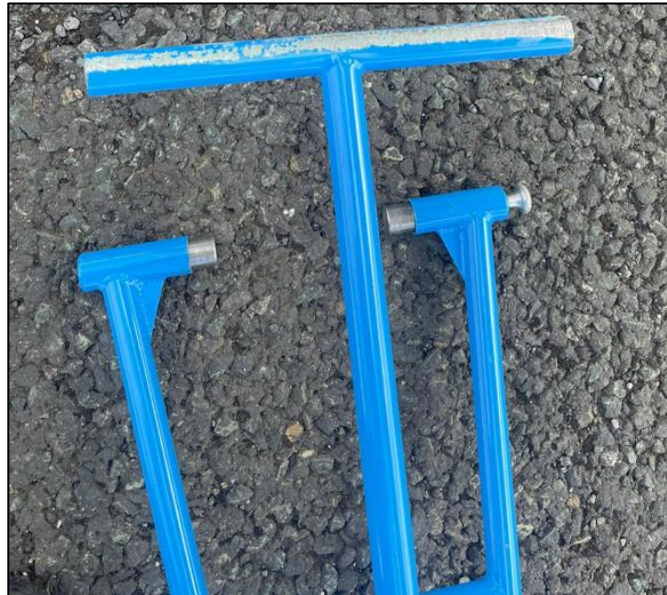
The towbar's handle sustained significant abrasion damage as it was dragged along the runway surface during the flare manoeuvre and subsequent ground roll (**Photo No. 3**). A knurled knob which secures one side of the towbar to the nose wheel, was missing. The Investigation weighed the towbar and found it to be 3.25 kgs.

Photo No. 3: Damage to towbar

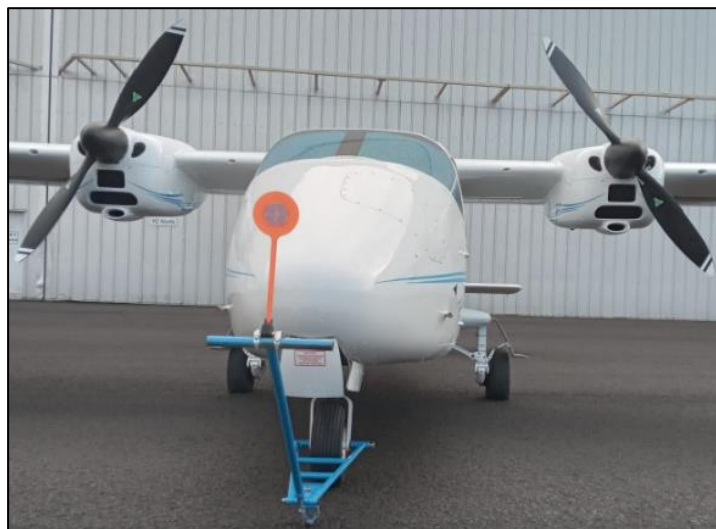
Photo No. 5: Modification to towbar

Subsequent to the occurrence, the Operator modified the aircraft's towbar in order to make it visible from the cockpit, when attached to the aircraft. The modification is shown in **Photo No. 5**. The Operator advised the Investigation that the modification to the towbar was subsequently removed as, in their opinion, it was impractical.

'Please note that irrespective and independently of any other Pre-flight external checks, the final pre-boarding action of the aircraft commander/instructor will be a 360 degree visual inspection/confirmation that all remove before flight external fittings have been removed, and hatches secured. This procedure is of particular importance with Tecnam type aircraft where external locks are employed. On aircraft where the instructor boards first, boarding will not be conducted until this procedure has been actioned.'
