Air Accident Investigation Unit Ireland

SYNOPTIC REPORT

**Boeing, 737-8AS, EI-DHH
Runway 28L, Dublin Airport**

9 April 2023

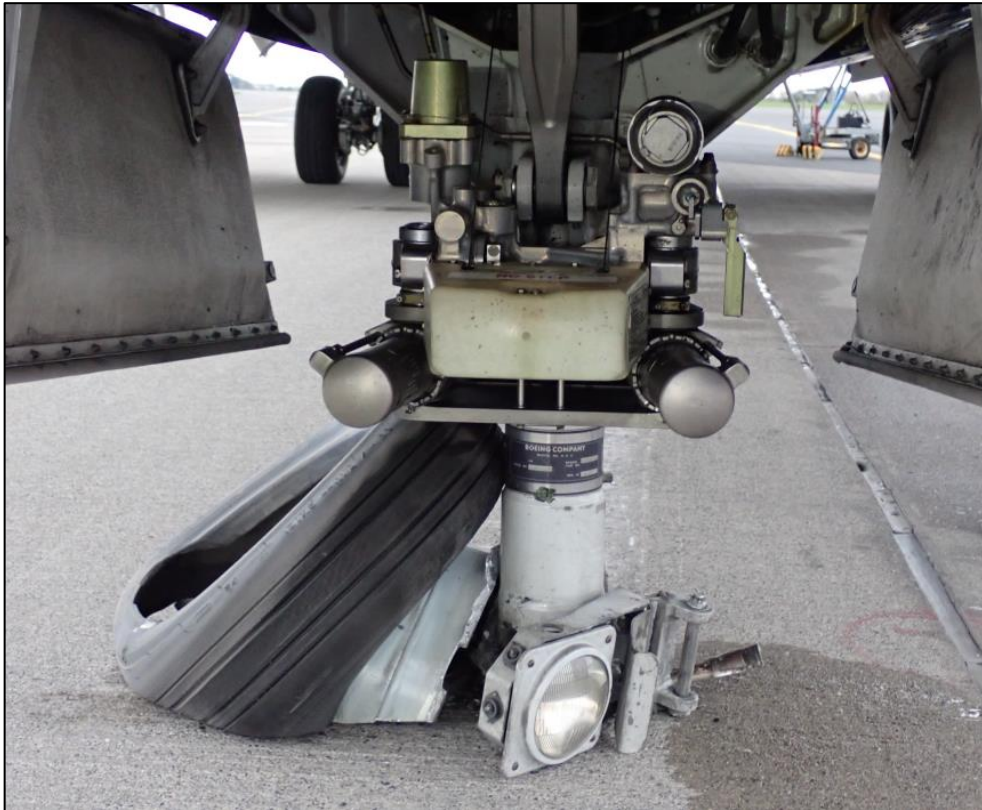
There was substantial damage to the Nose Landing Gear (NLG) assembly and wheels (**Photo No. 1**)

Photo No. 1: NLG assembly as the aircraft came to rest

While the damaged right-hand wheel and tyre remained loosely attached to the NLG assembly, the left-hand wheel and tyre were found to have separated from the assembly early in the landing roll.

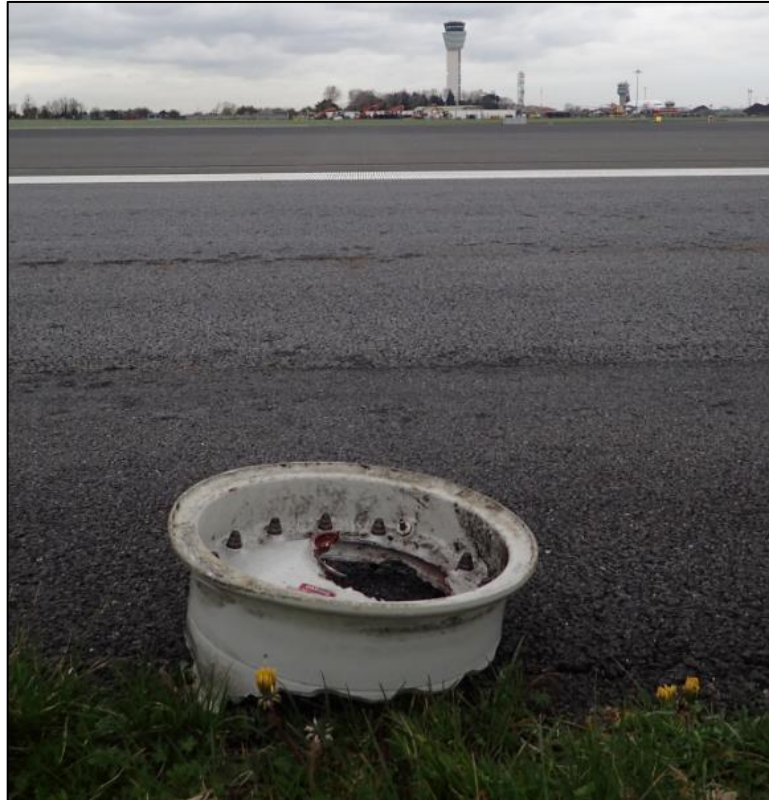
A large portion of the left-hand wheel was found on the left shoulder of the runway (**Photo No. 2**).

Photo No. 2: Portion of left-hand wheel at runway edge

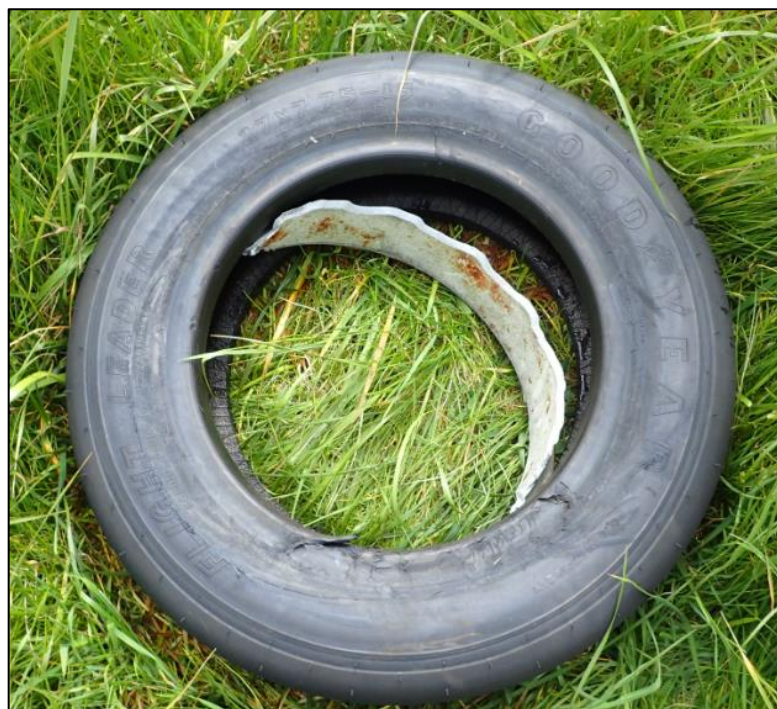
The left-hand tyre, and sections of the left-hand wheel, were subsequently recovered from the grass margin to the left of the runway at a distance of approximately 150 metres (m) from the runway edge (**Photo No. 3** and **Figure No. 1**).

Photo No. 3: Left-hand tyre and section of wheel hub

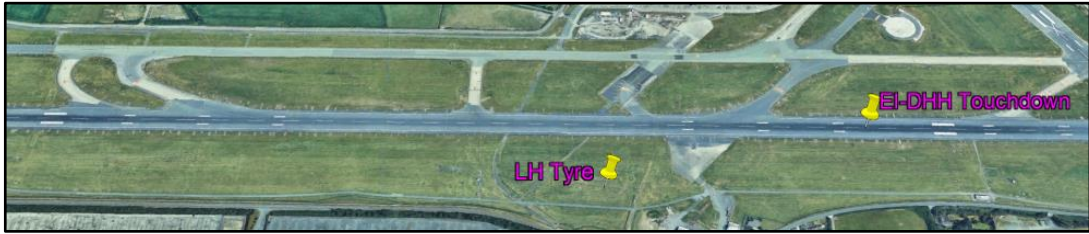
Figure No. 1: Location at which left-hand tyre was recovered

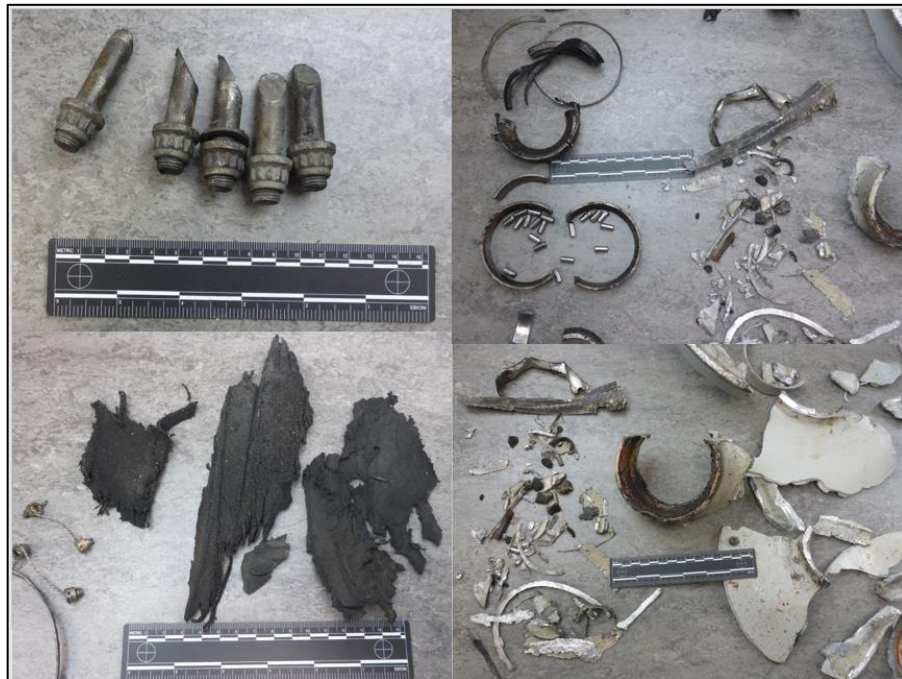
A large number of fragments of various parts of the NLG assembly were recovered from along the runway surface and margins, between the area where the NLG first touched down and where the aircraft came to a stop: these comprised fragments of hub material; tie-bolts, ground on a constant angle; bearing rollers, races and cages; locking wire; an inflation valve with cap in-situ; tyre fragments; axle nuts and washers. A sample of these items is shown in **Figure No. 2**.

Figure No. 2: Sample of the fragments recovered from the runway

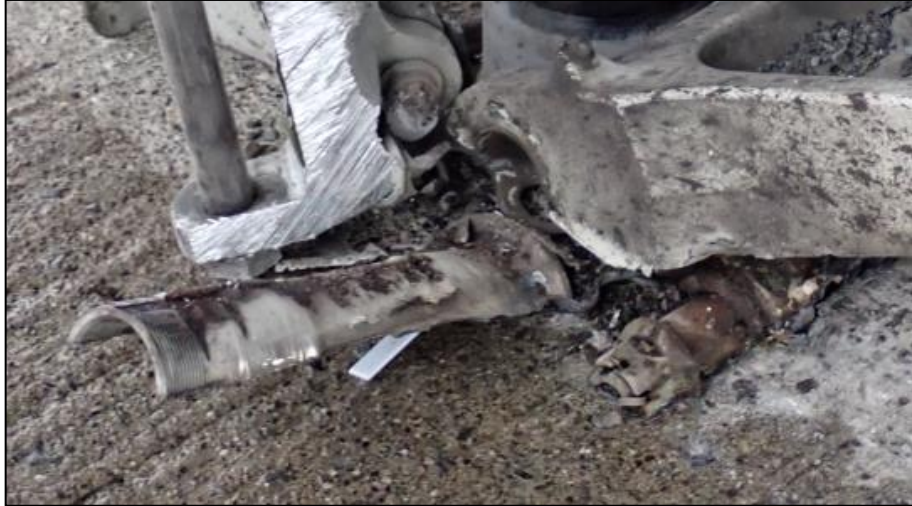
It was noted that the axles that had remained attached to the NLG assembly had been ground down to approximately half of their original circular profile (**Photo No. 4**).

Photo No. 4: Ground down axle

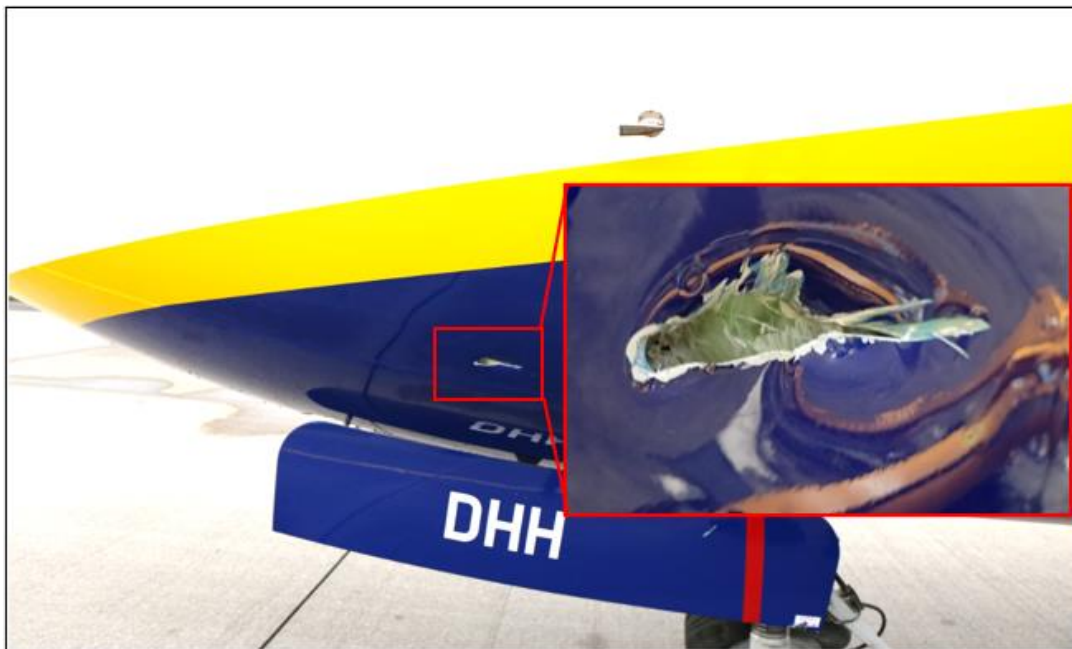
There was paint transfer evidence that a separated section of a NLG wheel had impacted, and punctured, the outer skin of the fuselage in the area underneath the left side of the cockpit (**Photo No. 5**). There was no damage to internal systems inside the fuselage.

Photo No. 5: Punctured fuselage skin on left side of aircraft

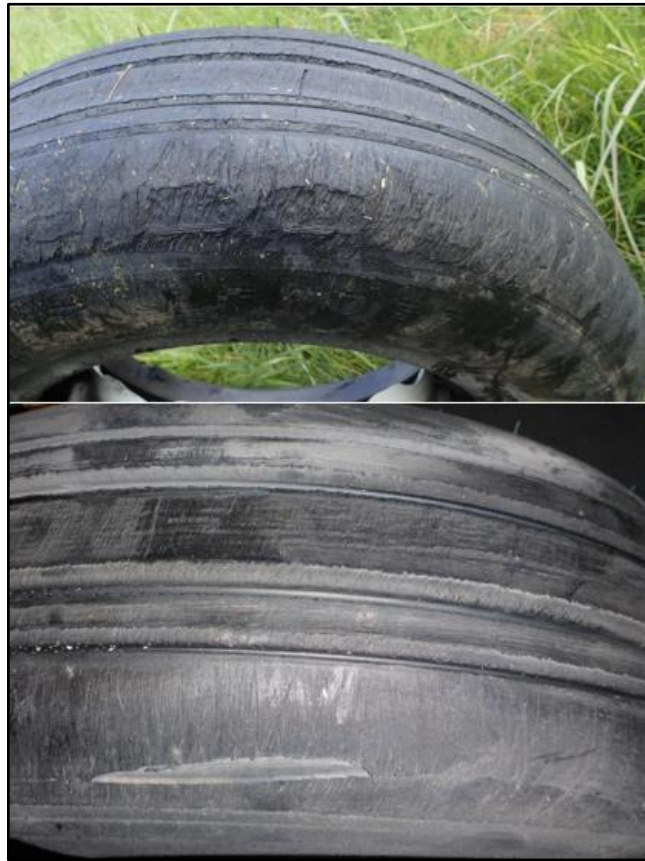
Examination of each of the nosewheel tyres revealed significant abrasion damage throughout the full available circumference of each tyre in a direction across the tyre ridges/grooves (**Figure No. 3**). The angle between the tyre grooves (thread pattern), which indicate the normal direction of rotation, and the majority (preponderance) of the abrasion marks was in the order of 70 degrees (values up to 72 degrees were observed).

Figure No. 3: Examples of the abrasion marks on the left (top) and right (bottom) tyres

In the LBA occurrence, the flight crew recalled that the tiller had indeed been used to attempt to prevent a lateral runway excursion. In the subject occurrence, the AAIU is similarly of the opinion that the tyre marks are consistent with tiller use and could not have been caused by rudder pedal steering alone.

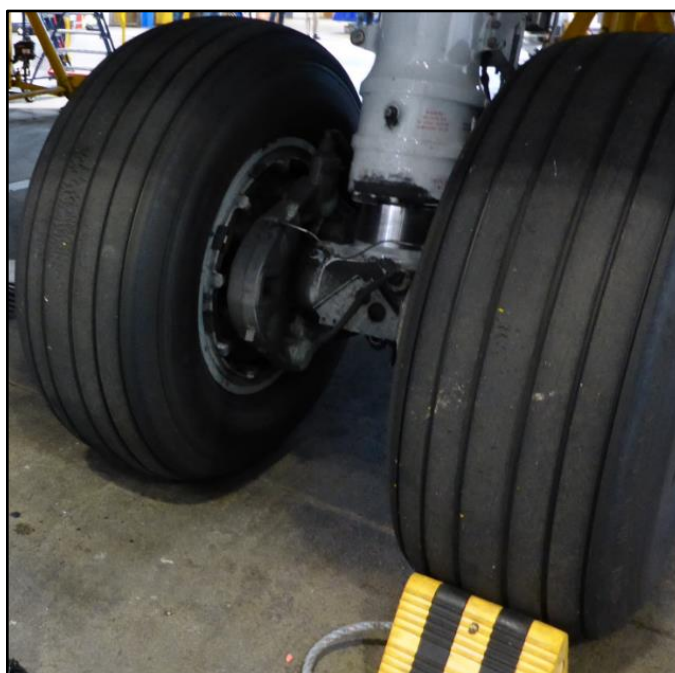
The Investigation notes that such abrasion marks, across the entire tyre face, and throughout the entire tyre circumference, were not present on the aircraft's main wheel tyres (**Photo No. 6**)

Photo No. 6: Main wheel tyres

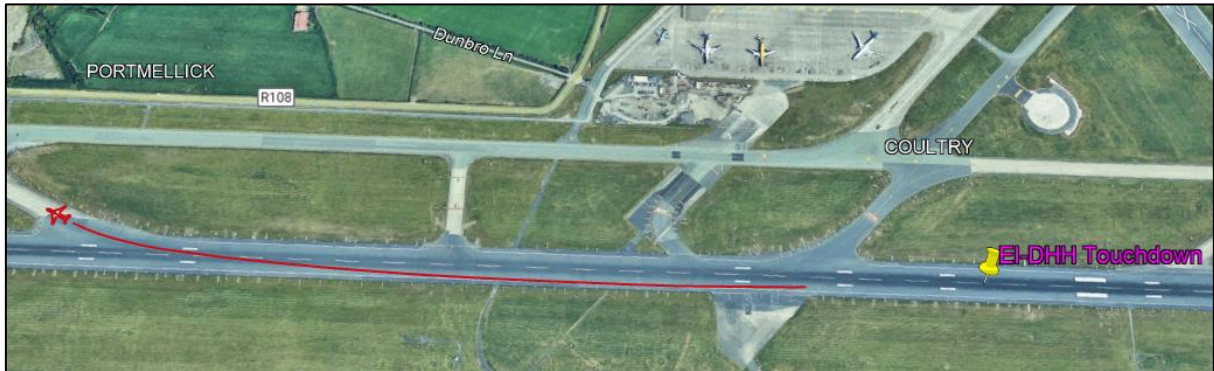
The Investigation conducted a survey of the runway surface to identify marks associated with the aircraft's ground roll. **Figure No. 4** shows the identified NLG-related markings overlaid, in red, on an image of the runway surface.

Figure No. 4: NLG-related runway marks (in red, overlaid on Google Earth imagery)

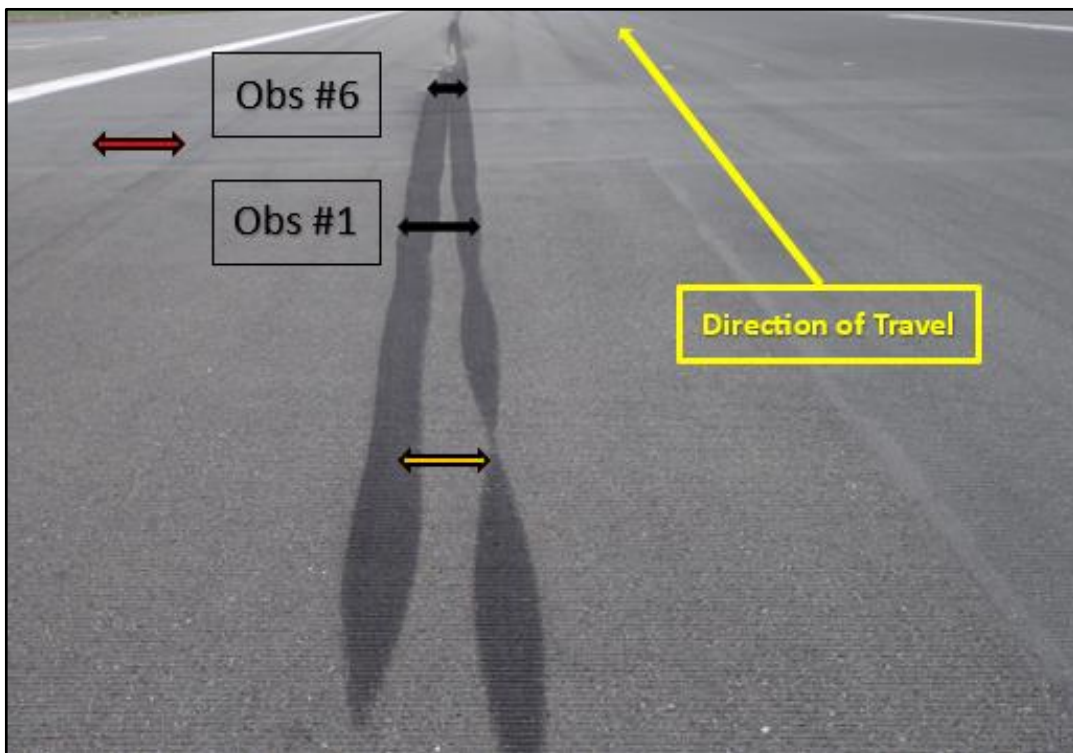
The Investigation noted that, in addition to the very pronounced NLG-related marks, tyre tracks from the two main landing gear (MLG) tyres were also apparent on the runway surface (**Photo No. 7** and **Photo No. 8**).

Photo No. 7: Initial NLG-related marks (orange) and left MLG marks (red)

Photo No. 7 show that the initial nosewheel track mark comprised two parallel tracks, one from each nosewheel tyre, which then merged to one track, wider than the normal contact width of a nosewheel tyre. Thereafter there is impact marking in the runway surface consistent with contact between the runway surface and the metal wheel hub and a divergent runway gouge likely due to left wheel separation. The Investigation noted the similarity between the track marks in **Photo No. 7** and those that were documented in relation to the Odesa and LBA occurrences as outlined in Section 1.17 — (**Photo No. 9**). The final report for the Odesa occurrence stated that *'having realized ineffectiveness of the rudder deflection, [the PIC] took decision to apply "Nose wheel steering" to large angles up to 78°, although FCTM does not recommend using this mode at speeds higher than the steering speed'*. The final report for the LBA occurrence stated that *'The angle of the nosewheels could only be achieved by use of the tiller rather than rudder pedal steering alone, and this corresponds with the commander's account of events.'* The AAIU Investigation is satisfied that in the subject occurrence, the tyre and skid marks, are consistent with the nosewheels being steered to the right at a speed higher than recommended by the manufacturer, and in the absence of any pre-existing conditions or failures of the NLG assembly or tyres, that this steering of the nosewheels was due to the tiller being used.

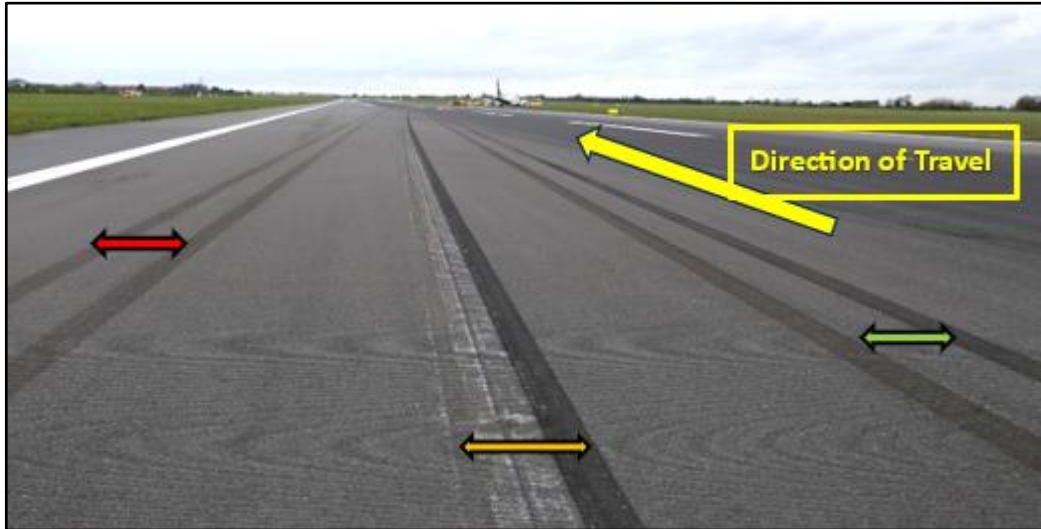
Photo No. 8: Runway marks — NLG-related (orange), left MLG (red) and right MLG (green)

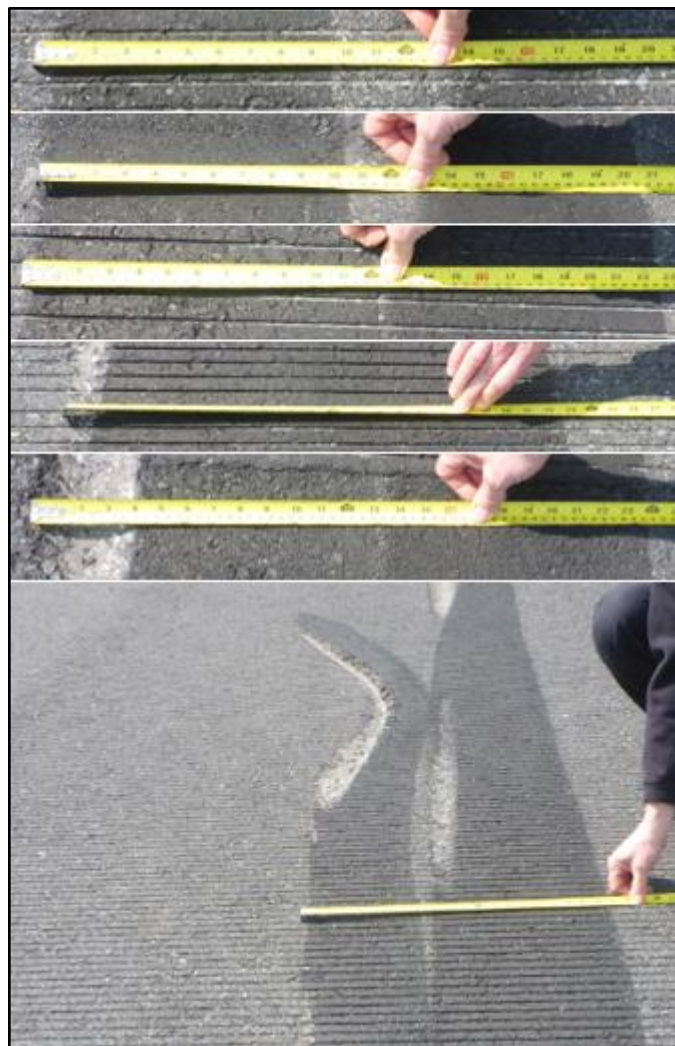
The Investigation carried out a detailed survey of the initial NLG-related marks; a composite of six observations is provided at **Figure No. 5**. The Investigation tabulated these observations in **Table No. 1**.

Figure No. 5: Composite of six observations progressing (top to bottom) along initial marks

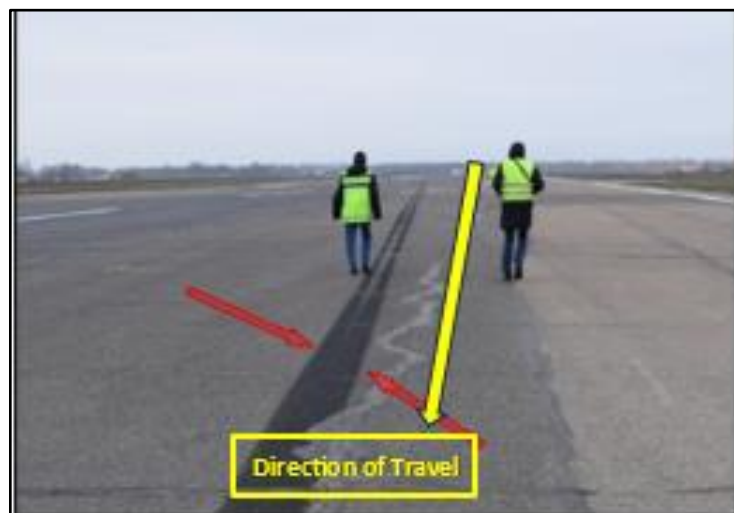
The National Bureau of Air Accidents Investigation of Ukraine Investigated the accident and published a final report (<https://nbaai.gov.ua/wp-content/uploads/2020/11/turkish-tc-jgz.pdf>); that final report contains a photograph of the tyre tracks from the NLG showing the two individual tyre tracks merging into one wider continuous track marked with red arrows (Photo No. 9).

Photo No. 9: Event involving another operator's aircraft at 'Odesa' Aerodrome

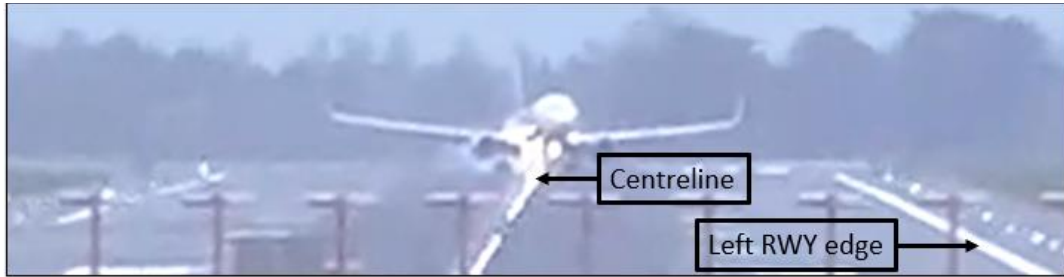
Figure No. 9: Head-on view of right main landing gear runway contact

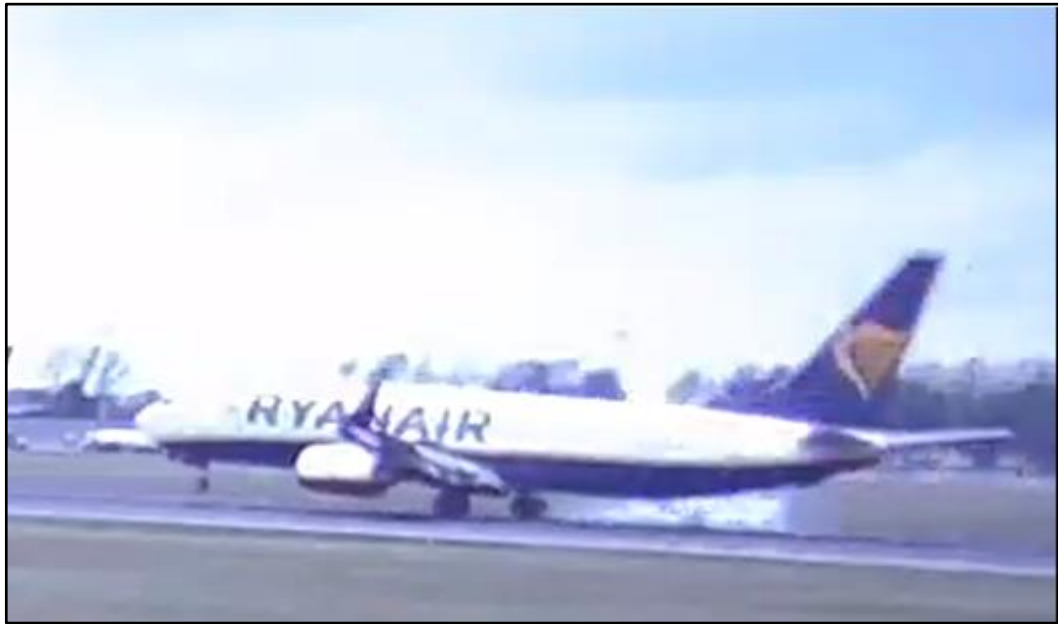
Figure No. 10: Oblique side-view of right main wheel runway contact

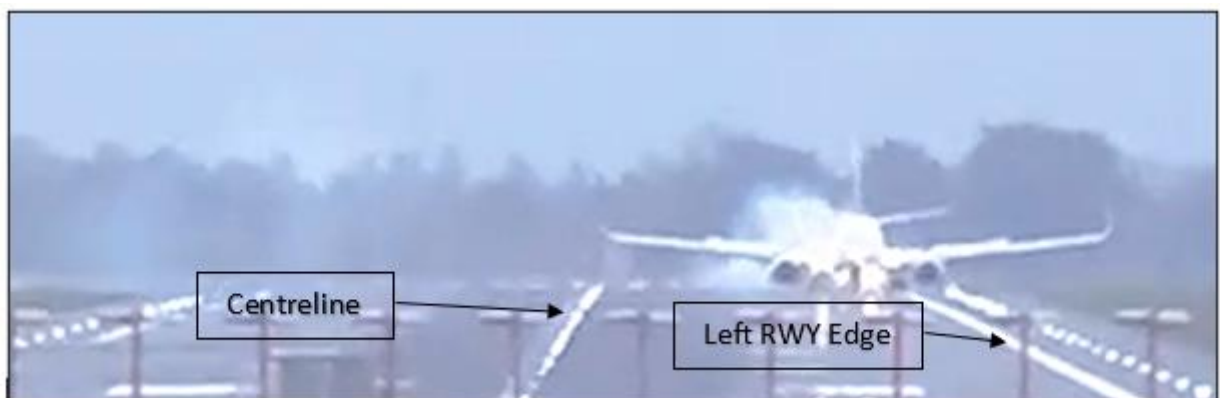
Figure No. 11: Head-on view of nosewheel runway contact

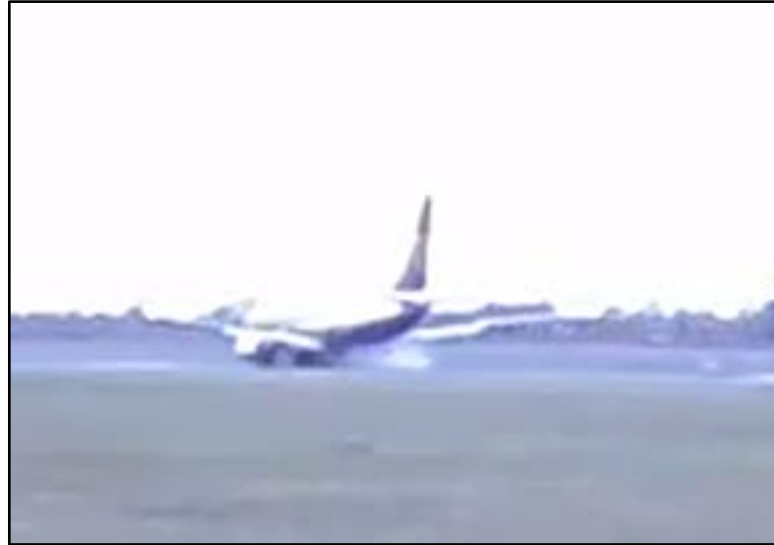
Figure No. 12: Oblique side-view of nosewheel runway contact

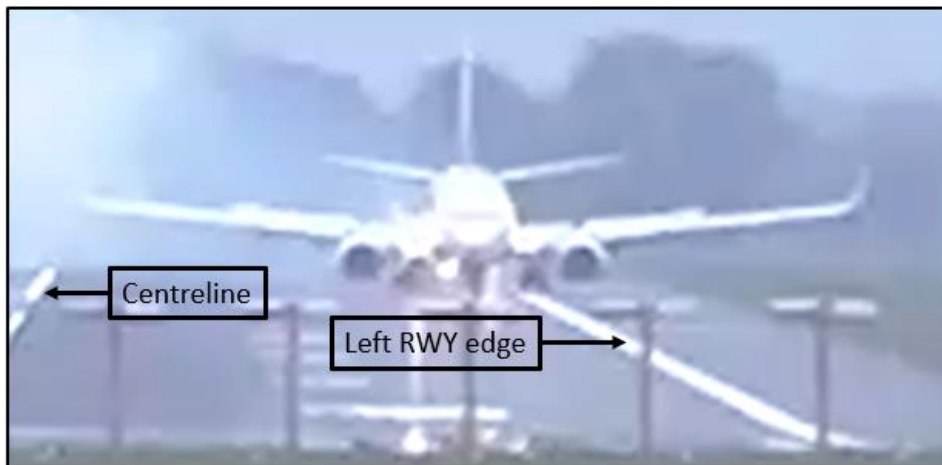
The Investigation also extracted an image from the head-on CCTV footage which showed the left main wheels outside of the marked runway pavement area (**Figure No. 13**). A Runway Excursion is defined by ICAO's Accident/Incident Data Reporting (ADREP) taxonomy as 'A veer off or overrun off the runway surface'.

Figure No. 13: Left main wheels outside of marked runway area
