# Air Accident Investigation Unit Ireland

**SYNOPTIC REPORT**

**Boeing 767-322ER, N670UA  
Shannon Airport, Co. Clare, Ireland**

**7 April 2022**

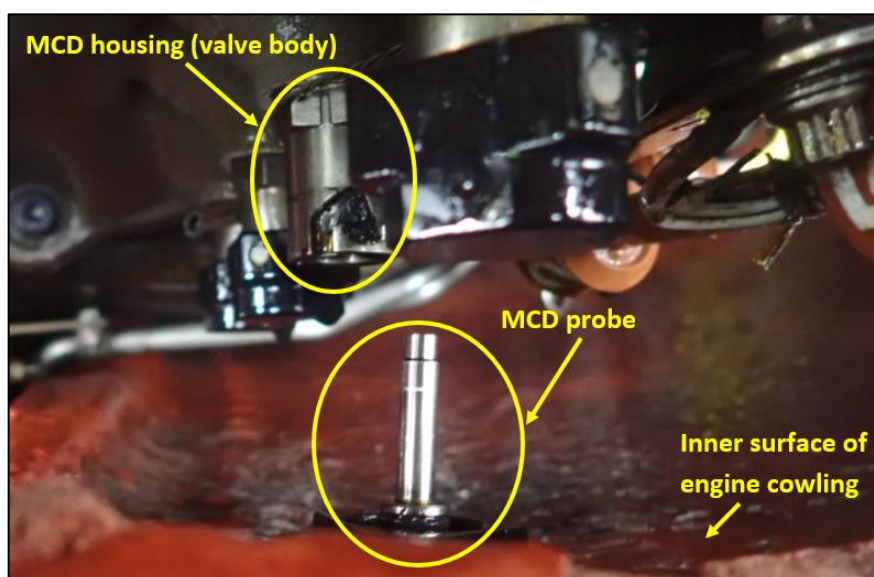
When the No. 1 engine was examined at EINN following the occurrence, the MCD probe for the engine's No. 4 main bearing scavenge line was found in an upright position in the engine cowling below its housing (valve body) (**Photo No. 1**), and there was evidence of oil in the surrounding area. The Operator informed the Engine Manufacturer of the occurrence.

**Photo No. 1:** MCD for No. 4 bearing on No. 1 engine as found following occurrence

9. When the No. 1 engine was inspected following the occurrence, the MCD probe for the engine's No. 4 bearing scavenge line was found in an upright position, in the engine cowling, below the MCD housing.

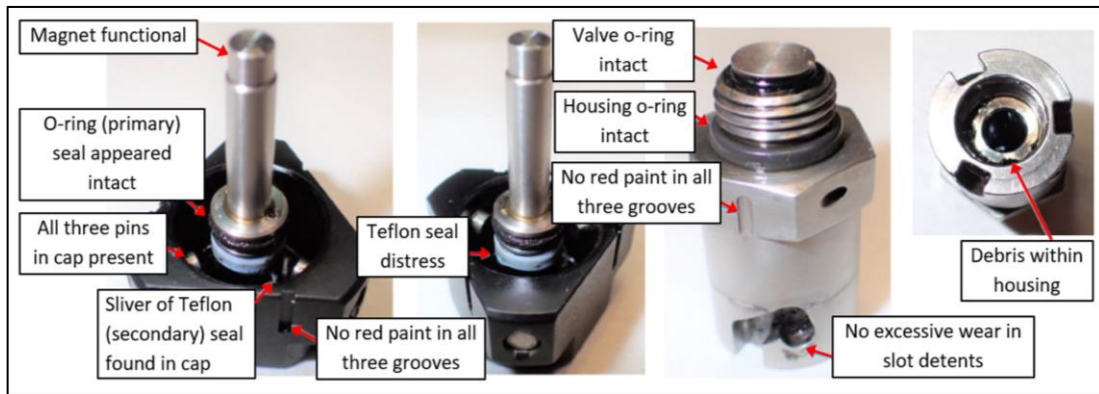
The MCD housing (valve body) and probe from the No. 1 engine's No. 4 main bearing scavenge line were shipped, in the *'as found'* condition, to the Engine Manufacturer for detailed examination and testing. An *'as received'* visual review report was prepared by the Engine Manufacturer (**Figure No. 3** refers).

- All three locking pins were present.
- The o-ring (primary) seal appeared intact.
- A sliver of Teflon® (secondary) seal was found within the grip of the probe.
- There was distress on the Teflon® seal on the side opposite the liberated sliver.
- There was no red paint in the three alignment grooves.
- The magnet was functional.

- The o-ring on the spring-loaded valve appeared intact.
- The o-ring that provides a seal between the housing and the engine appeared intact.
- There was no red paint in the three alignment grooves.
- Debris was present within the housing.

**Figure No. 3:** MCD probe and housing (Adapted from Engine Manufacturer's report)

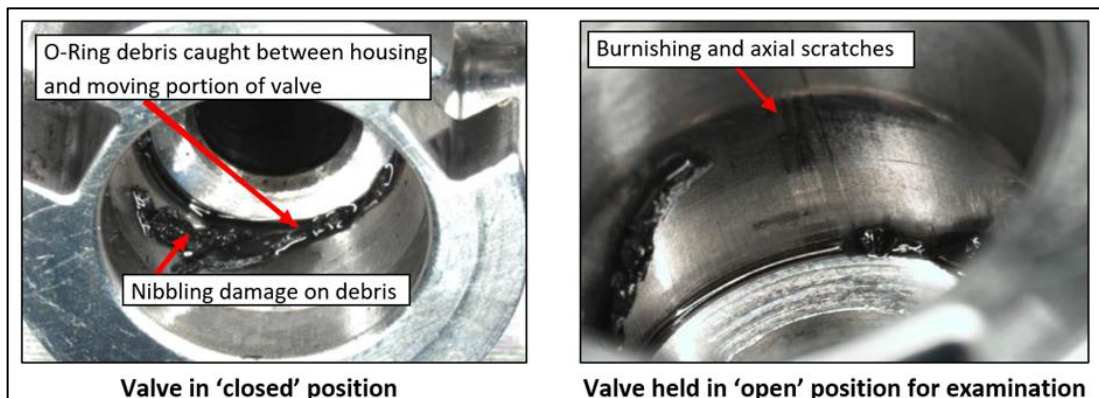
Several anomalies were identified on further examination by the Engine Manufacturer (**Figure No. 4**), including 'nibbling' damage to the o-ring (primary seal) fitted to the probe, in addition to the damage to the Teflon® seal already noted. Nibbling damage was also found on the debris within the housing. The Engine Manufacturer considered that the 'nibbling' damage on the debris in the housing 'suggests that it [the debris] was moving relative to the housing'. The debris within the housing was caught between the housing and the moving portion of the spring-loaded valve. It was noted that the amount and size of the debris recovered from the housing was 'greater than the missing material from [the] worn o-ring', and that the o-ring on the MCD probe and the debris were not the same material (probe o-rings are not all manufactured from the exact same material). When the valve was held in the open position for the purpose of the examination, 'burnishing [polishing/evidence of rubbing] and axial scratches' were identified on the housing wall in the valve operating area, which the Engine Manufacturer considered to be 'indicative of interference between the housing and the moveable valve'. In addition, scuff marks were found on the side of the shank of the probe.

**Figure No. 4:** Debris within the housing, and burnishing and axial scratches (Adapted from Engine Manufacturer's report)

The Engine Manufacturer's examination also noted that rubber debris that exhibited nibbling damage was observed to be caught between the housing and the moving portion of the spring-loaded valve. The Engine Manufacturer carried out an X-Ray examination of the housing and probe, with no adverse findings. The Engine Manufacturer sectioned the valve to permit disassembly. The sealing o-ring on the valve was found to be in good condition with no obvious wear observed on the spring or on the body of the valve; however, rubber debris was found on the valve spring coils.

The Engine Manufacturer's examination of the housing with the valve held in the open position for the purpose of the examination found burnishing and axial scratches on the housing wall, which the Engine Manufacturer deemed to be indicative of interference between the housing and the moveable valve. Any interference could adversely affect the closing of the valve, in the event of a migrated probe. However, the Engine Manufacturer considered the most likely scenario was that the MCD probe had been in a partially installed position due to lack of spring force from the self-closing valve as a result of debris. The Engine Manufacturer suggested that engine vibration caused the partially installed MCD probe to migrate and become liberated from the housing, while the debris in the valve caused the valve to remain partially open and permit oil leakage.
