Air Accident Investigation Unit Ireland

FACTUAL REPORT

**Aeroprakt A-22L2, EI-HNC
Cloongoonagh, Co. Mayo, Ireland**

7 September 2024

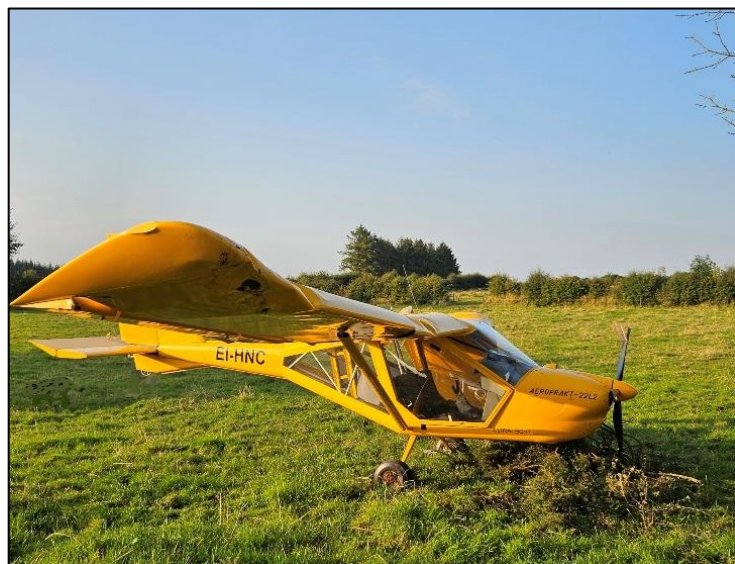
The Pilot reported that as the aircraft was approaching the runway threshold at Cloongoonagh, at a height of approximately 20 feet (ft), a sudden drop in height occurred, following which he applied power and right rudder to conduct a go-around manoeuvre (i.e. to reject the landing). He said that the left wing seemed to drop, and that the aircraft suddenly veered to the left. The aircraft impacted with a hedgerow, which ran parallel to the left side of the runway. It came to rest in an agricultural field on the other side of the hedgerow and was pointing back towards the hedgerow (**Photo No. 1**). The Pilot, who had been secured by a four-point harness, stated that he was uninjured and was able to exit the aircraft normally. There was no fire.

Photo No. 1: Position of aircraft post-accident (*photo provided by Pilot*)

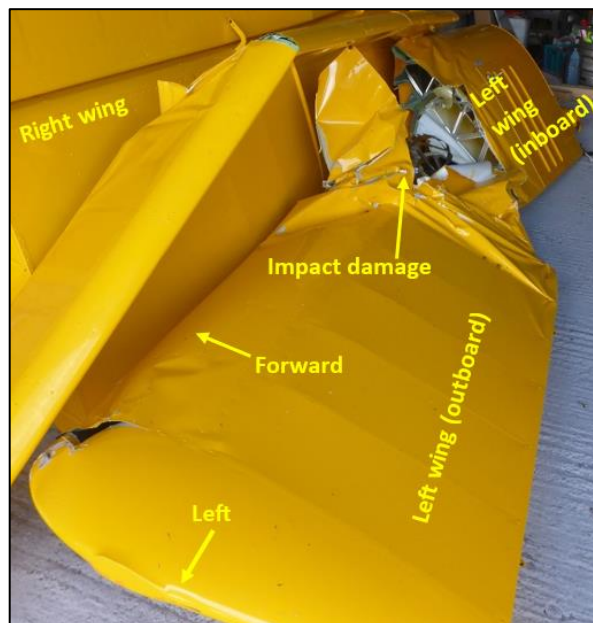
The left wing sustained significant impact damage approximately halfway along its span (**Photo No. 2**). There was also impact damage to the leading edge, close to the wingtip. The right wing was distorted near its root. All three propeller blades were broken. The nose landing gear leg was bent, and the left rear organic glass⁹ panel was fractured. The aircraft's ballistically operated parachute recovery system appeared to be undamaged and had not deployed during the occurrence.

Photo No. 2: Damage to left wing (wings removed from aircraft)

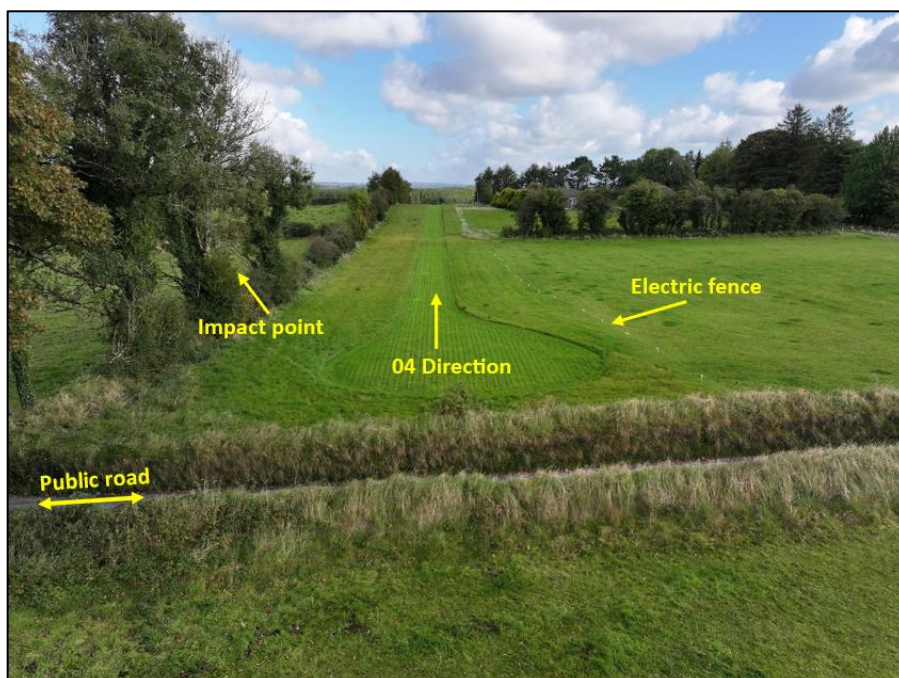
The runway was located on a private site at Cloongoonagh, Co. Mayo. It was grass-covered and was orientated in the 04/22 direction (**Photo No. 3**). The Investigation measured it to be approximately 254 m long and 4.3 m wide. The approach was being made in the 04 direction (approximately north-easterly). There was a hedgerow located approximately 9 m from the left-hand edge of the runway (when viewed in the 04 direction). The section of hedgerow nearest the threshold contained several trees. A single-wire electric fence ran parallel to the right-hand side of the runway. The runway sloped upwards in the 04 direction for the first 150 m, gaining approximately 4 m of elevation, before sloping downwards for the final 100 m approximately. The elevation at each end was approximately 96 m Above Mean Sea Level (AMSL). The site was not licensed by the IAA, nor was it required to be.

The point of impact with the hedgerow was approximately 20 m from the 04 threshold. The threshold was located approximately 6 m from an embankment that bounded a public road, which was orientated approximately perpendicular to the runway. An embankment was also present on the other side of the road. The final approach in the 04 direction crossed overhead electrical cables that were fitted with warning markers. The cables were located approximately 78 m before the runway threshold. The ground elevation at the location of the cables was approximately 92 m (AMSL). The cables were at a height of approximately 8 m above the ground and at an elevation of approximately 100 m (AMSL). Dense trees were located approximately 100 m beyond the far end of the runway. A weathervane located to the side of the runway, close to its mid-point, was used to indicate wind direction. There was no windsock.

Photo No. 3: Runway and impact point
