Air Accident Investigation Unit Ireland

FACTUAL REPORT

**Cessna T303 Crusader, G-PUSI
Navan Airfield, Co Meath, Ireland**

AAIU Report No: 2025-004

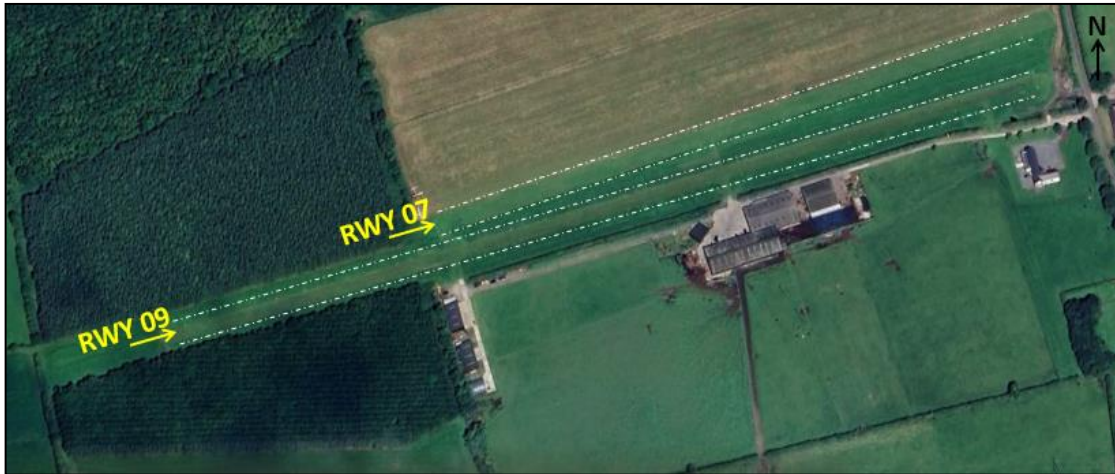
Figure No. 1: Navan Airfield (runway markings added by Investigation) (*Google Earth*)

The white dashed lines have been added by the Investigation to provide clarity regarding the proximity of both runways and do not indicate actual runway markings on the day of the accident. RWY 07/25 is approximately 530 m in length and RWY 09/27 is approximately 700 m in length. There is a forest of mature trees on either side of the first 200 m approximately of RWY 09 and the distance between the trees on either side of the runway is approximately 35 m. There is approximately 500 m of remaining runway after the trees and a wedge-shaped grass area separating both runways to the east of the trees.

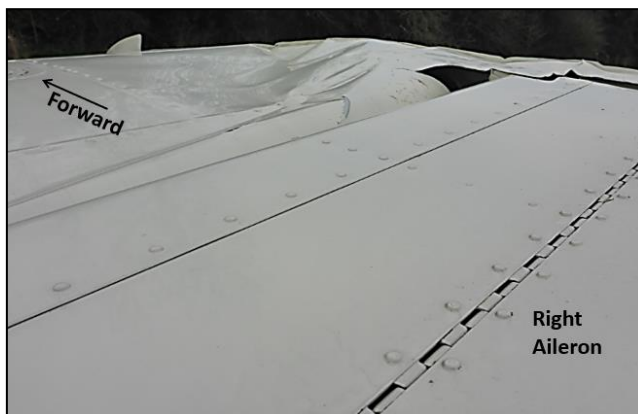
Figure No. 2: Right wing surface

The aircraft sustained substantial damage during the accident sequence. The underside of the right wing sustained impact damage due to contact with the runway surface. The upper wing surface was buckled forward of the right aileron and a portion of the upper wing skin was torn (**Figure No. 2**). There was significant damage visible to the internal framework of the right wing; part of this damage was visible through an inspection port in the wing (**Figure No. 3**).

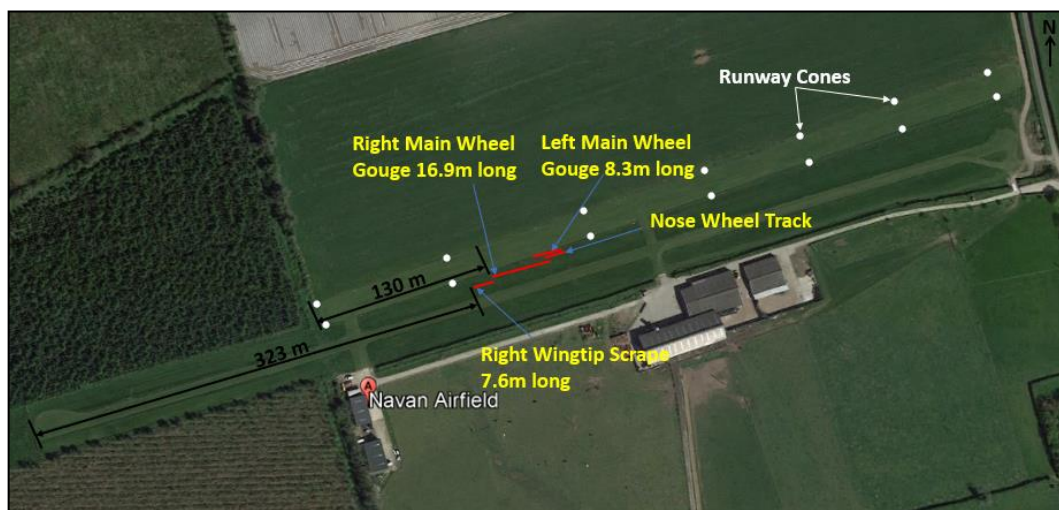
Figure No. 4: Site survey (Google Earth)

During a site survey conducted on the day after the accident, ground markings were identified on the wedge-shaped grass area between the two runways, and to the left of RWY 09. The dimensions between the ground markings were consistent with the aircraft undercarriage dimensions. The markings began 323 m from the beginning of RWY 09 and are depicted in **Figure No. 4**. The white runway cones which outlined RWY 07 as shown in **Figure No. 4** have been added by the Investigation to show which runway was marked with cones on the day of the accident.

The markings indicate that the first ground contact occurred when the right wing touched the ground in the wedge-shaped grass area approximately 123 m from the end of the treeline, followed by the right main wheel which caused a gouge in the soft surface. The left main wheel touched down next, causing a more significant gouge. The nose wheel then touched down. All of the impact marks were noted to be on the wedge-shaped grass area between the two runways, and to the left of RWY 09. White cones marked the sides of RWY 07, whereas RWY 09 did not have white cones marking its edges on the day of the accident.

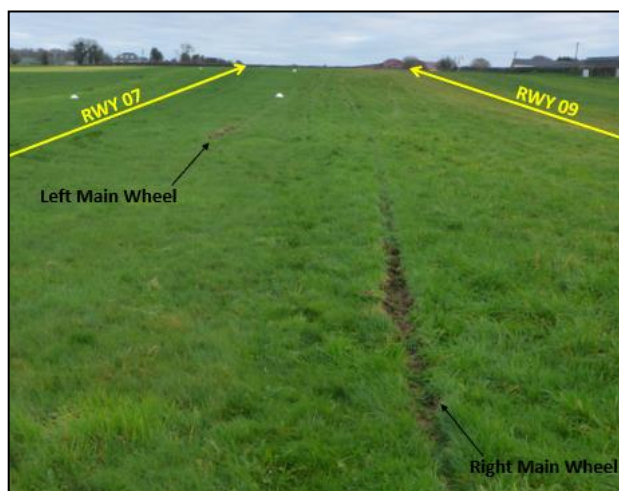
Figure No. 5: Ground impact marks looking east

The ground impact marks as observed during the site survey are shown in **Figure No. 5** (looking east) and **Figure No. 6** (looking west).
