# Air Accident Investigation Unit Ireland

**FACTUAL REPORT**

**Windtech AMBAR 29 Paraglider  
Maughanablagher Cliffs, Co. Kerry, Ireland**

**AAIU Report No: 2025-010**

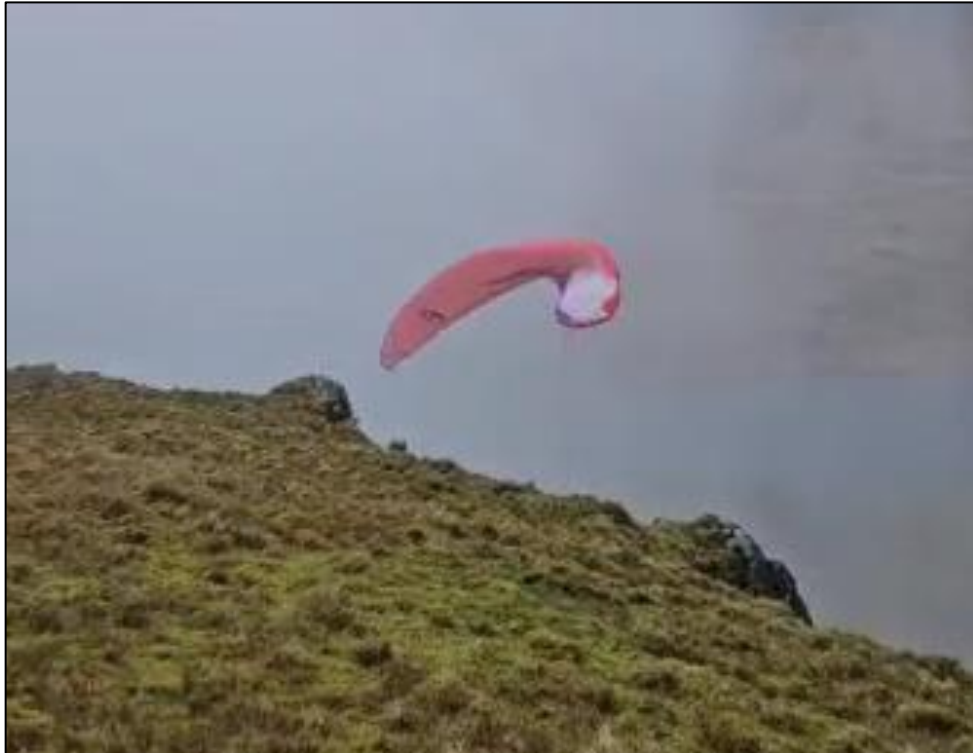
Video footage provided to the Investigation shows no observable lift during the initial run up and the Pilot and Paraglider disappearing from view following the initial jump. The footage also shows that prior to the jump, the canopy was fully inflated but moved from the overhead position to slightly forward of the Pilot, and that following the jump, the canopy suffered an asymmetric collapse on the right-hand side (**Photo No.1**).

**Photo No. 1:** Asymmetric canopy collapse on the right-hand side (with low cloud obscuring the valley below)

The asymmetric canopy collapse caused a rapid right turn towards the cliff face and although the canopy reinflated, it was too late for the Pilot to regain effective control, and he impacted with terrain. The Pilot, who was not wearing a helmet, said that prior to impact he braced himself and that following the impact he was dragged down the cliff face.

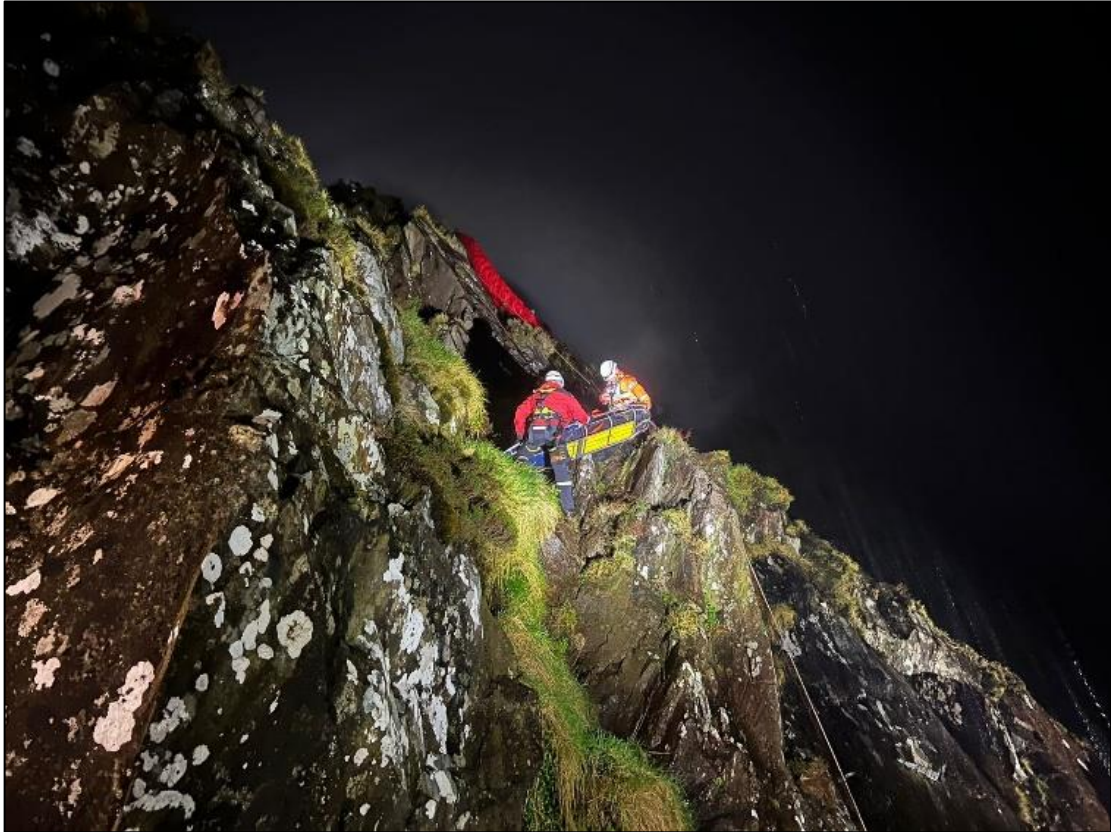
**Photo No. 2:** A view of the accident site

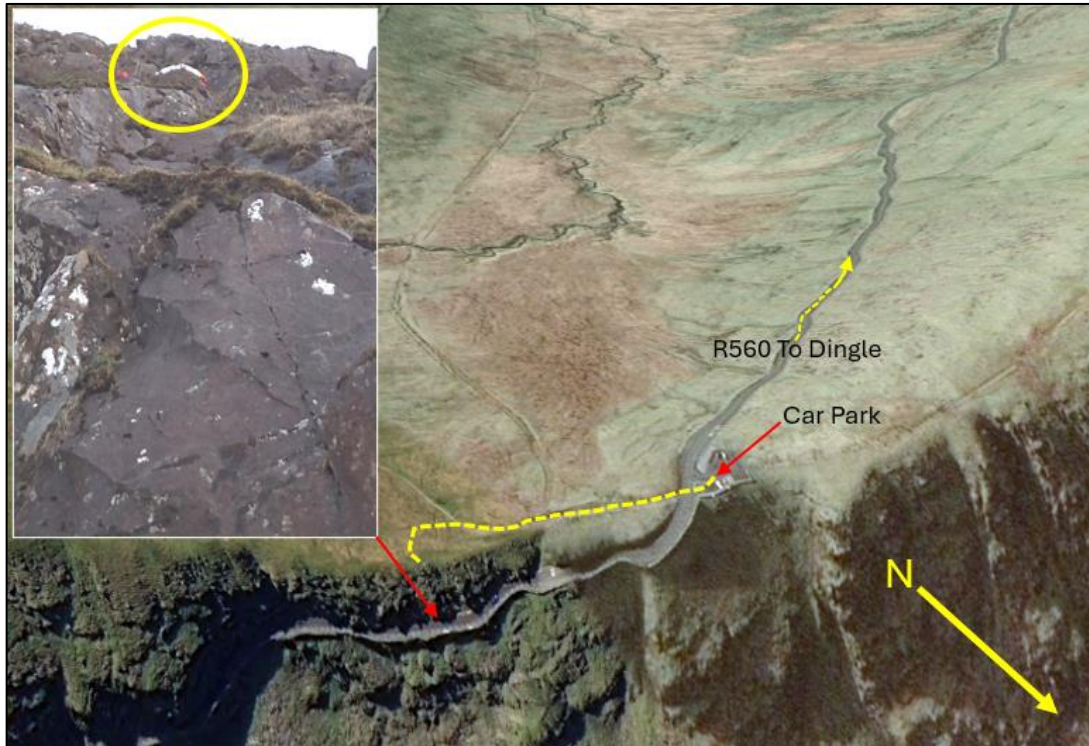
The accident occurred at the Maughanablaghar Cliffs to the east of a car park located at the Conor Pass. **Figure No. 2** shows an image taken of the Paraglider from the road below on the day after the accident and prior to retrieval by the Dingle CGU. The dashed yellow line leading from the car park represents the Pilot's hike to the launch site prior to the accident.

**Figure No. 2:** The accident location and Paraglider (ringed in yellow)
