Technical report

IN-019/2024

Incident occurred on 19 June 2024 to aircraft ATR72-212A, registration CN-COE, operated by RAM Express, and Boeing 737-800, registration EI-DYC, operated by Ryanair, at Seville airport

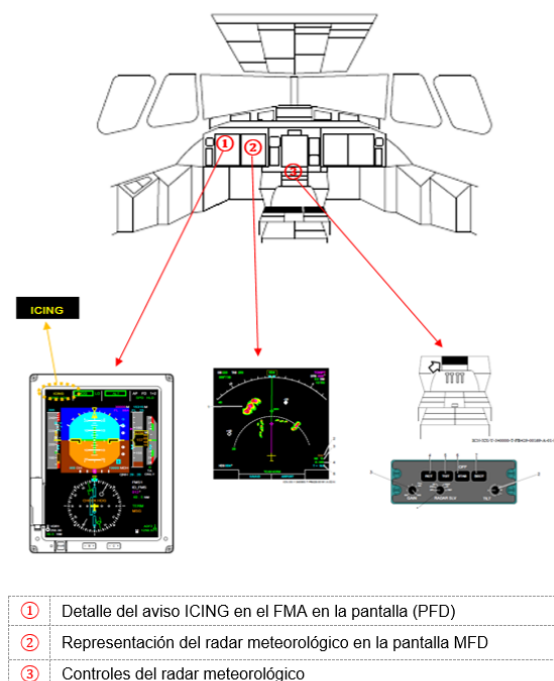
Figura 1: Representación de la cabina de vuelo

①	Detalle del aviso ICING en el FMA en la pantalla (PFD)
②	Representación del radar meteorológico en la pantalla MFD
③	Controles del radar meteorológico

⁵ ICING alert: an amber ICING alert is generated on the FMA and EWD, alerting the flight crew that ice detector probe detects accumulation of ice on the aircraft. On land, heavy rain may generate the activation of this alert despite not being in icing conditions as indicated in FCOM DSC 30.2 *Ice detector*.

During taxiing, the crew of RAM925 checked the weather with the weather radar which, together with the identification of an ICING alert, caused them to focus their attention and eyes in the cockpit for a few moments as they continued to taxi slowly. Both crew members assessed the alert as false, which indeed proved to be the case, as the confirmed temperature was 18°C.

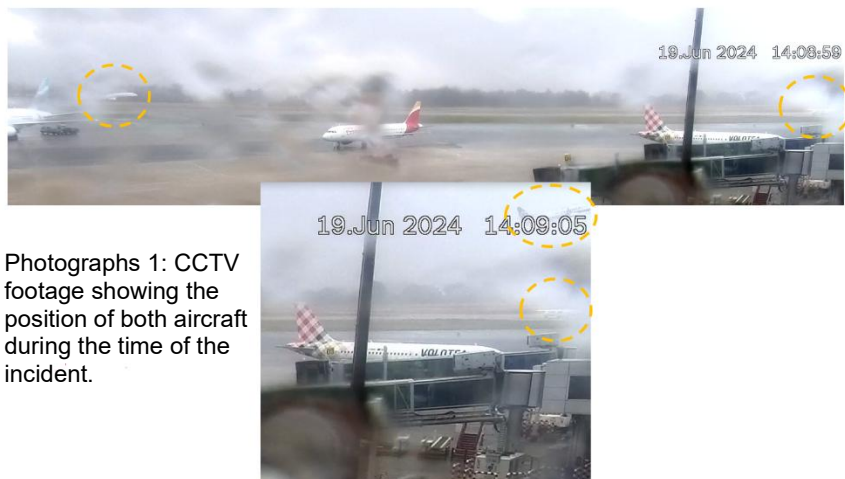
Photographs 1: CCTV footage showing the position of both aircraft during the time of the incident.

Therefore, in the spatial and temporal domain where the incident took place, moderate to heavy thunderstorms and showers were present, locally and temporarily reducing runway visibility. See photographs 1 showing the limited visibility due to rain captured by the airport's CCTV cameras at the time of the event.

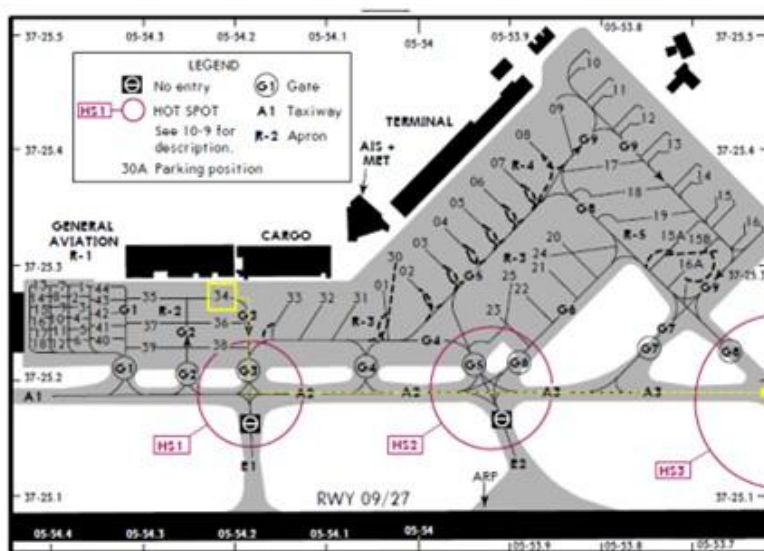
Figure 7: Authorised taxiway from stand 34 to holding point 27 in yellow.

The aircraft in the event, RAM925, which was parked at stand 34, taxied through gate "G3" and instead of turning left onto taxiway A, continued straight ahead on E1. This point is classified as critical location 1 (HS1) as shown in Figures 7 and 8.

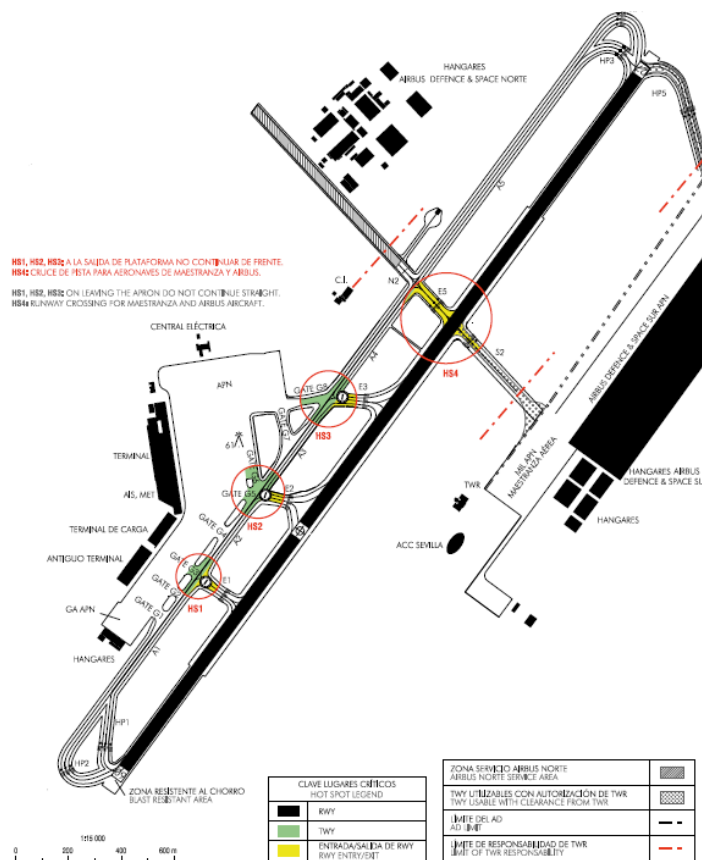
Figure 8: Extract from the map of Seville airport with the critical locations marked with a red circle.

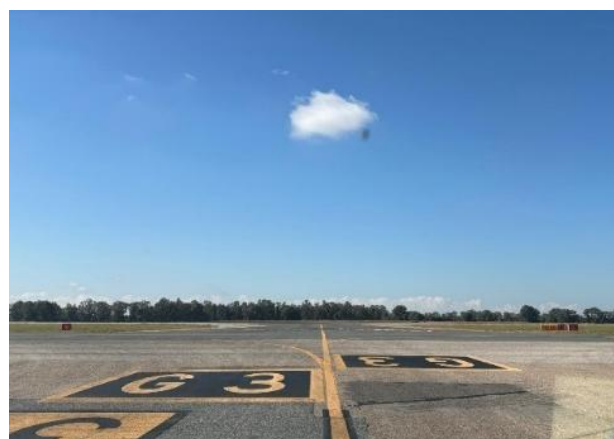
Photograph 3: Taxiway E1 Exit/entry through gate G3

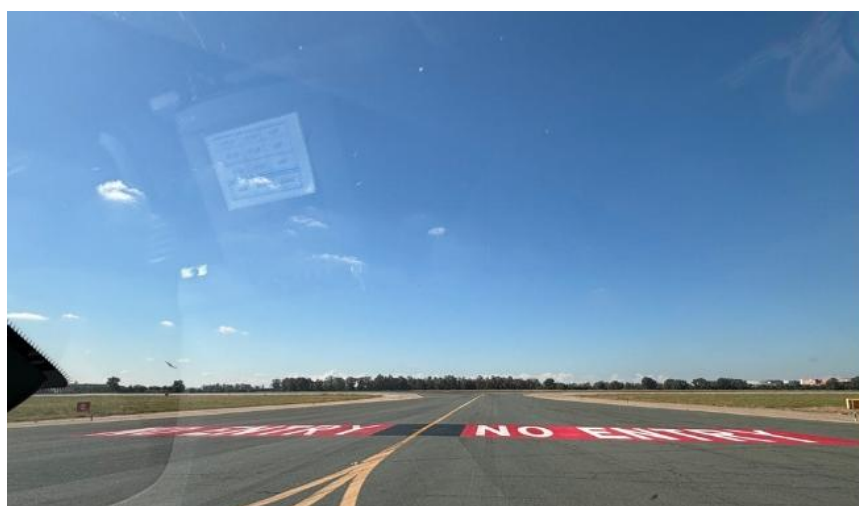
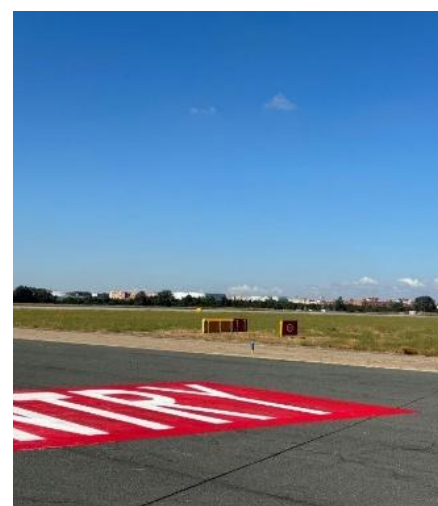
- Two NO ENTRY signs on the ground in E1 (Photos 4), and,

Photographs 4: From gate G3, access marked "NO ENTRY".

- Airport:
 - The taxiways and runway markings were in accordance with the applicable regulations and are visible to pilots and drivers of vehicles travelling airside at the airport. The "NO ENTRY" signs, painted in red on the pavement, were in a good state of repair.

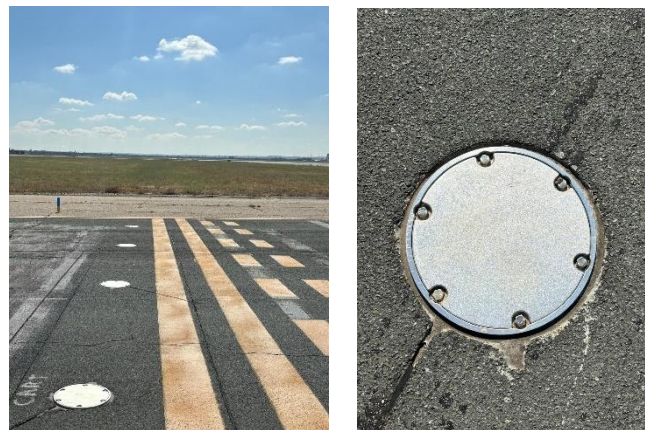
- It does not have stop bar lights, according to the manager, precisely because it is NO ENTRY, it only has a waiting point sign.
- It has axle lights, but only in the runway exit direction and location sign E1 in the runway exit direction, as it is a runway exit only lane.

Photographs 5: Holding point signal at E1

The crew also failed to notice the holding point signs; at E1 the holding point has no guard lights or stop bar installed. Had they existed, they could have helped to better visualise the taxiing area in situations of impaired visibility due to rain.

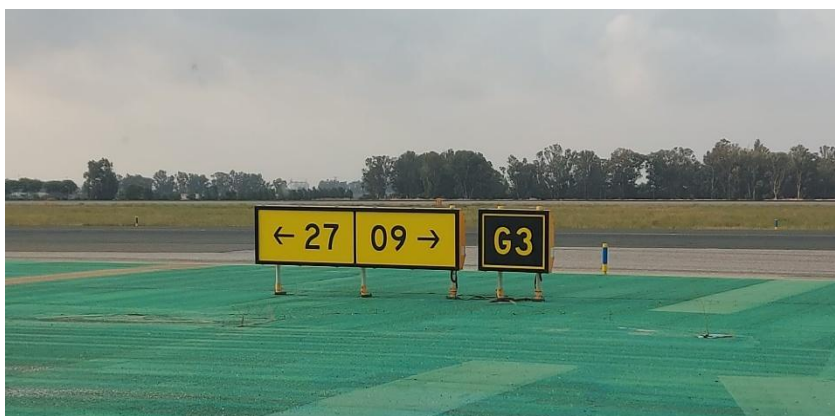
Photograph 6: Information signs to the left of the platform exit through gate G3

At exit G3, on the left hand side there is a destination information sign (with lighting available) indicating the direction to runways 09 and 27 in yellow, see Photo 6, and a location sign indicating the current taxiway, G3.

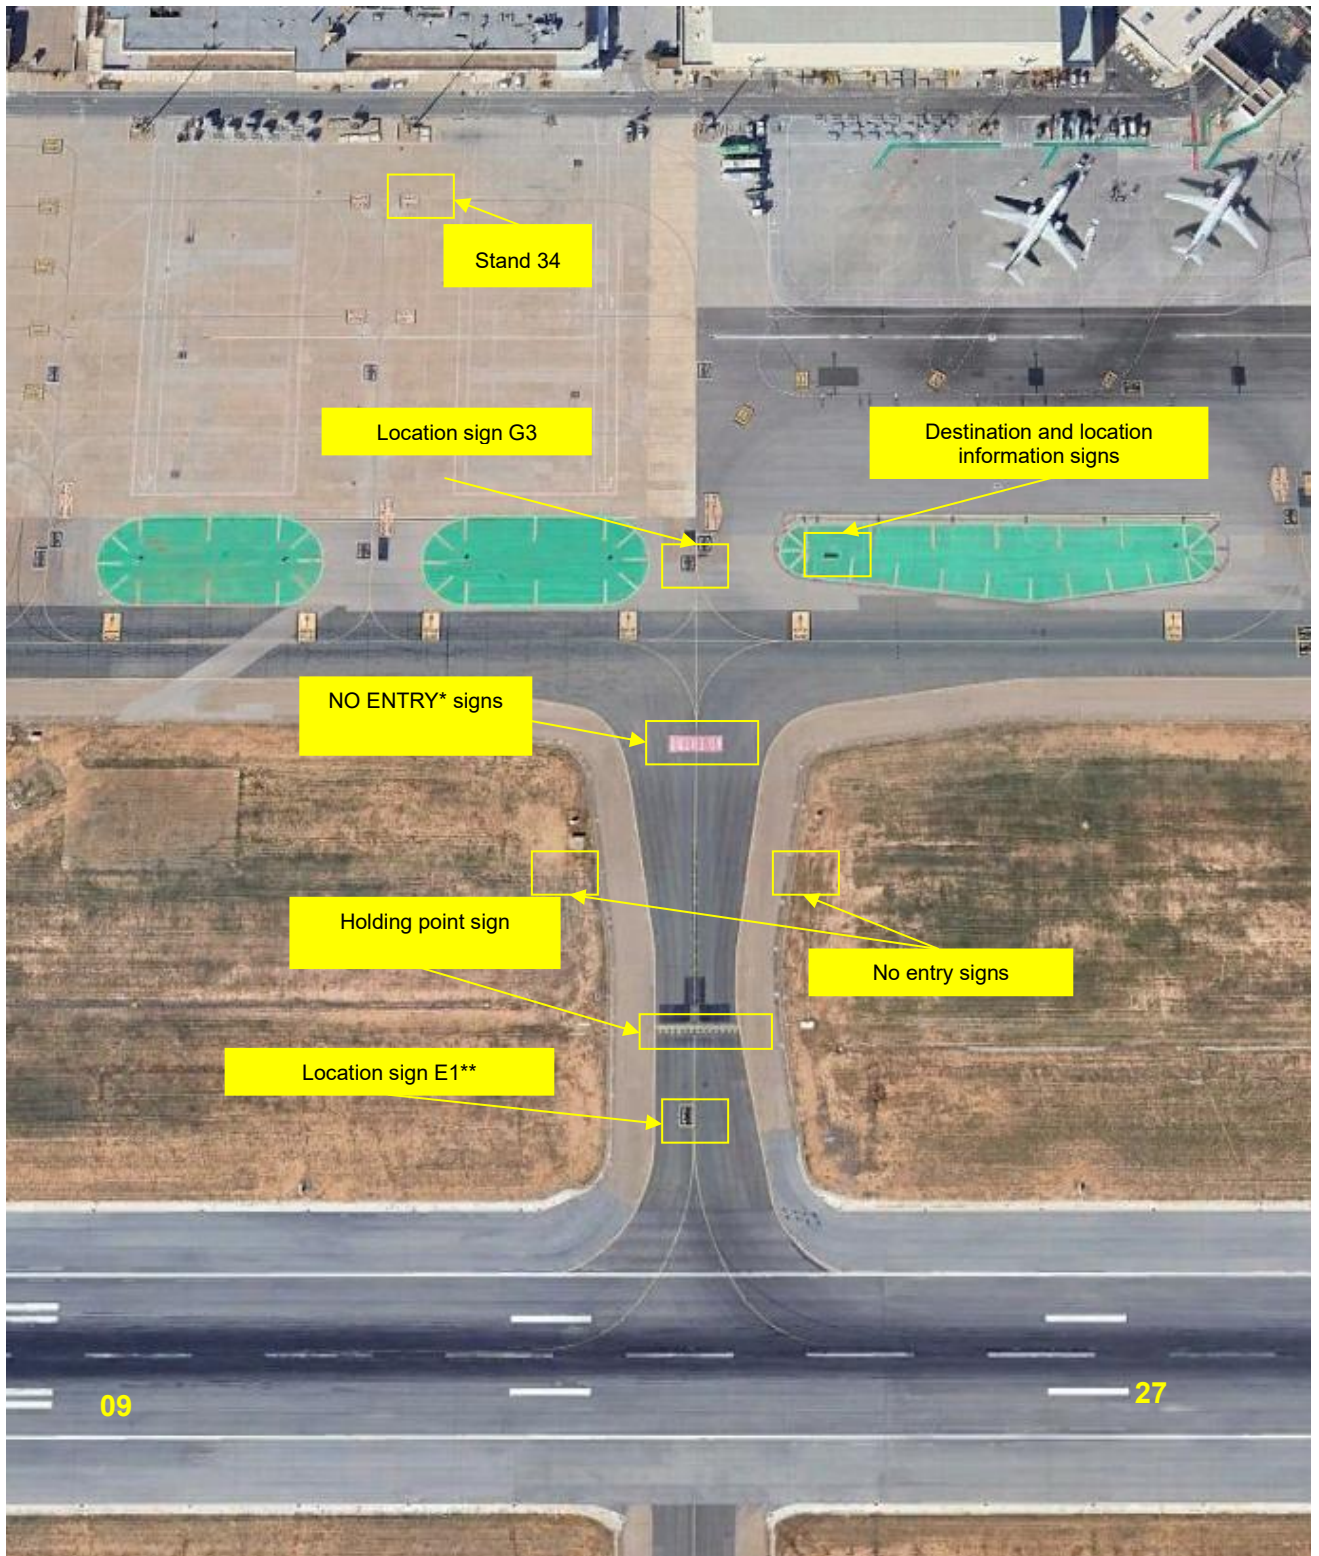
At the time of the incident, the panels were not illuminated, nor were the taxiway A lights.

Photograph 7: Airport signage in the area where the runway incursion occurred.

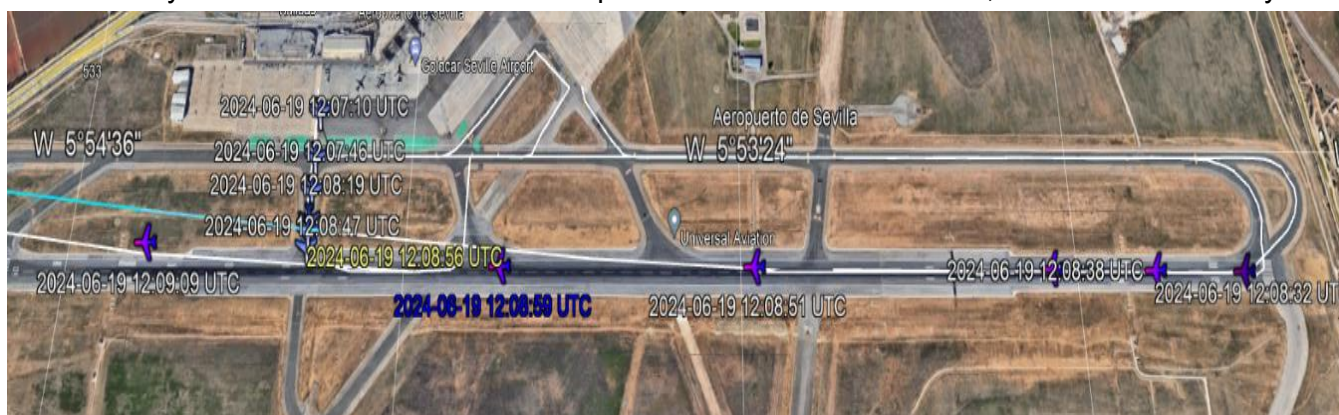
Figure 9: Recreation of the trajectories of RYR3262 and RAM925 at the time of the event.

⁹ The height at which RYR3262 overflew the RAM925 has been calculated taking into account that radio altimeter height records are recorded every two seconds. Thus, at 12:09:02 h, 40 ft was recorded and at 12:09:04 h, 90 ft, with a height of RAM925 of 25 ft.

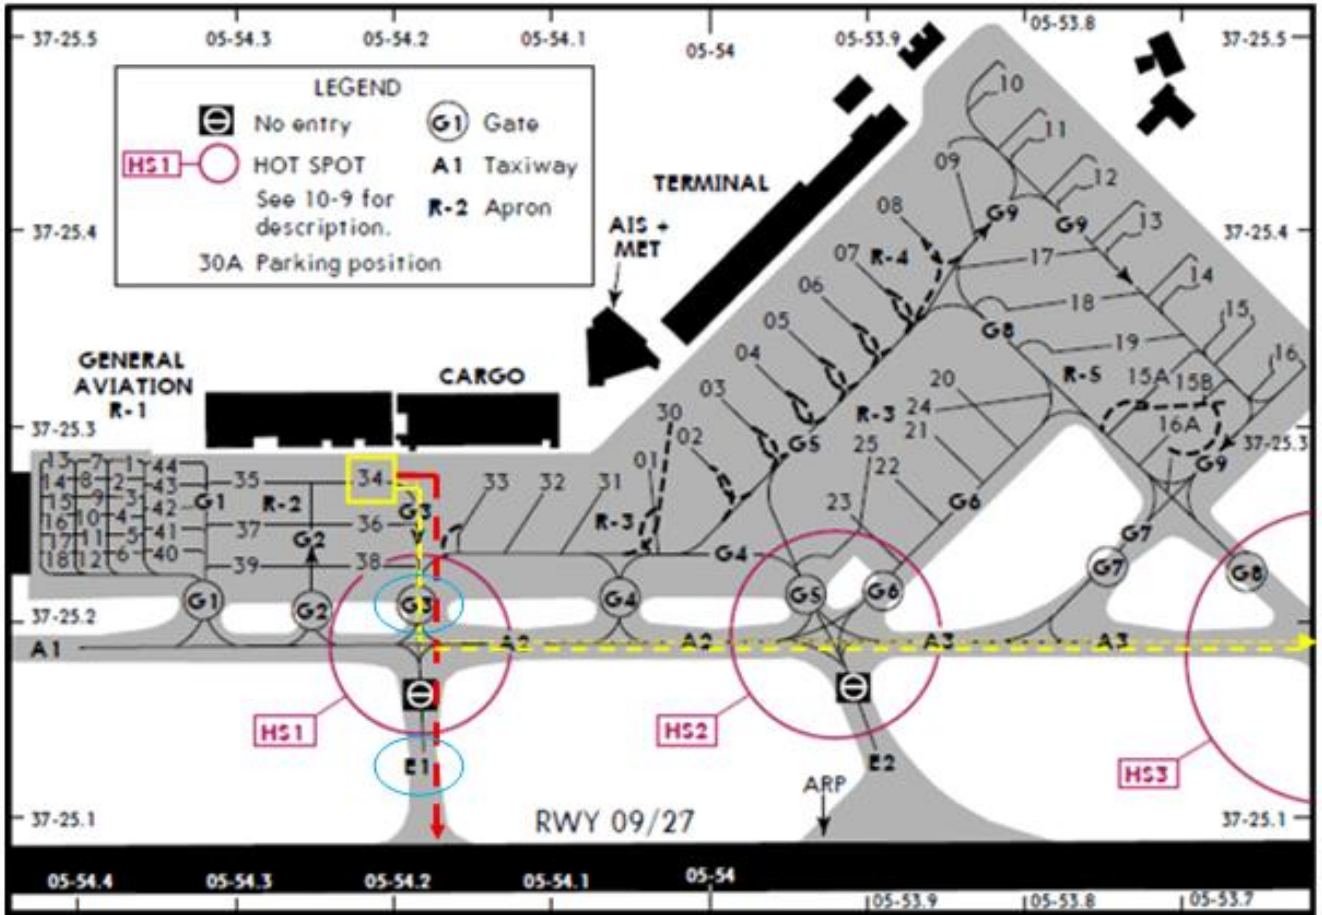
The actual trajectory of RAM925 is marked in Figure 10 with a red dashed line.

At 12:07:46 h, the control tower cleared RYR3262 to the requested heading 290°, and to take off on runway 27, commencing the take-off run. While this was taking place, RAM925 continued to taxi slowly straight ahead, merging onto E1, instead of turning left onto taxiway A, at holding point 27 (12:08:26 h).

Figure 10: Authorized taxiing path (yellow) and actual path (red) from stand 34 to the holding point for runway 27.

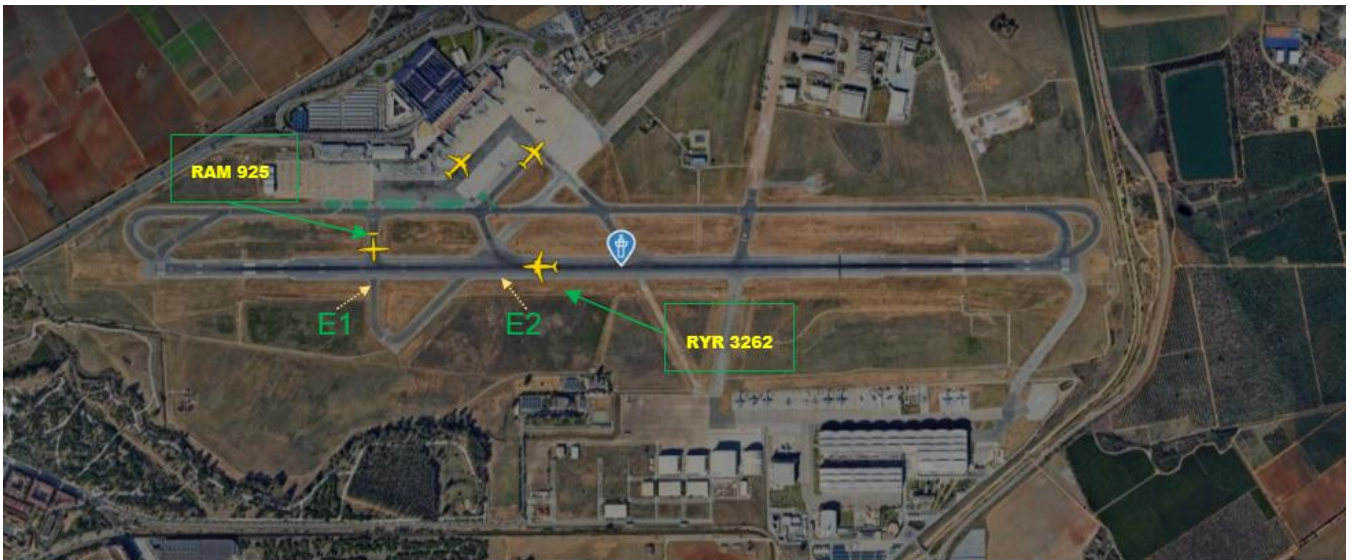
At E2, RYR3262 started the rotation (12:08:56 h), overflying RAM925 that had stopped at E1, at the edge of the runway.

Figure 12: Representation of the position of both aircraft at 12:08:56 h
