Air Accident Investigation Unit Ireland

FACTUAL REPORT

**Airbus Helicopters, AS 355 F2, G-PDGT
Ireland West Airport**

15 January 2025

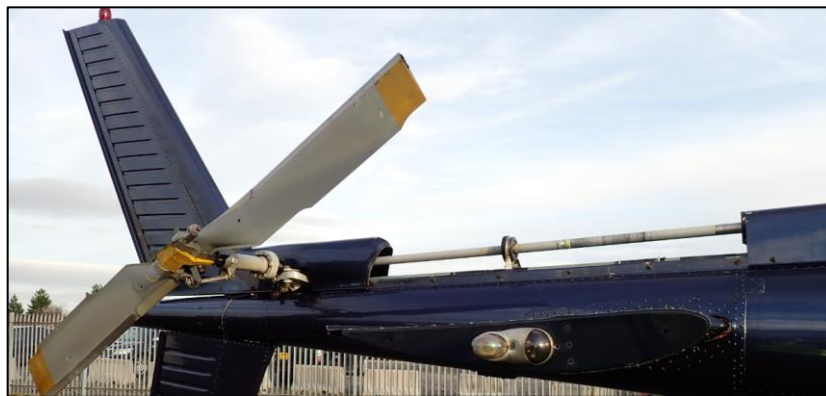
Photo No. 1: Exposed section of tail rotor driveshaft

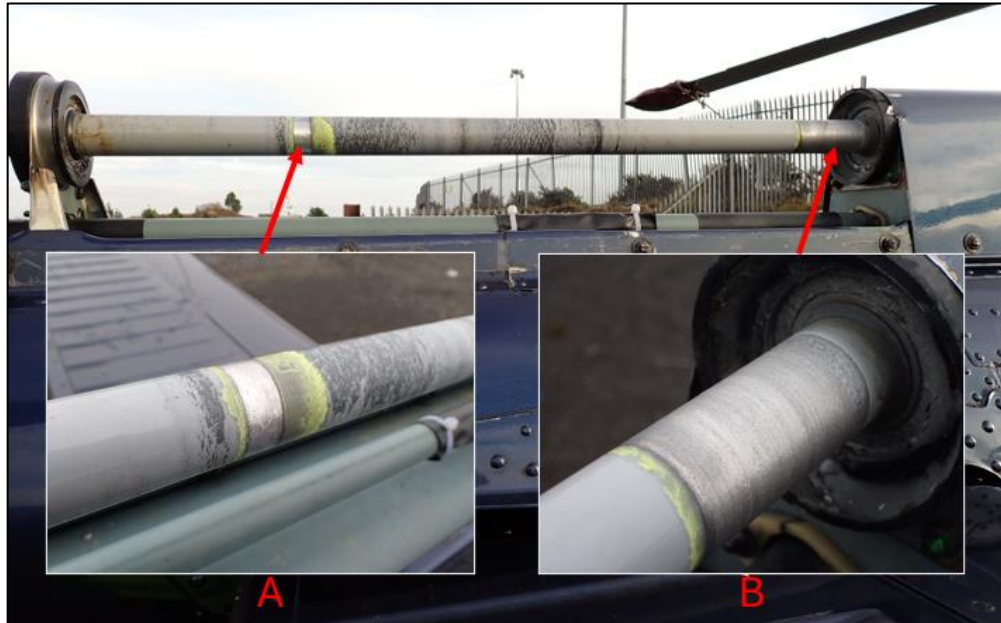
The tail rotor drive shaft sustained circumferential damage, with scoring observed at two locations (**Figure No. 2**). Area 'A' on the aft portion of the shaft, was approximately 18 millimetres (mm) in length and 0.35 mm deep; area 'B' was approximately 68 mm in length and 0.31 mm deep.

Figure No. 2: Damage to tail rotor driveshaft

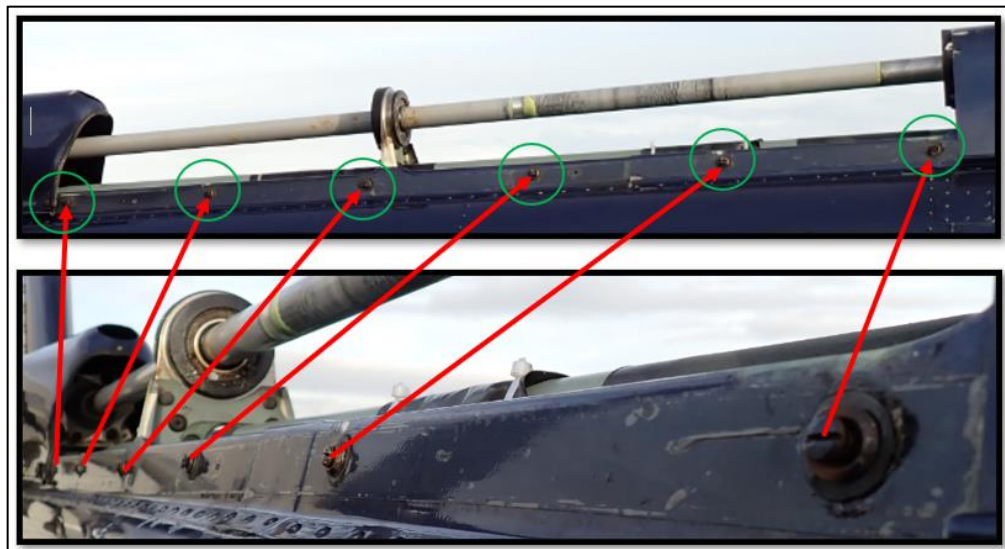
Following separation of the fairing, six of its captive fasteners were found secured to the right-hand side of the tail boom (**Figure No. 3**).

Figure No. 3: Fasteners in place on airframe

The nature of damage to the detached fairing and the fact that fasteners were missing from the left-hand side indicates that the fairing began to lift on that side due to missing or unsecured fasteners. It then likely peeled back and made contact with the tail rotor drive shaft and tail rotor blades which were rotating at high speed, and tore away from the tail boom on the right-hand side, leaving the associated fasteners in place.

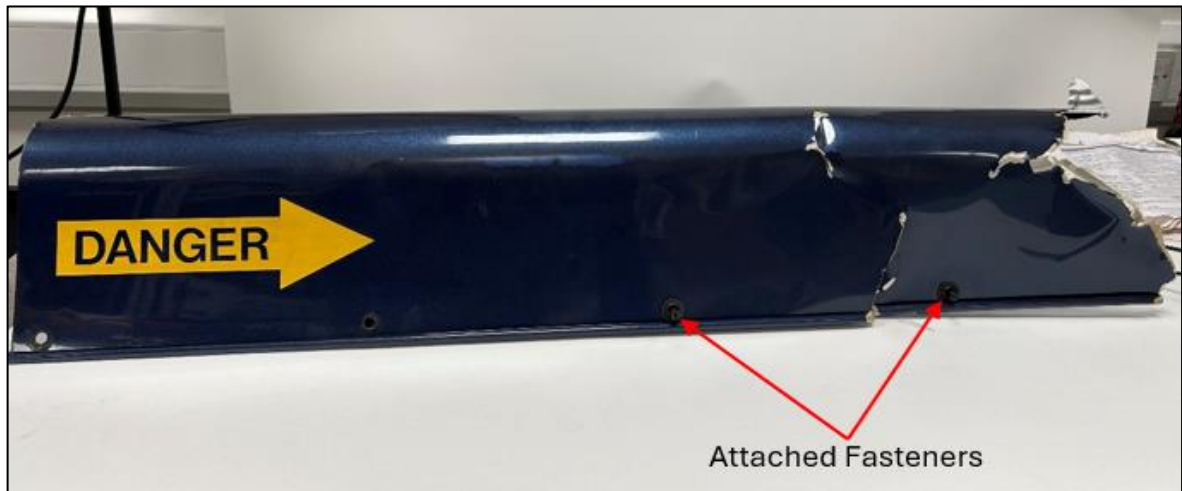
Of the six fasteners on the left-hand side, two remained attached to the fairing (**Photo No. 3**), four were missing, and during the runway inspection, only one was recovered.

Photo No. 3: Left-hand side view of damaged fairing

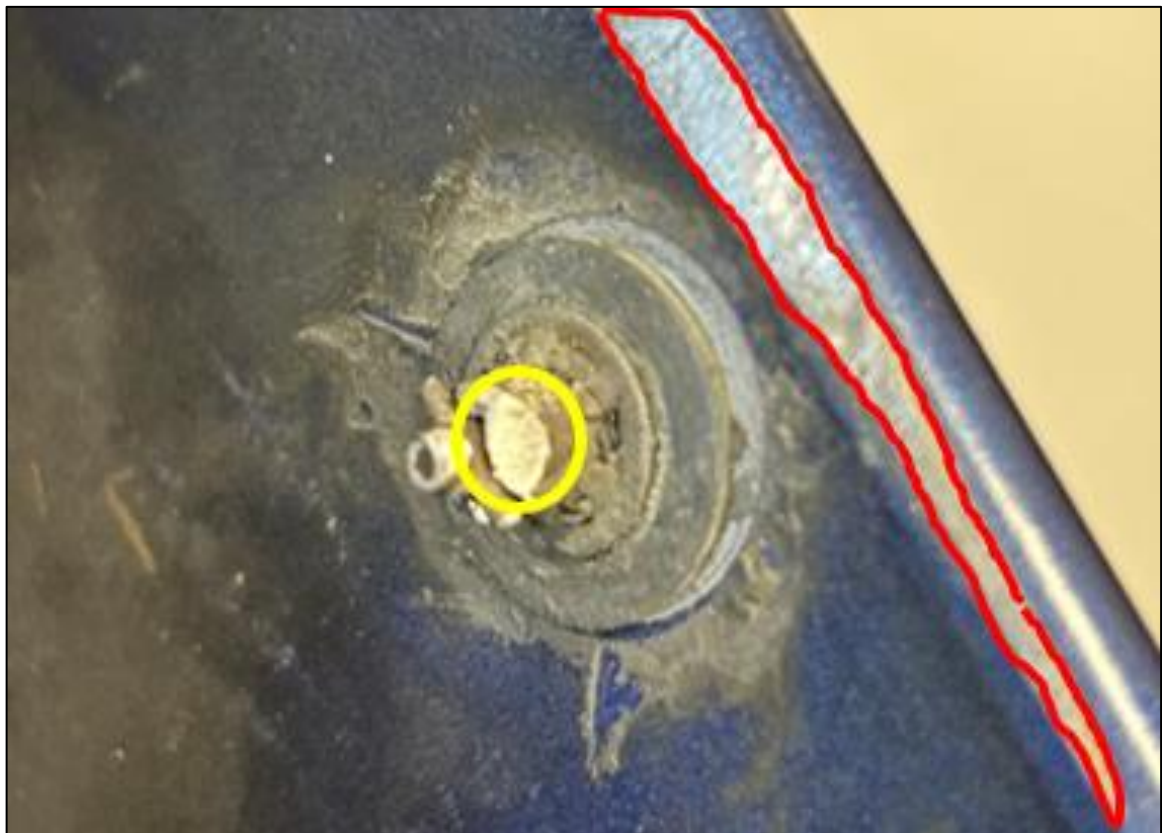
One of the fasteners that remained attached to the left-hand side of the fairing (first from the left) sustained damage from where it came into contact with the aft area of the tail rotor driveshaft (area 'A' in **Figure No. 1**). This damage is ringed in yellow in **Photo No. 4**. This photo also shows abrasion damage (outlined in red) consistent with the lip of the fairing contacting the rotating drive shaft.

Photo No. 4: Damage to fastener and lip of fairing

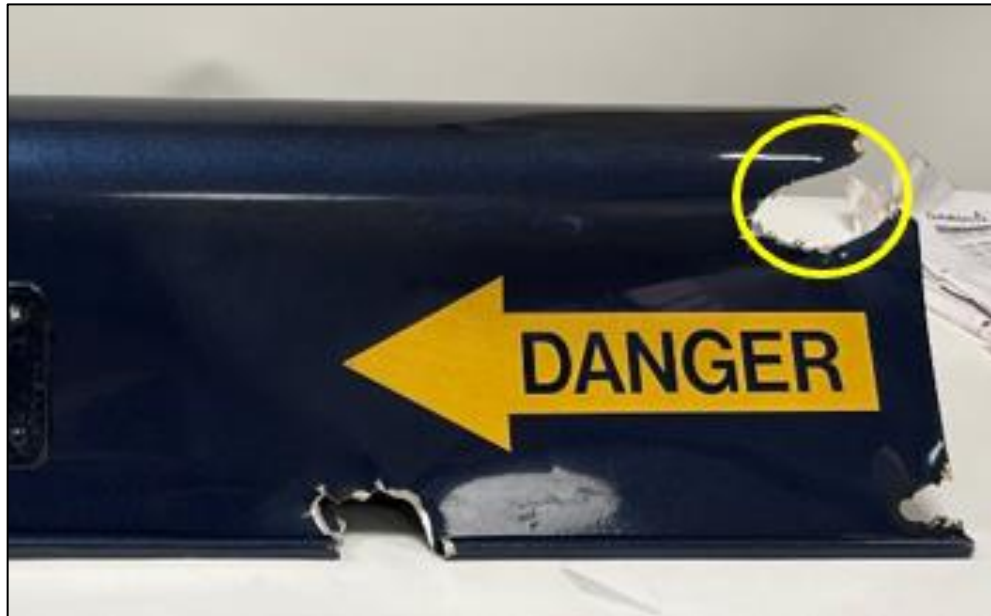
An area of damage on the right-hand side of the fairing is ringed in yellow in **Photo No. 5**. The pattern of this damage is consistent with the fairing coming into contact with the rotating tail rotor drive shaft. The tail rotor blades sustained several areas of damage due to contact with the fairing as it departed from the Helicopter in flight; however, both blades remained intact and attached to the hub.

Photo No. 5: Damage to fairing

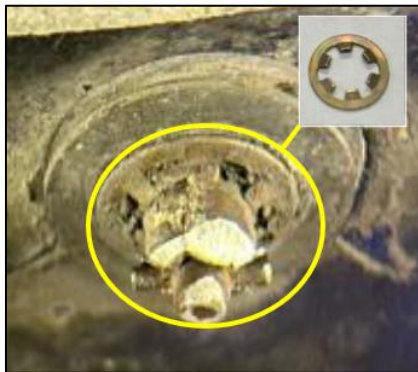
The Operator found that the fasteners installed on the subject Helicopter's tail rotor drive shaft fairings were not fitted with the correct retaining washers and that the installed washers should only have been used in conjunction with the type of fastener that secures the tail rotor gear box fairing. The Operator stated that they acquired the subject helicopter in 2007 from the United States and believe that the incorrect washers had already been installed at the time of purchase. The Operator reported that although the fasteners on the front and centre fairings were installed using the incorrect retaining washers, the fairings remained secure and functioned in the correct manner when inspected.

The incorrect retaining washer as fitted to G-PDGT is shown in **Photo No. 7** and the correct fastener/split washer combination is shown in **Photo No. 8**. The retaining washers are designed to retain an open fastener in its fairing. It should be noted that the incorrect washers would not affect the correct functioning of the camlock fastener.

Photo No. 7: Incorrect combination

The Operator's report identified that an incorrect washer/fastener combination had been used to secure the three tail rotor drive shaft fairings on the subject helicopter. Following a fleet review, a further four helicopters were found to be affected by the same incorrect washer/fastener combination. It should be noted that the incorrect washers would not affect the functioning of the camlock fastener when correctly locked. However, it is essential that all components fitted to aircraft comply with the relevant technical publications.

The Operator informed the Investigation that all of its affected helicopters, including G-PDGT, now have the correct fastener installation in accordance with the Helicopter Manufacturer's Illustrated Parts Catalogue (IPC).

The Operator introduced several Safety Actions to mitigate the possibility of such an event reoccurring, and it also replaced the fasteners on the affected helicopters in its fleet in accordance with the relevant IPC.

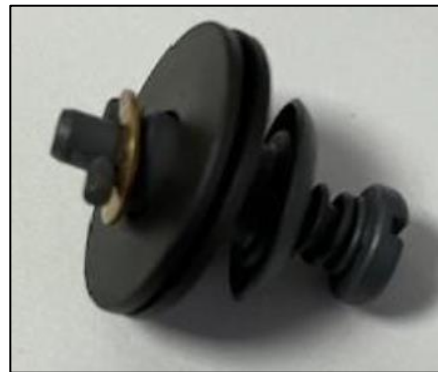
Photo No. 8: Correct combination
