Investigation Report

Type of Occurrence: Serious Incident

Type: B737-8AS

State File Number: BFU18-0975-EX

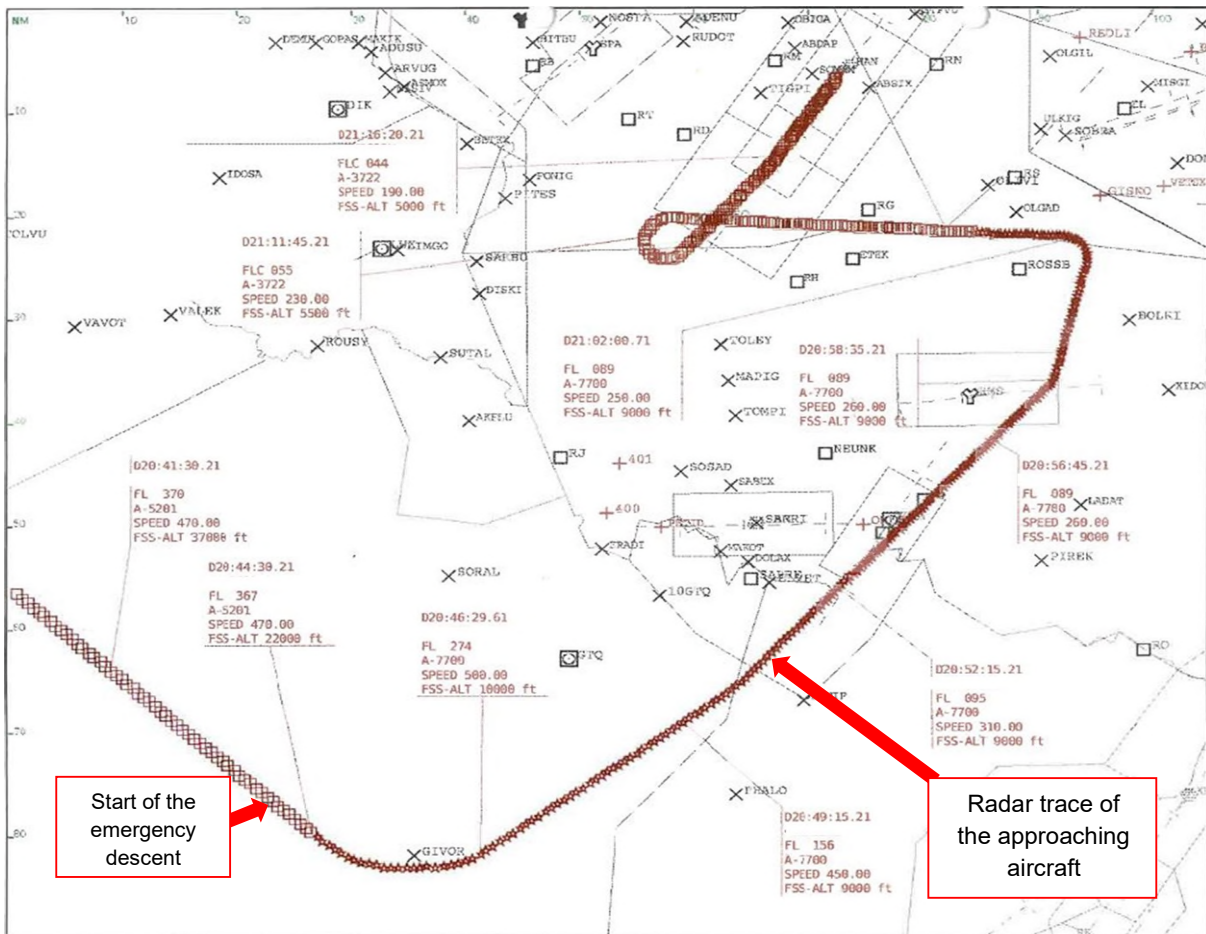
Fig. 3: Secondary radar recording of the approach to Frankfurt-Hahn Airport

The air navigation service provider provided the BFU with the secondary radar data of the aircraft of the relevant time period (Fig. 3). The recording started at 2240:05 hrs and ended at 2320 hrs.
