## FINAL REPORT

**AAIU Report No: 2010-002**  
**State File No: IRL00909037**  
**Published: 03/03/10**

<b>Aircraft Type and Registration:</b>	Boeing 757-28A, C-GTBB
<b>No. and Type of Engines:</b>	2 x Rolls-Royce RB211-535
<b>Aircraft Serial Number:</b>	32447
<b>Year of Manufacture:</b>	2001
<b>Date and Time (UTC<sup>1</sup>):</b>	29 May 2009 @ 01.53 hrs
<b>Location:</b>	Dublin Airport (EIDW)
<b>Type of Flight:</b>	Public Transport
<b>Persons on Board:</b>	Crew - 8          Passengers - 198
<b>Injuries:</b>	Crew - Nil          Passengers - Nil
<b>Nature of Damage:</b>	None
<b>Commander's Licence:</b>	Air Transport Pilot Licence (Canada)
<b>Commander's Details:</b>	Male aged 54 years
<b>Commander's Flying Experience:</b>	14,000 hours, of which 1,800 were on type
<b>Notification Source:</b>	Operations Manager, Dublin Air Traffic Control (ATC)
<b>Information Source:</b>	AAIU Field Investigation

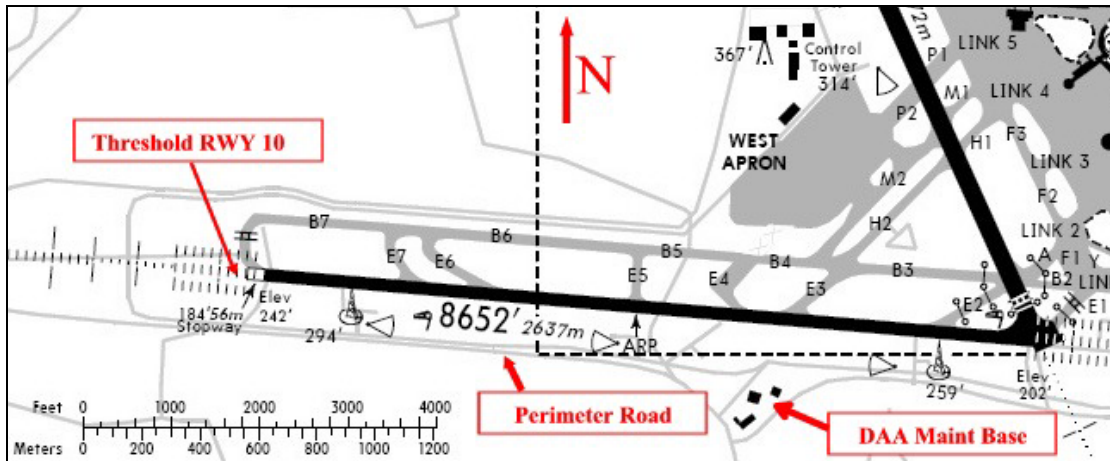
**Figure No. 1:** Airport Layout – EIDW (Source Jeppesen)

The ride-on mower operator, T3, informed the Investigation that he had commenced cutting close to taxiway E2 towards the eastern end of RWY 10/28. His small vehicle was suitable for cutting around lights and runway signage and he gradually made his way westwards in the grass to the North of RWY 10/28 across taxiways E3 through to E7. By 01.40 hrs he was operating in the threshold area of RWY 10, as was T2, the DAA operator with the forage harvester, (**Figure No. 1**).
