Air Accident Investigation Unit Ireland

SYNOPTIC REPORT

Boeing 737-8AS, EI-DPA

24 October 2011

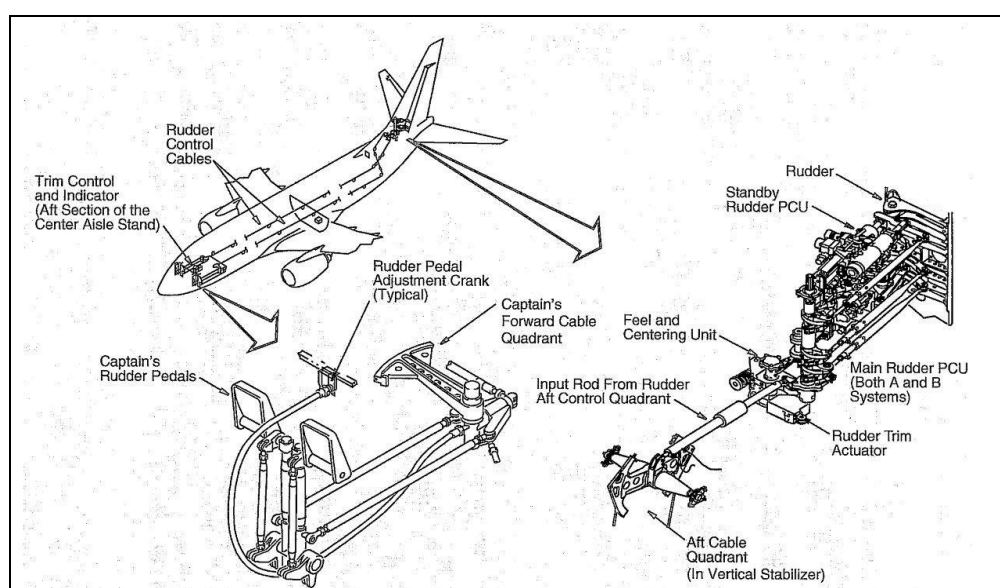
Figure No. 1: Rudder Trim and Control System (Boeing)

The Operator's engineering staff removed panels from the aircraft's vertical stabiliser to gain access to the areas of the Main and Standby rudder Power Control Units (PCUs), see **Figure No. 1**.

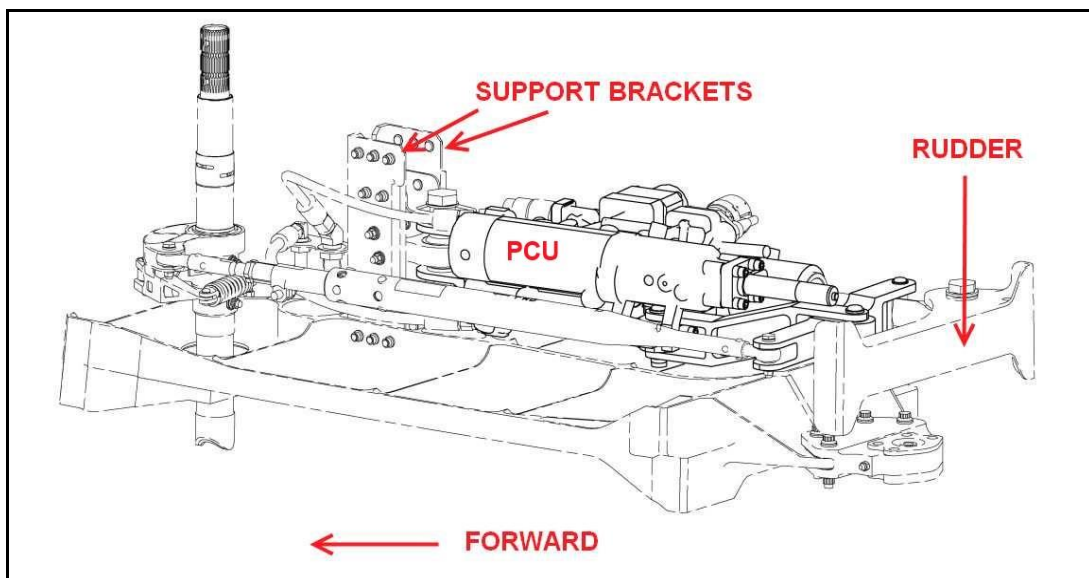
Figure No. 2: Standby PCU with Support Brackets (Boeing)

Figure No. 2 illustrates the location of a PCU with respect to the support brackets while **Figure No. 3** illustrates how the support brackets are attached to the internal structure of the vertical stabiliser.

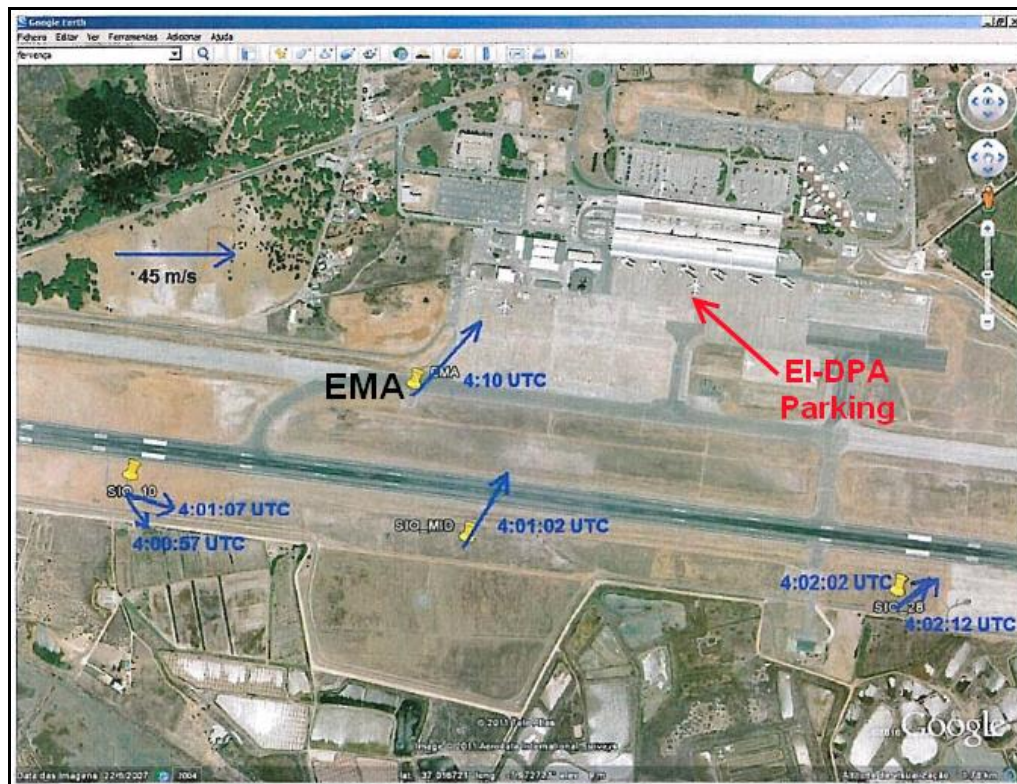
Photo No. 5: Maximum wind vectors at LPFR (Google Maps).

Photo No. 5, which is reproduced from the report, shows the location of four weather stations on LPFR airfield. Station EMA is located between RWY 28/10 and the parking area and there are three stations along the runway, SIO_10, SIO_MID and SIO_28, all of which are referenced in the report. The blue arrowed lines annotated with UTC times represent the maximum wind vectors at the four stations, which were recorded at the noted times. The vector marked 45 m/s in the upper left of **Photo No. 5** is provided for scaling purposes. The location of Stand 18 where EI-DPA was parked overnight is also shown for reference.

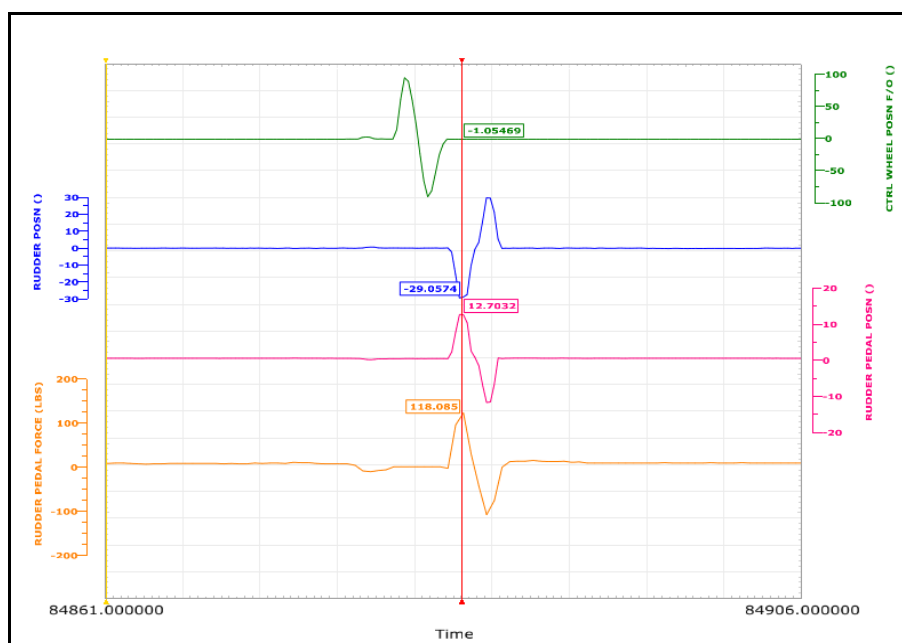
Figure No. 4: Rudder Data - Flight Prior to Occurrence Flight

Figure No. 4 illustrates control wheel position and relevant rudder data during the flight controls full-and-free check performed by the Flight Crew immediately prior to the flight preceding the occurrence flight. **Figure No. 5** illustrates similar data for the same check carried out on the occurrence flight.

Data from the DFDR illustrates how the characteristics of the rudder position changed between the flight immediately before the occurrence and the occurrence flight itself. The data shows that, on the preceding flight, when the rudder pedals’ position was at 0° and minimal force was being applied to the pedals, the rudder position was at 0° deflection, **Figure No. 4**. Also, the rudder movement was recorded between 29° trailing edge left and 29.7° trailing edge right, i.e. the rudder movement was approximately symmetrical around the 0° neutral point.
