Air Accident Investigation Unit Ireland

FACTUAL REPORT

**Sud Aviation SE 313B, Alouette II, N577AG
Newcastle Airfield, Co. Wicklow**

16 July 2022

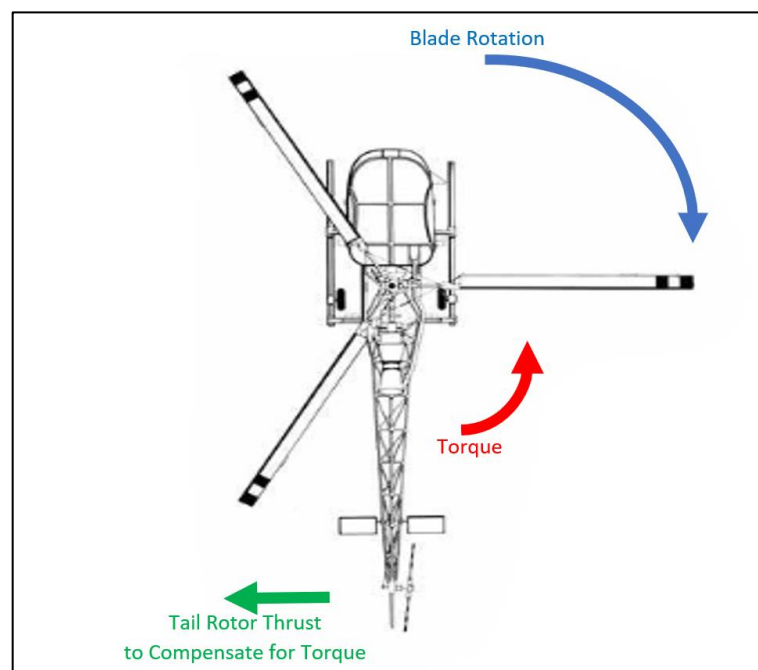
Figure No. 4: Torque Reaction

The main rotors on the Alouette II, when viewed from above, rotate in a clockwise direction, therefore, there is a tendency for the fuselage to turn in the opposite direction (i.e., yaw to the left). This is known as torque reaction (**Figure No 4**). To counteract this tendency to yaw left, opposite right pedal (anti-torque pedal) is applied which alters the pitch of the tail rotor blades and increases the thrust produced by the tail rotor.

A failure of the anti-torque system can be the result of, *inter alia*, tail rotor driveshaft failures, tail rotor pitch control system failures, tail rotor gear box failures or a complete loss of the tail rotor itself. If a failure occurs at a low airspeed and a high power setting on a helicopter with clockwise-rotating main rotors, then a yaw or spinning motion to the left will occur, with the rate of yaw increasing rapidly.
