Technical report

IN-031/2022

Incident on 29 April 2022 involving an Airbus 320 aircraft operated by Vueling, registration EC-KLT, and a Boeing 737 aircraft operated by Ryanair, registration EI-EPA, at Josep Tarradellas Barcelona-El Prat Airport (Barcelona, Spain)

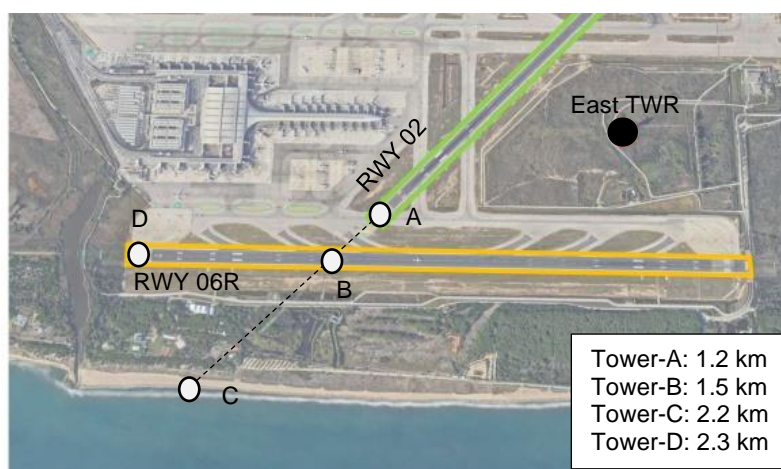
Figure 5. Separation between TWR and the aircraft (ENR configuration)

The TWR control service at Barcelona airport is provided by ENAIRE and its staff are stationed in two towers. The controller responsible for the aircraft involved in the event was stationed in the east TWR, the location of which is shown in Figure 5.

- The arriving traffic is almost head-on, so the controller has no perspective of the separation between two consecutive traffics on approach.
- The only way to discern distance is through the brightness of the aircraft's landing lights, and this only serves to discern very long distances from very short distances.
- The separation distances between the controller and the traffic operating on the intersecting runways vary between 1.2 and 2.3 km, as shown in Figure 5.

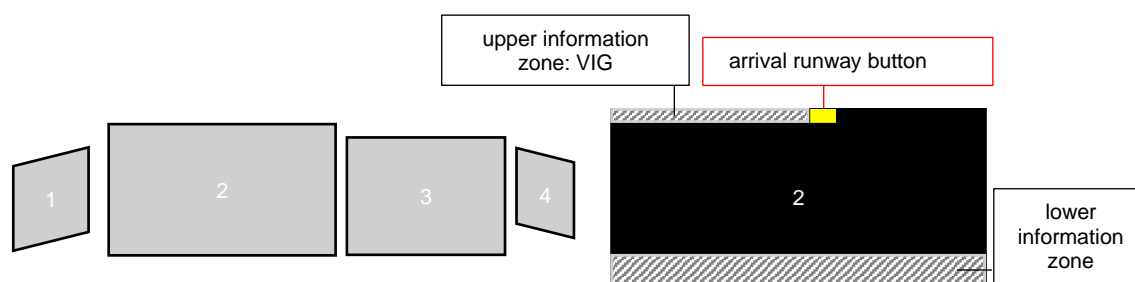
Figure 11. Controller's workstation and relative position of the VIG on screen 2

The workstations in the Barcelona tower have 4 horizontal screens arranged as shown in Figure 11. The screen identified as number 2, the largest of the four, shows the traffic on a black background, a map of the area to be controlled, which each controller configures according to the relevant area, and any alerts emitted by the A-SMGCS level 2 system.

Of the total surface area of screen 2, 80% is dedicated to displaying traffic and 20% to displaying information and/or configurations, the latter being distributed between two areas: an elongated area at the bottom of the screen (18%) and an upper information line, the VIG, at the top left of the screen (2%). The VIG covers half the length of the screen, and the arrangement of its 18 buttons is always the same, with the arrival runway button on the right.

Of interest to the investigation is the fact that the information contained in the VIG does not have to be consulted to carry out control tasks but provides information on the operational status of the system's functions. The only exception is the QNH, which is included in the VIG, but the controllers consulted reported that they normally check the QNH on screen 4, which displays information about the weather and wind conditions (Cefiro and Hermes applications).
