Air Accident Investigation Unit Ireland

ACCIDENT

**Robinson R44 Raven II, N999RL
Kennycourt, Co. Kildare, Ireland**

AAIU Report No: 2024-007

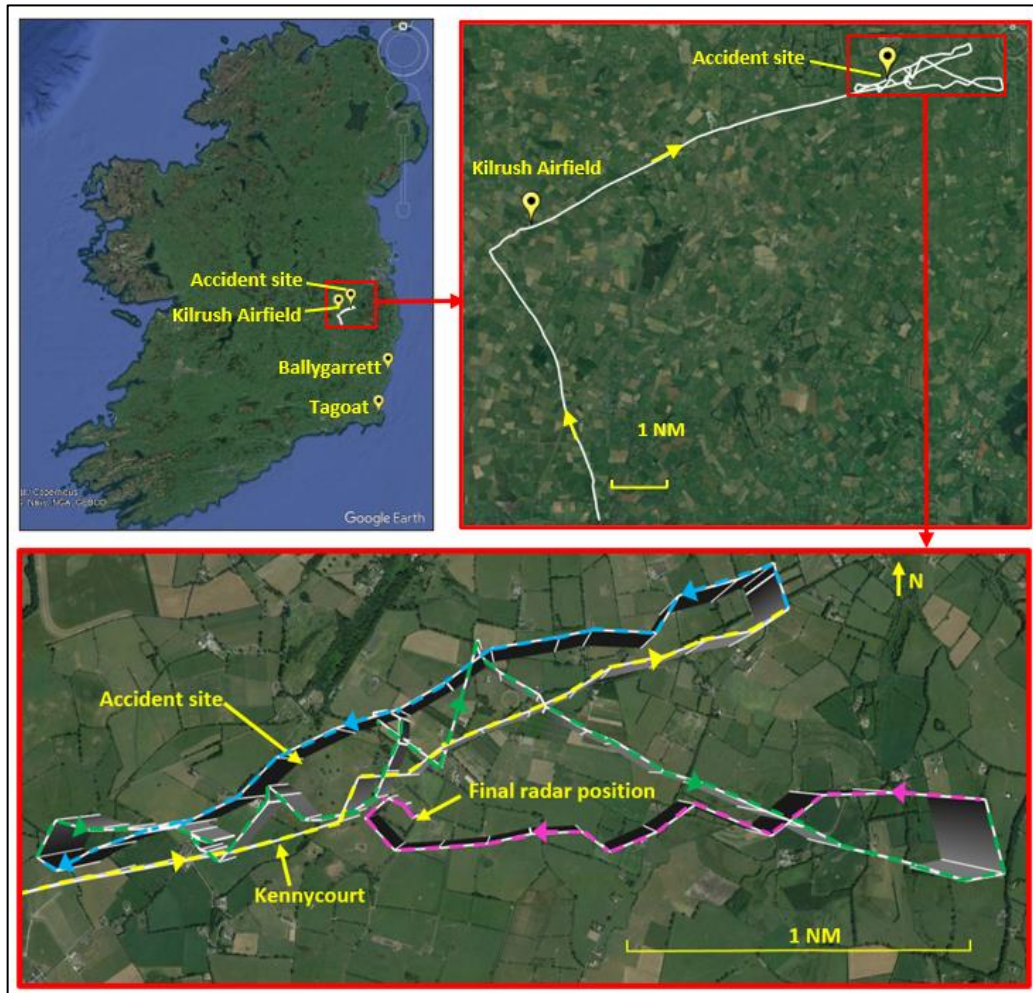
The Pilot, who was the sole occupant of the Helicopter, contacted the Flight Information Service (FIS)⁵ at Shannon ATC at 14:32 hrs on the day of the accident to report that the Helicopter was departing from Ballygarrett, Co. Wexford, '*en route to Rosslare and then over to Kilrush Airfield [EIKH]*'. The Pilot confirmed to Shannon FIS that the communications were for '*information only*'. The Helicopter landed at approximately 14:42 hrs in Tagoat, Co. Wexford, which is 1.6 nautical miles (NM) south of Rosslare Town. At 14:58 hrs, the Pilot contacted Shannon FIS to advise that he was '*lifting out of Rosslare for Kilrush Airfield*', which is located approximately 52 NM to the north-west, in Co. Kildare. At 15:26 hrs, the Pilot reported to Shannon FIS that he was '*switching now to Kilrush frequency*'⁶. The Helicopter was first recorded by ATC radar at 15:28 hrs, when it was 5.5 NM south-east of EIKH and at an altitude of approximately 2,300 feet (ft) (**Figure No. 1**).

Figure No. 1: N999RL track from radar data (For clarity, coloured dashed lines divide the flight path into separate sections: yellow, followed by blue, then green, then magenta. **Note:** The terrain imagery is historic and does not represent the meteorological conditions prevailing on the day of the accident)

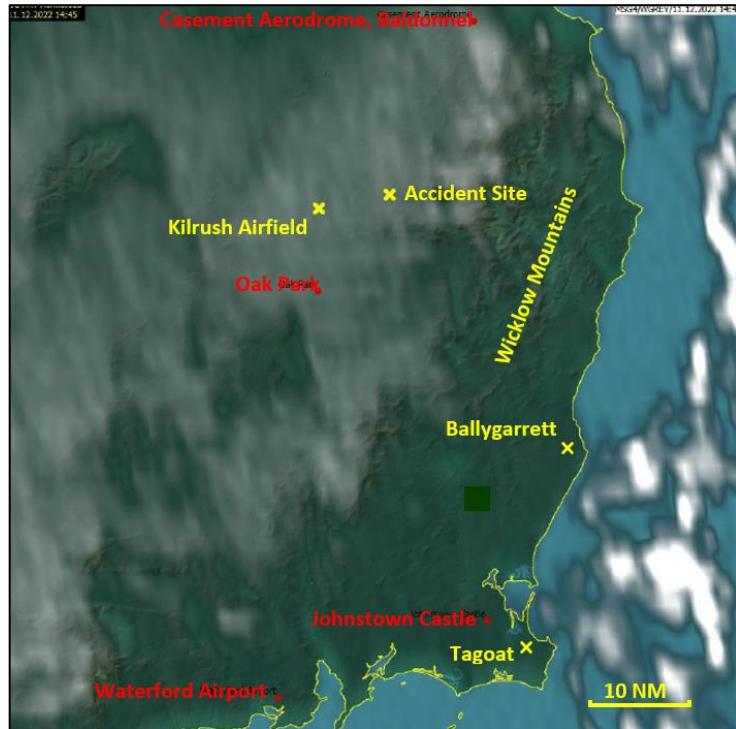
Met Éireann provided a satellite image of what was described as ‘*low cloud and fog*’ at 14:30 hrs over the south-east of Ireland (**Figure No. 3**). The image shows clear sky over Ballygarrett and Tagoat and an area of cloud/fog further inland. Clear skies are also visible to the east. The Wicklow Mountains area is also visible (approximately 3,000 ft maximum elevation). *Met Éireann* stated that at 15.45 hrs, the visible satellite imagery quality was ‘*poor due to darkness*’ but that fog and low cloud coverage was similar at that time.

Figure No. 3: Satellite image at 14:30 hrs (adapted from Met Eireann image)

Met Éireann noted that there would have been largely clear conditions through Co. Wexford, which is in the south-east of Ireland, and that fog and low cloud below the flight level would have been encountered through counties Carlow and Kildare. *Met Éireann* also noted that surface temperatures across Leinster between 15:00 hrs and 16:00 hrs on the accident date ranged between $-1\text{ }^{\circ}\text{C}$ and $+2\text{ }^{\circ}\text{C}$ and that patches of freezing fog would have been expected but that they did not have observations at their sites at that time.

It is therefore likely that, as indicated by the aftercast, the sky was clear when the Helicopter departed Ballygarrett (which is approximately 20 NM north-east of Tagoat); this is supported by the satellite image provided by *Met Éireann* (**Section 1.7.3, Figure No. 3**), which showed clear sky over Ballygarrett and Tagoat around the time of departure. When the Helicopter departed Tagoat for EIKH in clear conditions, the Pilot likely expected that the en route weather conditions would have remained favourable. He may also have expected that due to the clear skies (i.e. no visible moisture), there was no risk of icing (**Section 2.8.3**).

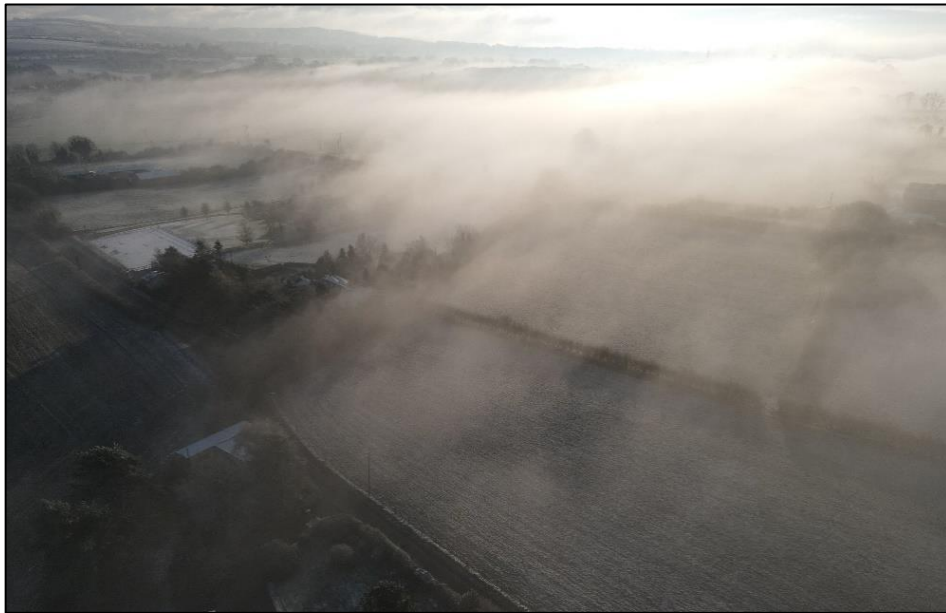
The Punchestown area of Co. Kildare is located approximately 4.5 NM north-east of the accident site. A person who was in the Punchestown area at 10:35 hrs on the day of the accident (approximately five hours prior to the accident) provided the Investigation with aerial images taken with a Remotely Piloted Aircraft System (RPAS). The images showed low-lying cloud/fog and poor visibility in that area at that time. Ground frost is also visible (**Photo No. 3** and **Photo No. 4**).

Photo No. 3: Aerial image of conditions at 10:35 hrs, 4.5 NM north-east of accident site (looking south-east) (*used with permission of photographer*)

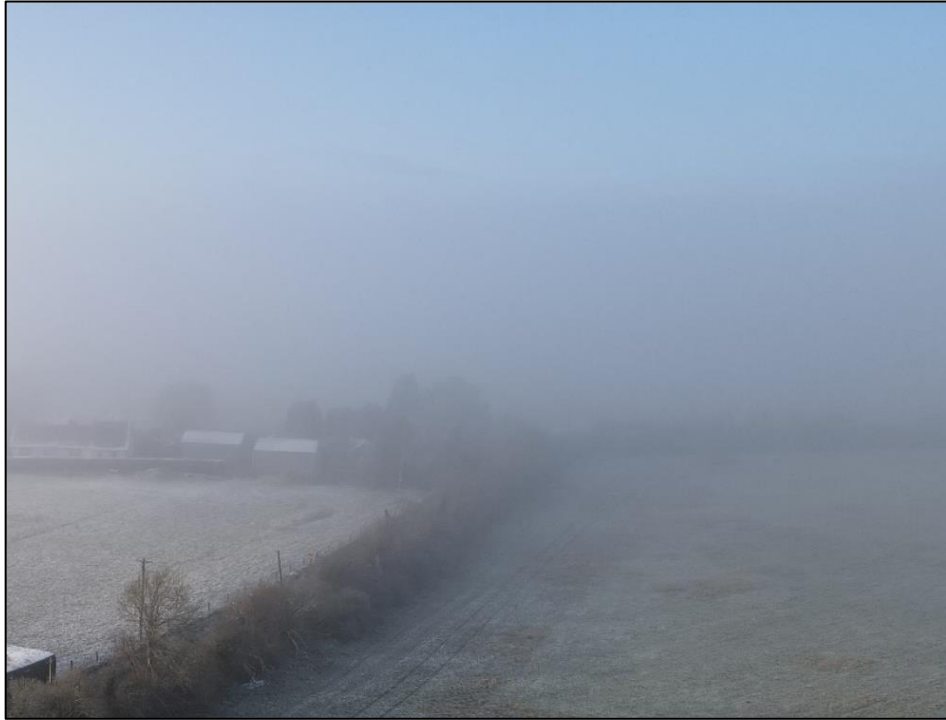
Photo No. 4: Aerial image of conditions at 10:35 hrs, 4.5 NM north-east of accident site (looking south-west) (*used with permission of photographer*)

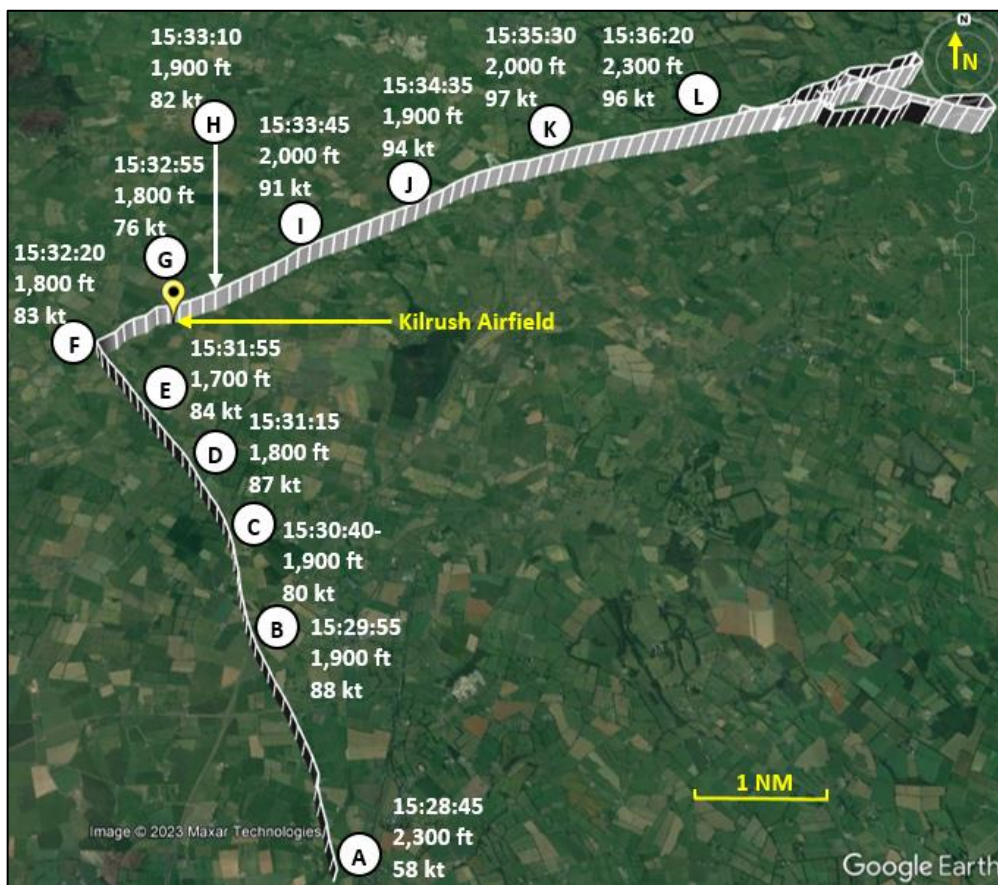
The earlier part of the flight path is annotated by letters **A** to **L** in **Figure No. 4**. Time, altitude and ground speed are also indicated. The figures included below for altitude and ground speed are to be considered approximate values.

Figure No. 4: Flight path, with time, altitude (corrected for the air pressure on the day), and ground speed as indicated by ARTAS data (**Note:** The terrain image is historic and does not represent the meteorological conditions prevailing on the day of the accident)

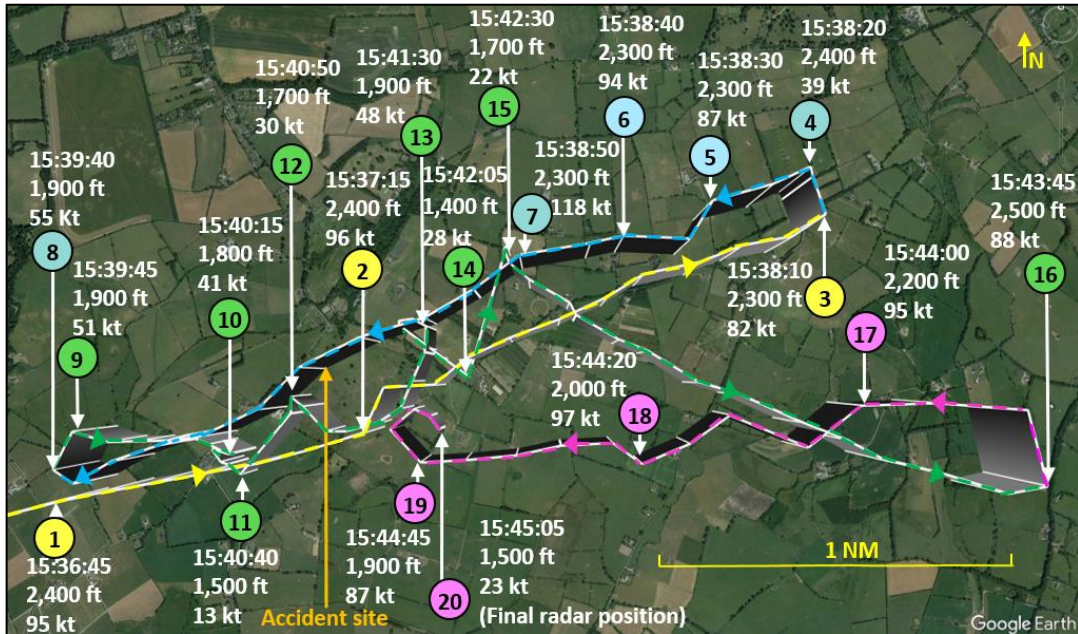
The latter part of the flight, as indicated by the ARTAS data is shown in **Figure No. 5**. Time, ground speed and altitude are also indicated (as noted earlier, for clarity, altitude figures have been corrected for the air pressure on the day). The altitude profile and ground elevation are shown in **Figure No. 6**.

Figure No. 5: Latter part of flight path as indicated by ARTAS data (altitudes corrected for the air pressure on the day) (For clarity, coloured dashed lines divide the flight path into separate sections: yellow, followed by blue, then green, then magenta)

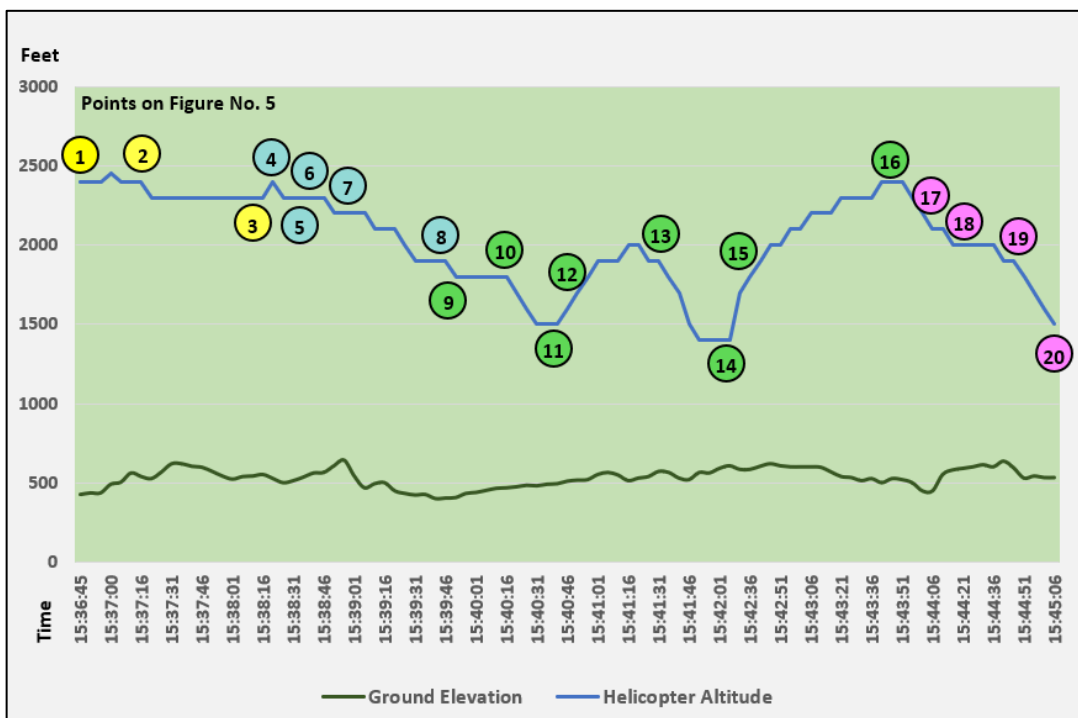
Figure No. 6: Altitude profile as indicated by ARTAS data and ground elevation (Helicopter altitude corrected for the air pressure on the day)

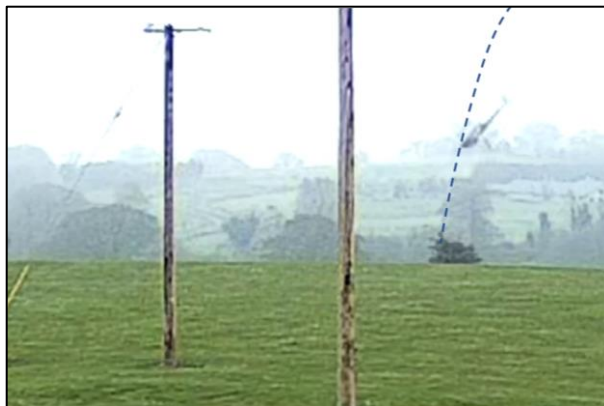
Video footage, which was captured by a camera located approximately 350 m to the south-west of the accident site and at an elevation of approximately 525 ft (160 m)³⁴, was provided to the Investigation. The video footage had a resolution of 2,688 × 1,520 pixels. The frame rate of the video, when the Helicopter was visible, was 25 frames per second (fps). The video footage shows the final 0.8 seconds approximately of the flight, in which the Helicopter can be seen travelling towards the ground on a steep trajectory (**Figure No. 7**), albeit with some motion from right to left (approximately east to west). The entire Helicopter was visible for approximately 0.5 seconds. The main rotor blades were visible in the video for approximately 0.3 seconds. The actual impact was obscured from view by terrain. The video footage shook moments after the Helicopter disappeared from view. The time at this stage, as indicated by the video's on-screen clock, was 15:45:50 hrs. This was followed by a rising plume of smoke. There was no evidence in the video footage of a fire prior to impact.

Figure No. 7: Image extracted from video (dashed line indicates trajectory of Helicopter)

To determine the trajectory and descent rate of the Helicopter, the NTSB used a camera optics computer model, which was calibrated using the position of the camera and other reference points in the camera's field of view. Once calibrated, the computer model was used to estimate the location of the Helicopter in a sequence of video frames. A constant descent rate was identified, which was estimated to be 43 metres per second (m/s) (8,465 ft per minute). It was estimated that the trajectory of the Helicopter nose (as shown in **Figure No. 7**) was along a path inclined by 72° relative to the ground with a nose-down pitch angle of 45° .

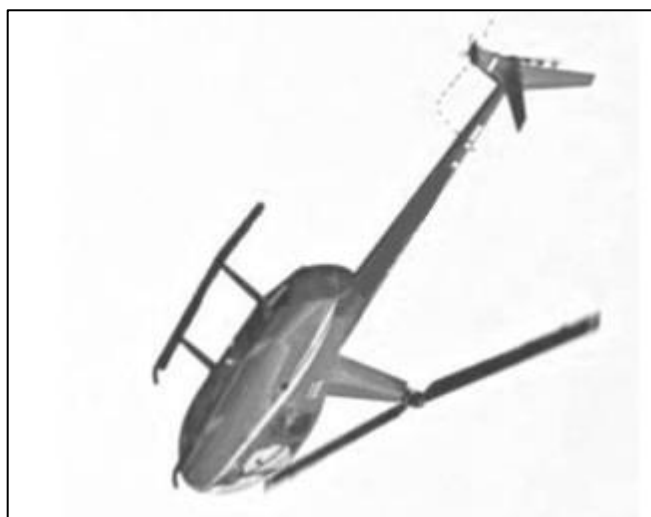
The Helicopter's main rotor blades rotate counterclockwise when viewed from above. In order to analyse the main rotor rpm, the NTSB orientated a reference image of an R44 Helicopter (**Figure No. 8**) to match the attitude of the Helicopter visible in **Figure No. 7**. This showed that the video recorded the lower surfaces of the main rotor blades; therefore, the direction of rotation of the main rotor blades in the video was assessed to be clockwise.

Figure No. 8: Reference image orientated to match Helicopter attitude as in **Figure No. 7**
(**Note:** Rotor blades are not in the same position)

Using the video frame rate and the angular position of the rotor blades in a sequence of video frames, the NTSB's video analysis estimated the main rotor speed to be approximately 375 rpm. Due to a lack of clarity in some of the video frames, a tolerance of ± 15 rpm was assigned, i.e. the rotor speed was estimated to be 375 ± 15 rpm.

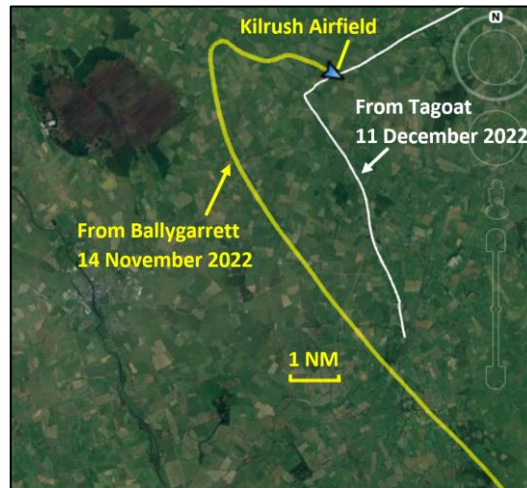
The data for the flight from Ballygarrett to EIKH on 14 November 2022 indicates that the Helicopter departed Ballygarrett at 14:35 hrs and flew to the west of the airfield and beyond it, before turning towards the airfield and approaching it from the north-west (**Figure No. 13**). The data indicates that the Helicopter arrived at EIKH at 14:59 hrs. The data for the return flight indicates that the Helicopter flew directly to Ballygarrett. The Investigation obtained information from *Met Éireann* regarding the wind conditions at EIKH at approximately 15:00 hrs on 14 November 2022. *Met Éireann* estimated that the wind was south to south-easterly, 10-15 kt, with gusts 18-22 kt.

Figure No. 13: Flight Track from Ballygarrett to EIKH 14 November 2022 (yellow line)

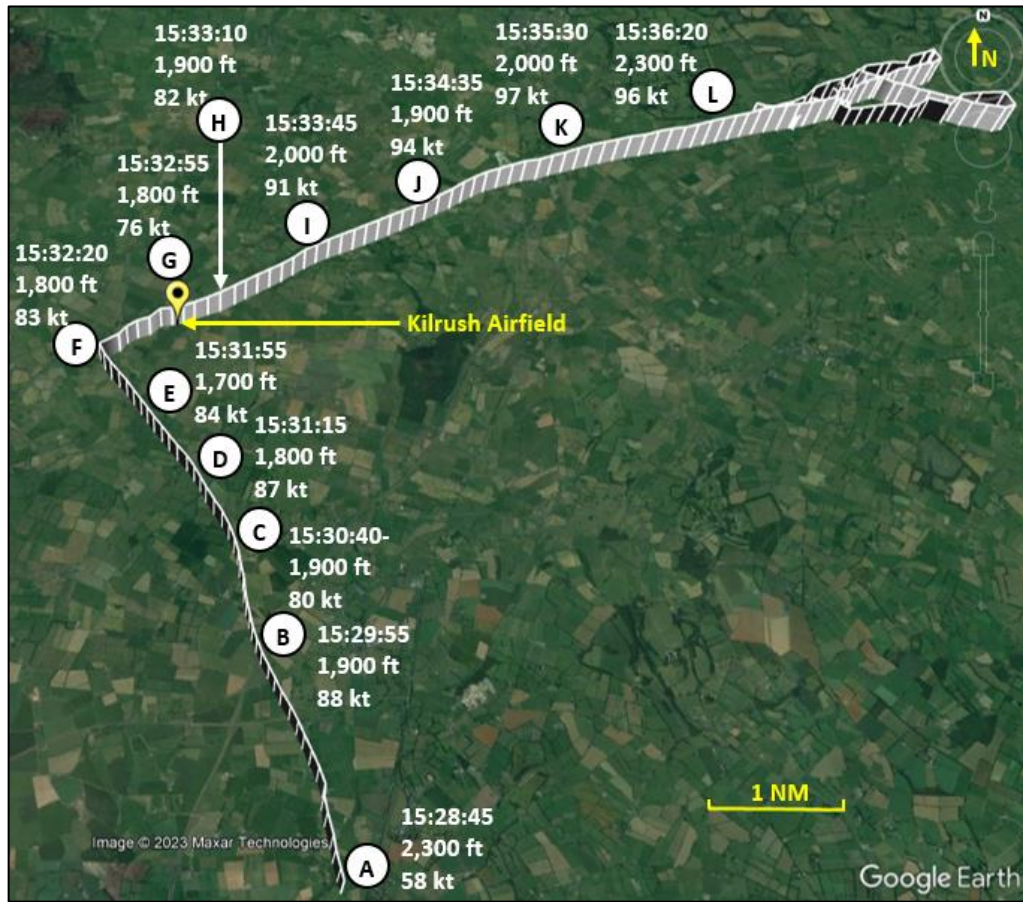
The Helicopter departed Tagoat for EIKH at approximately 14:58 hrs. It was first recorded by ATC radar at time 15:28:45 when it was approximately 5.5 NM south-east of EIKH and travelling north-westerly towards EIKH at an altitude of approximately 2,300 ft (**Point A** in **Figure No. 14**). The radar-generated ground speed was 58 kt; however, it was unlikely to have been accurate at this stage, as it is calculated using the difference in positions recorded versus the time elapsed between positions, and this was the first position recorded.

The ARTAS data indicated that the Helicopter began to descend approximately 30 seconds later and reached approximately 1,900 ft at time 15:29:55 (**Point B** in **Figure No. 14**). The Investigation established that the Pilot made use of a GPS navigation application to assist in navigation. A mobile phone, and a computer tablet and associated mount were found in the wreckage of the Helicopter. As the flight path was initially in the direction of EIKH, the Investigation considers it likely that the navigation application was being used to assist in navigation during the accident flight; the descent may indicate that the Pilot was aware that he was nearing EIKH.

Figure No. 14: Flight path indicated by ARTAS data (altitudes corrected for the air pressure on the day) (**Note:** The terrain image is historic and does not represent the meteorological conditions prevailing on the day of the accident)

The ARTAS data indicated that the Helicopter, now at approximately 1,900 ft and a ground speed of 80 kt, appeared to deviate slightly to the left at time 15:30:40 (**Point C in Figure No. 14**), which resulted in it tracking to the south-west of EIKH.

The ARTAS data indicates that when the Helicopter was approximately 0.7 NM to the south-west of EIKH, it turned right (north-east) in the direction of the airfield (**Point F in Figure No. 14**). The sharpness of the turn indicated is likely an artefact of the sample interval of the ARTAS data. The Helicopter flew directly overhead EIKH at approximately 1,800 ft (**Point G in Figure No. 14**). The data indicates that the Helicopter's groundspeed reduced slightly (to 76 kt), which may be an indication of an attempt to acquire visual contact with the airfield. However, the Helicopter's altitude and track did not vary significantly as it flew overhead the airfield (airfield elevation 260 ft according to the airfield website), which indicates that there was no attempt made to land there at that time. This was likely due to poor visibility of the airfield at that stage. Aerial photographs taken several hours earlier on day of the accident in the Punchestown area, which is approximately 4.5 NM north-east of the accident site (**Section 1.7.6, Photo No. 3 and Photo No. 4**), may provide an indication of the prevailing conditions in the Kennycourt/Kilrush area around the time of the accident.

The ARTAS data indicates that the Helicopter then flew north-eastwards past EIKH at altitudes of between 1,900 ft and 2,300 ft (**Points H to L in Figure No. 14**), where, according to the meteorological aftercast, the skies were likely to be clear. The satellite image of the conditions at 14:30 hrs over the south-east of Ireland shows cloud/fog over a large area, which included Kilrush and Kennycourt; meteorological aftercasts and witness evidence also reported the presence of fog and cloud. The satellite image shows clearer conditions to the east with no indication of cloud over the Wicklow mountains. It is possible that the flight towards the north-east was an attempt to acquire a clearer view of the surface, with the intention of landing or descending and attempting to fly back towards EIKH at a lower altitude. Based on the radar data, the Helicopter flew approximately 8.3 NM beyond EIKH, which seems like a significant distance; however, it took just under five and a half minutes – a short period of time. This equates to an average ground speed of 89 kt.

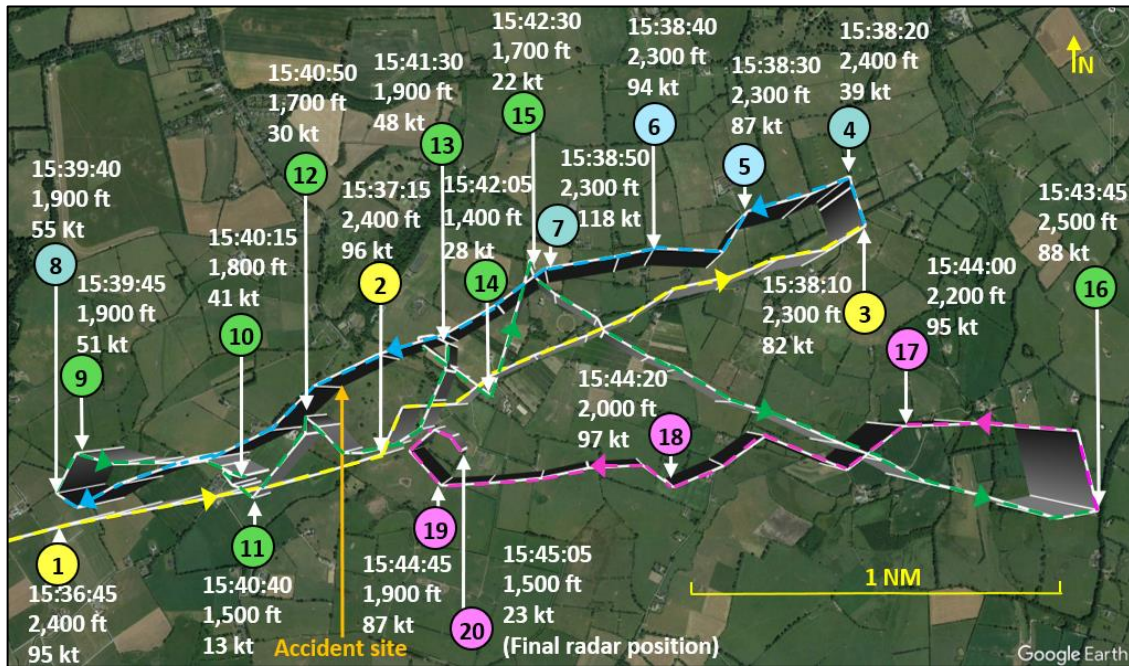
The ARTAS data indicates that when the Helicopter was approximately 8.3 NM beyond EIKH (**Point 3 in Figure No. 15**), it turned around, and in the subsequent one and a half minutes, flew approximately 2.3 NM towards the south-west, i.e. back in the general direction from which it had come, while at the same time descending. (**Note:** The terrain image in **Figure No. 15** is historic and does not represent the meteorological conditions prevailing on the day of the accident).

Figure No. 15: Flight path indicated by ARTAS data (altitudes corrected for the air pressure on the day) (coloured dashed lines divide the flight path into separate sections: dashed yellow line, followed by blue, then green, then magenta)

The ARTAS data indicates that the Helicopter turned around again (**Point 8 in Figure No. 15**) and flew generally eastwards on a zigzag path. The data indicates that at one point during this stage of the flight, at time 15:40:40, approximately five minutes before the accident, the Helicopter descended to approximately 1,500 ft (and approximately 1,000 ft AGL), while its ground speed reduced to 13 kt (**Point 11 in Figure No. 15**). Although the radar positional data continued to be recorded around this location, the age of the last altitude data received by radar was 12.75 seconds and therefore the Helicopter's altitude was potentially lower at this point. It is possible that the back-and-forth pattern and this descent was an attempt to locate an area where there was a clearer view of the surface, with the intention of landing. It is also possible that at this stage, the Pilot believed that he was close to EIKH and was attempting to locate it visually.

The ARTAS data indicates that the Helicopter then climbed before descending towards the south-east, and at time 15:42:05, reached approximately 1,400 ft, the lowest altitude recorded by radar (**Point 14 in Figure No. 15**). The age of the altitude data received by radar (Mode C) was 16.5 seconds at this stage and therefore the Helicopter's altitude could have been lower. The Helicopter's ground speed was 28 kt and it was approximately 750 m east of the accident site. The witness (**Section 1.1.1.1**), who thought that the Helicopter was going to land, before it climbed 'nose straight up' into cloud and was heard to be operating for a further 'three to four minutes', was located close to this point. ATC radar heads sweep every four or six seconds depending on their location; however, no further data was recorded until 25 seconds later at time 15:42:30 (**Point 15 in Figure No. 15**), which indicates that the Helicopter had descended below radar coverage and was not recorded again until it climbed.

The ARTAS data indicates that the Helicopter then travelled towards the south-east for approximately 1.5 NM, while continuing to climb to an altitude of approximately 2,500 ft (**Point 16** in **Figure No. 15**). This took one minute and 15 seconds, equating to a ground speed of approximately 72 kt. The climb to this altitude may have been an attempt to survey the cloud cover and locate an area with a clearer view of the surface. The Helicopter then turned around and flew generally westwards for approximately 1.7 NM at an average ground speed of 94 kt approximately and at an altitude of no less than 1,900 ft, where the Helicopter was likely above the layer of cloud/fog (**Points 17, 18 and 19** in **Figure No. 15**).
