Air Accident Investigation Unit Ireland

FACTUAL REPORT

**SERIOUS INCIDENT
TECNAM P2006T, EI-WST
Weston Airport, Co. Dublin**

22 August 2023

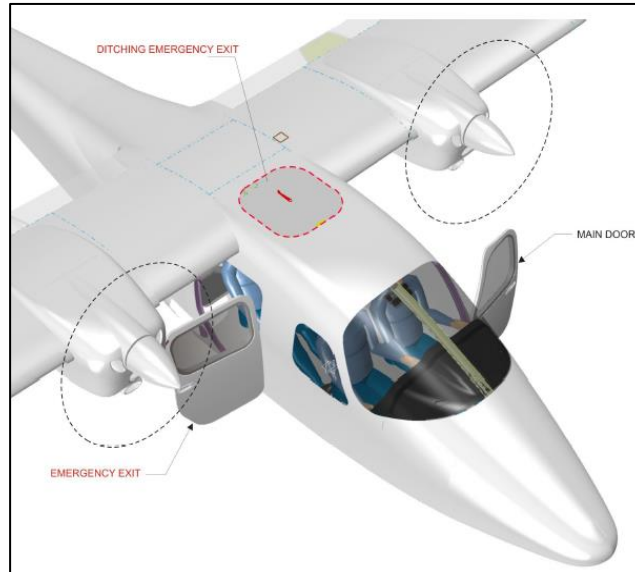
Figure No. 3: Aircraft main door and emergency exits

The main cabin door is located on the left side of the fuselage while the emergency exit (passenger door) is located aft on the right side of the fuselage. An emergency exit for use in the event of ditching, is located on top of the cabin (**Figure No. 3**).

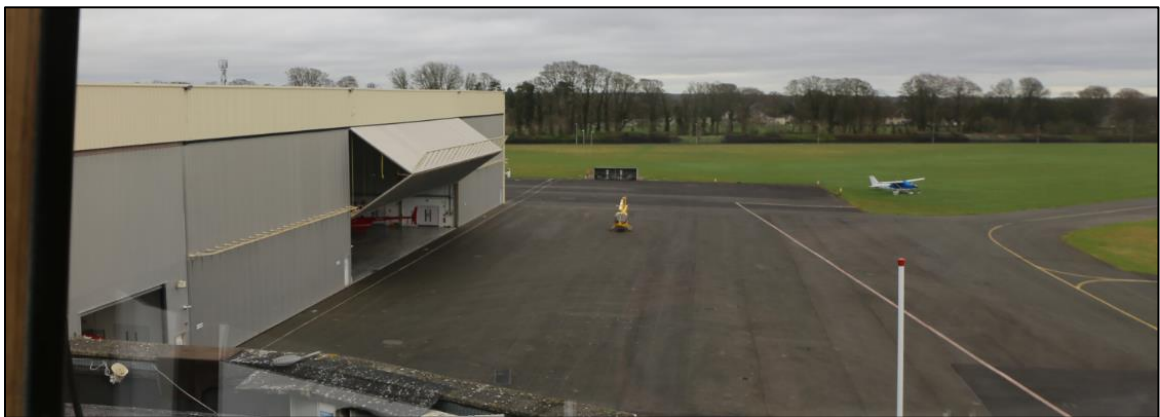
Photo No. 4: View from the control tower of the south apron

Rescue and firefighting services are available during the airport's operating hours. The Air Traffic Control tower is located approximately 110 m from where the aircraft started to taxi and provides an unobstructed view of the south apron (**Photo. No 4**).
