Air Accident Investigation Unit Ireland

SYNOPTIC REPORT

**Boeing, 737-8AS, EI-DHH
Runway 28L, Dublin Airport**

9 April 2023

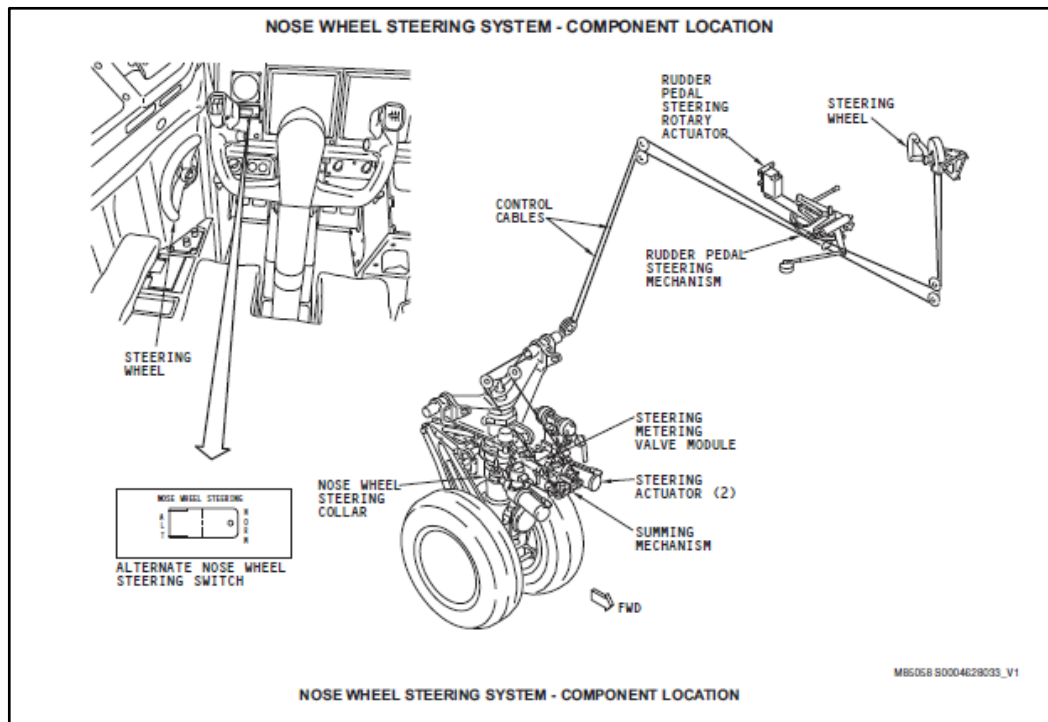
Figure No. 6: NWS system

The aircraft Manufacturer provided the Investigation with details of the Nosewheel Steering (NWS) System. A schematic of the system is presented at **Figure No. 6**.

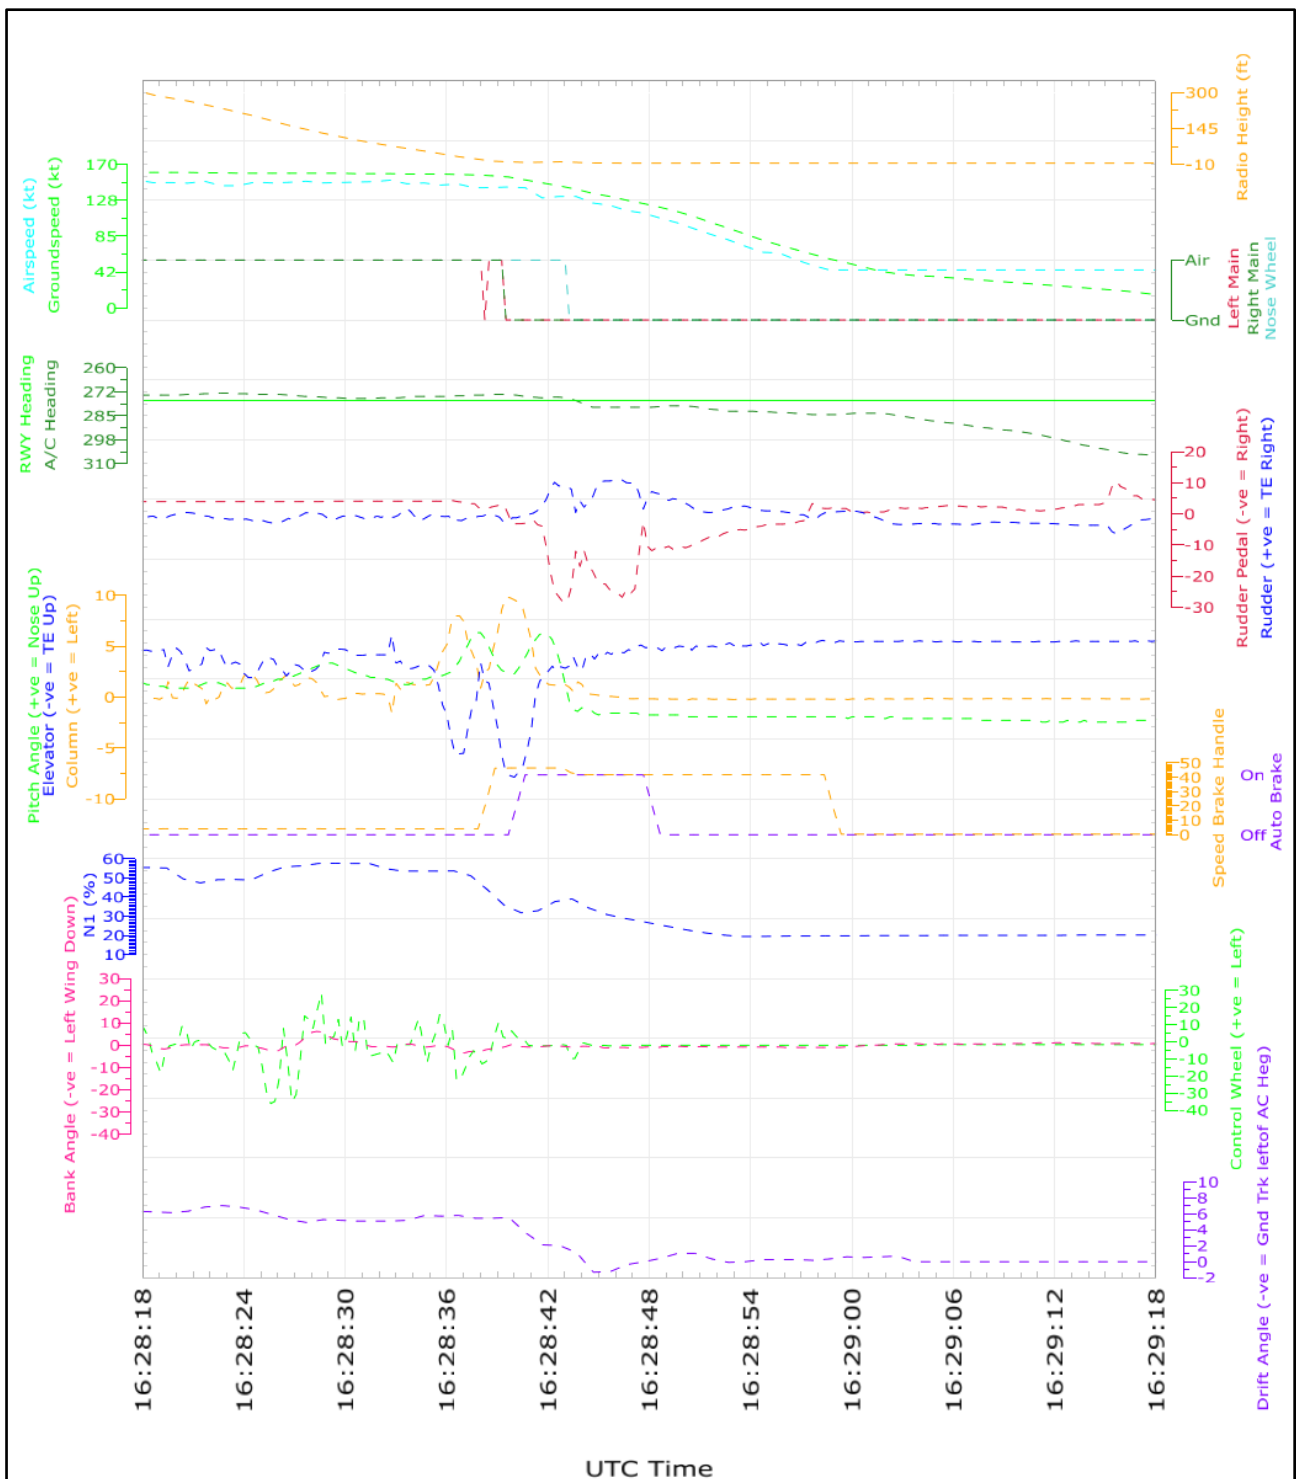
Figure No. 8: Selected FDR parameters around the time of landing

Figure No. 8 shows a plots of a selection of parameters, as recorded by the FDR between times 16:28:18 and 16:29:18, during which the aircraft descended from approximately 300 ft radio altitude, and landed on RWY 28L. The Investigation notes the following:

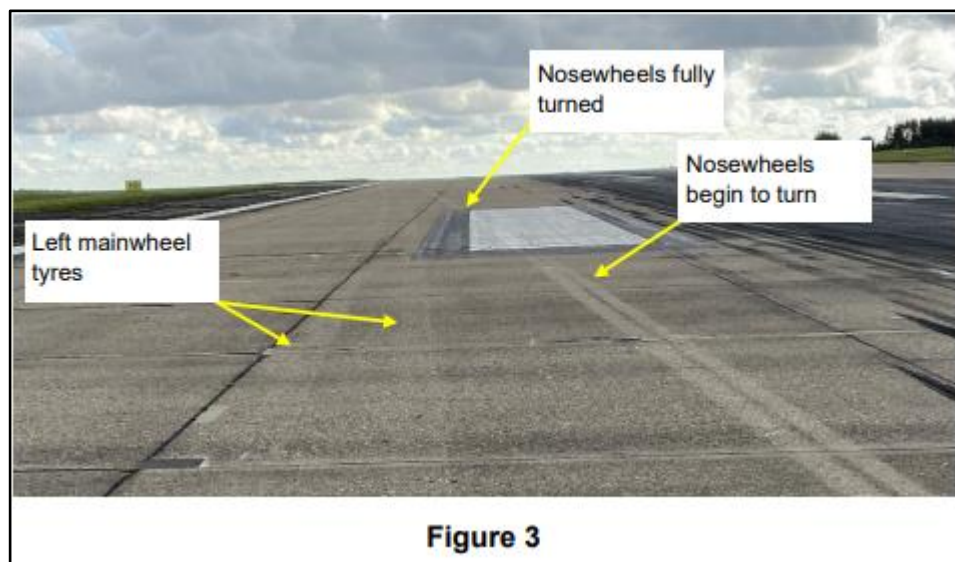
'The mainwheel and nosewheel tyres left light 'cleaned' marks on the runway surface which became visible after the surface had dried (Figures 3 and 4). The marks began approximately level with taxiway Lima, and continued until G-TAWD left the runway. The nosewheel track changed from two clear tyre marks to a single tyre mark at approximately 840 m after touchdown, where it continued for more than 200 m until the aircraft left the runway. The change in mark indicates that the nosewheels were turned to one side instead of in the direction of the aircraft's travel.

'Steam-cleaned' tyre marks can indicate the presence of reverted rubber hydroplaning.

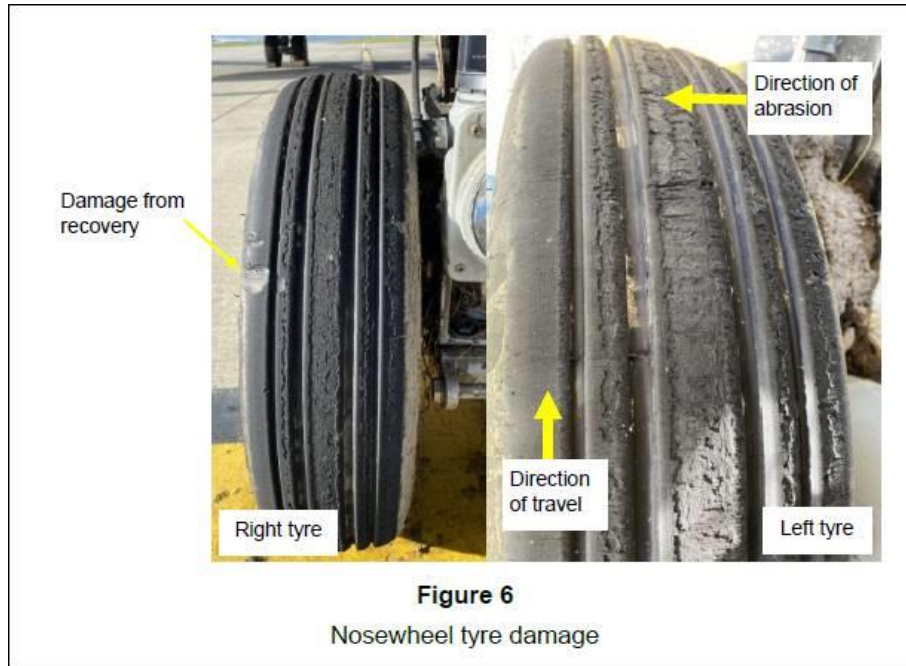
Both nosewheel tyres had abrasion surface damage around their entire circumference. The type, direction and quantity of damage indicates it occurred when the nosewheels were turned nearly perpendicular to the direction of travel (to the right), and that the wheels were still rotating (Figure 6). Neither nosewheel tyre showed damage corresponding to a locked wheel condition or rubber reversion in the un-abraded sections of their surface.

The nosewheel tyre damage is consistent with abrasion scrubbing from being turned to an angle nearly perpendicular to the direction of travel whilst the tyres were rotating and in contact with the runway; also demonstrated by the runway marks left by the nosewheel tyres. The angle of the nosewheels could only be achieved by use of the tiller rather than rudder pedal steering alone, and this corresponds with the commander's account of events.
