# Air Accident Investigation Unit Ireland

**SYNOPTIC REPORT**

**Boeing 767-322ER, N670UA  
Shannon Airport, Co. Clare, Ireland**

**7 April 2022**

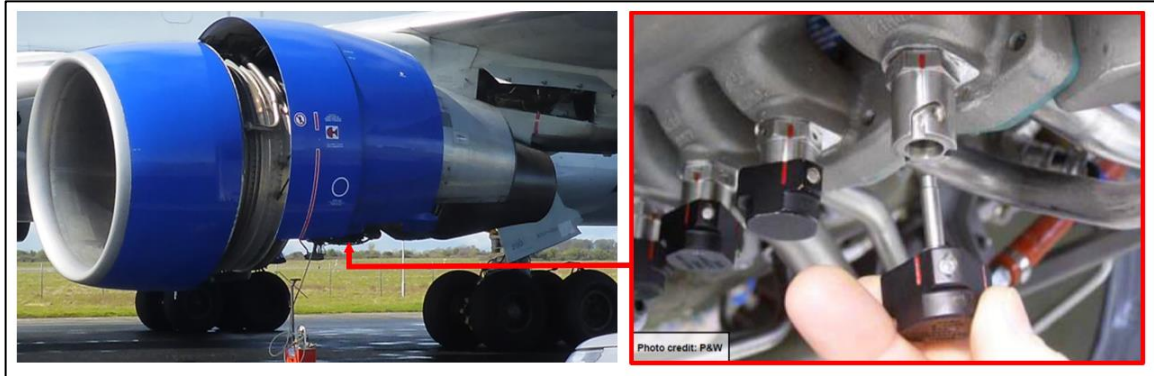
In the case of the subject engine type, four MCDs are fitted to the lubrication and scavenge oil pump located at the base of the engine to collect any magnetic particles present in the engine oil scavenge circuits (**Figure No. 1**). An additional MCD is located at the engine's main gearbox, and another is located at the oil tank.

**Figure No. 1:** Location of MCDs at the base of the engine (typical installation)

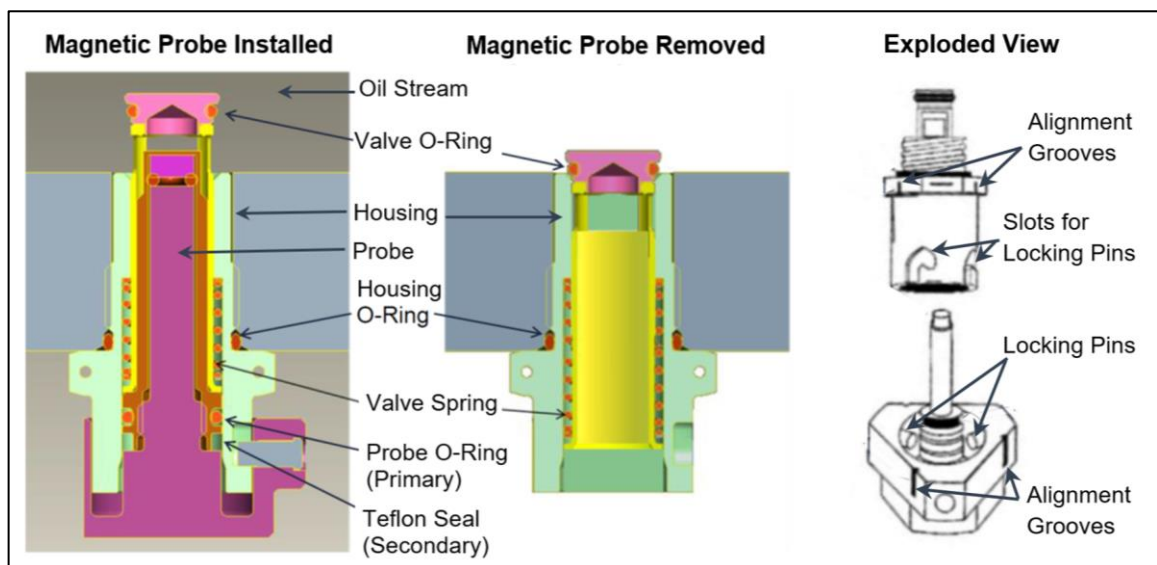
The design of the MCDs fitted to the No. 1 engine on the subject aircraft is such that when a magnetic probe is installed in its housing (valve body), it opens a spring-loaded valve and enters the oil stream (**Figure No. 2**). An o-ring (primary seal), described as a '*packing*' in the associated technical publications, and a Teflon® (secondary) seal fitted to the probe, prevent oil leakage. The grip of the probe is fitted with three locking pins, which insert into three corresponding slots in the housing. The probe is installed in the housing by pushing the probe in and rotating it clockwise until it stops rotating. The slots in the housing contain detents, which together with the force from the spring-loaded valve, are designed to lock the probe in the installed position. To indicate correct installation, three equally spaced probe alignment grooves, which are normally painted red, are located on each housing and on the body (grip) of each probe. The grooves on the grip and housing align when the probe is correctly installed. When the probe is removed from its housing for inspection purposes, the spring-loaded valve, which incorporates an o-ring, closes to prevent oil leakage from the engine.

**Figure No. 2:** MCD design on subject engine type  
(adapted from Engine/MCD Manufacturer documentation)

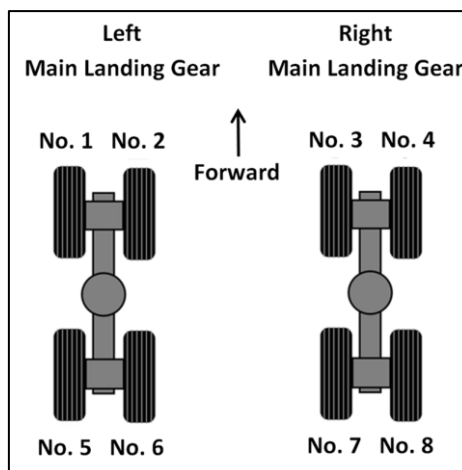
The Flight Crew subsequently reported in the aircraft's technical logbook that they had received a Brake Temperature warning and that there was a brake temperature of '9' at the 'left truck/left rear wheel' (the No. 5 position as shown in **Figure No. 5**).

**Figure No. 5:** Wheel and brake unit numbering convention

The left main landing gear was inspected by the Operator's maintenance personnel in the presence of the Investigation. Excess lubrication grease was evident at several of the lubrication points and brake dust was also present; however, there was no visible evidence that a fire had occurred. Based on the reported fire and the entry in the aircraft's technical logbook, maintenance personnel replaced the No. 5 wheel and brake unit. Subsequently, following clarification from the AFRS regarding the exact location of the observed fire, maintenance personnel inspected the No. 6 main wheel and brake unit, and found no defects.
