Air Accident Investigation Unit Ireland

FACTUAL REPORT

**Aeroprakt A-22L2, EI-HNC
Cloongoonagh, Co. Mayo, Ireland**

7 September 2024

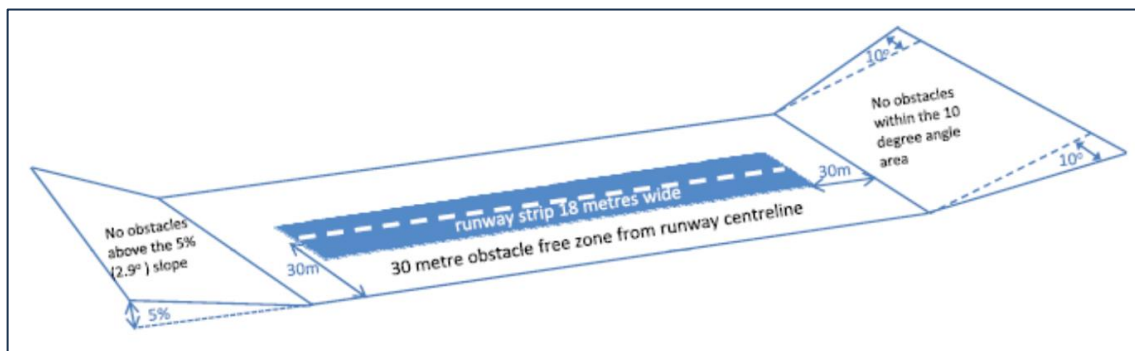
The following diagram (**Figure No. 1**) is included in the leaflet in a section titled 'Methods to Reduce the Risk'. The diagram provides guidelines regarding obstacle-free areas and highlights that there should be a '30 metre obstacle free zone from runway centreline'.

Figure No. 1: Guidance regarding obstacle-free zones (IAA Safety Promotion Leaflet AED 1)

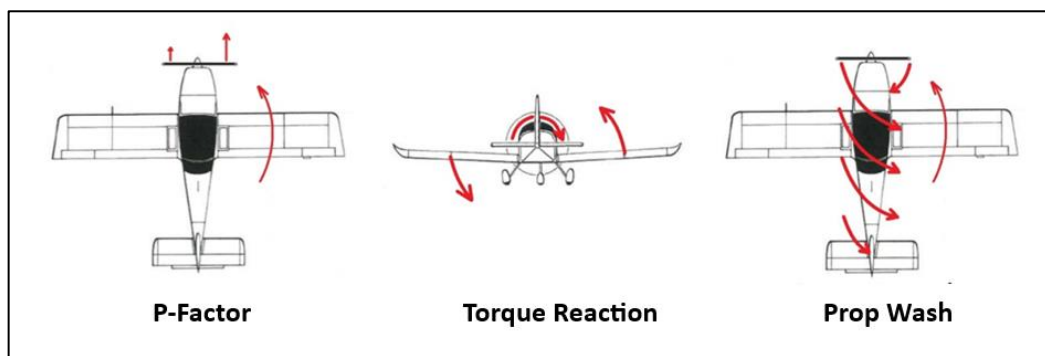
The first three effects listed above are depicted in **Figure No. 2**. The fourth effect listed (gyroscopic precession) is more applicable to tailwheel aircraft and therefore is not discussed further.

Figure No. 2: Propeller effects
