Air Accident Investigation Unit Ireland

FACTUAL REPORT

**Cessna T303 Crusader, G-PUSI
Navan Airfield, Co Meath, Ireland**

AAIU Report No: 2025-004

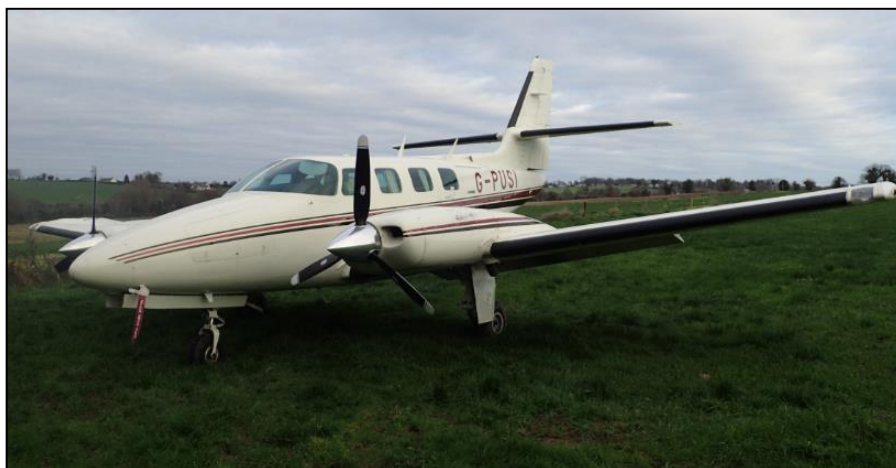
Photo No. 1: G-PUSI parked and secured at the side of the airfield

The Cessna T303 Crusader (**Photo No. 1**) is an all-metal six-seater low wing aircraft which is 9.27 m long, 4.06 m high and has a wingspan of 11.9 m. The aircraft has a standard empty weight of 1,525 kg. The aircraft is powered by two 250 brake horsepower (at 2,400 rpm) Teledyne Continental engines. A TSIO-520-AE model engine is fitted on the left side and a LTSIO-520-AE model engine is fitted on the right side. Each engine is fitted with a 3-bladed variable-pitch McCauley propeller. The propellers are contrarotating. The aircraft is equipped with a retractable tricycle type landing gear. The aircraft Manufacturer's records state that the subject aircraft was manufactured in 1984.
