# Air Accident Investigation Unit Ireland

**FACTUAL REPORT**

**Windtech AMBAR 29 Paraglider  
Maughanablagher Cliffs, Co. Kerry, Ireland**

**AAIU Report No: 2025-010**

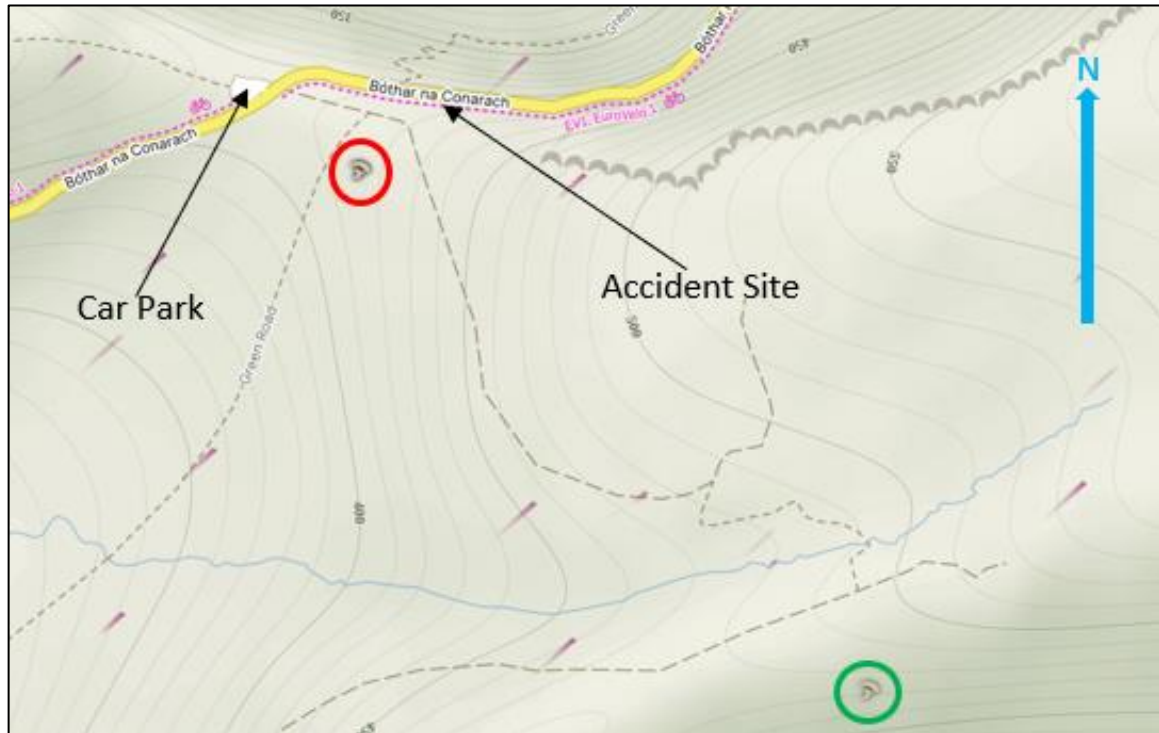
**Figure No. 3:** Flying sites as depicted in the website link (Figure adapted)

The link indicates the existence of two flying sites in the Conor Pass area. The site circled in red is described as being at an elevation of 1,328 feet (ft) with suggested launch directions to the north, north-east and north-west. There is a caution that states *'The take off is very steep, beware northwesterly winds at the take off as there may be rotor<sup>7</sup> from Mt. Brandon'*. The site circled in green is described as the *'Dingle Bowl'* with options to launch in a southerly to a westerly direction.
