Air Accident Investigation Unit Ireland

FACTUAL REPORT

**Airbus Helicopters, AS 355 F2, G-PDGT
Ireland West Airport**

15 January 2025

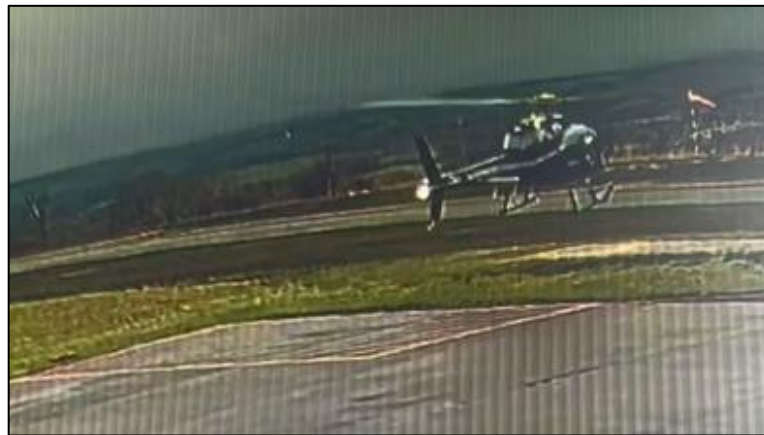
Photo No. 6: G-PDGT hover taxiing towards the departure runway

The United Kingdom’s Air Accidents Investigation Branch (AAIB) provided the Investigation with a copy of CCTV footage from EGPG on the day of the occurrence. According to CCTV timestamps, the Helicopter was pulled out of the hangar at 07:36 hrs, and at 08:41 hrs, it lifted off from its stand where it had been parked into wind. It then commenced a right turn of approximately 90 degrees and hover-taxied towards the departure runway (**Photo No. 6**). The Helicopter then made a left turn over the runway, transitioned to forward flight and departed normally. When the Helicopter was close to the CCTV camera, it was possible to see the tail boom fairing in place; however, it was not possible to see if it was fully secure as the Helicopter became airborne.

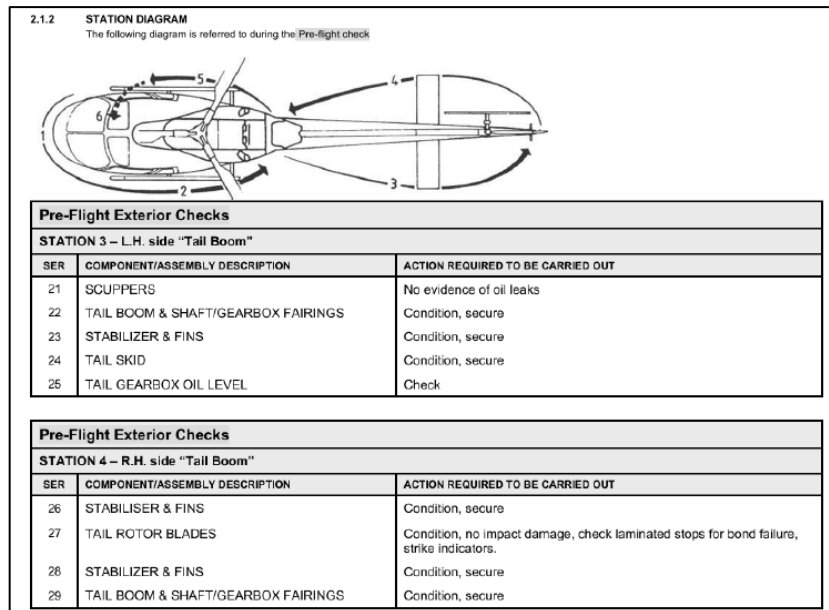
Figure No. 4: Pre-flight exterior checks

Notwithstanding the requirement to conduct an ALF inspection, the Operator requires all of its pilots to conduct a Pre-flight check prior to departure. The relevant station diagram for use during the Pre-flight check is reproduced in **Figure No. 4**. Items No. 22 and No. 29 at Station 3 and 4 respectively require that the tail boom and shaft/gearbox fairings be checked for condition and security.
