## FINAL REPORT

AAIU Report No: 2010-011  
State File No: IRL00909063  
Published: 19/08/2010

<b>Aircraft Type and Registration:</b>	Powered para-glider, no registration	
<b>No. and Type of Engines:</b>	1 x Bailey 175 cc 4-stroke	
<b>Aircraft Serial Number:</b>	None	
<b>Year of Manufacture:</b>	2005	
<b>Date and Time (UTC):</b>	26 July 2009 @ 09.00 hrs	
<b>Location:</b>	Salterstown, Co. Louth, Ireland	
<b>Type of Flight:</b>	Private	
<b>Persons on Board:</b>	Crew - 1	Passengers - 0
<b>Injuries:</b>	Crew - 0	Passengers - 0
<b>Nature of Damage:</b>	Minor	
<b>Commander's Licence:</b>	Exempt	
<b>Commander's Details:</b>	Male, aged 52 years	
<b>Commander's Flying Experience:</b>	132 hours, of which 87 were on type	
<b>Notification Source:</b>	Pilot	
<b>Information Source:</b>	Pilot's Report Form

After a flight of one hour, the Pilot decided to practise a forced landing exercise. He overshot the landing point and struck power lines near the field boundary. The para-glider suffered minor damage but there was a loss of power to a significant number of electricity users as a result of the incident.

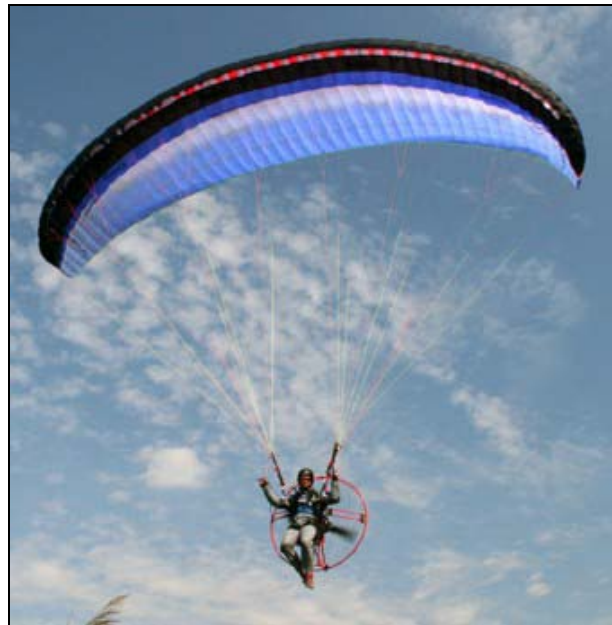
**Photo No. 1: A Similar Powered Para-Glider**

The powered para-glider consists of a canopy similar to a parachute, but designed so that the canopy performs like an aircraft wing, generating lift. The pilot is suspended in an underslung harness. Speed and direction are controlled by pulling on toggles. Pulling both toggles results in a braking action. The para-glider can be launched without a power unit from hilltops. For taking off from flat sites the pilot can attach a small engine, which drives a propeller mounted in a protective cage, to his back and this provides enough forward speed to enable the wing to generate sufficient lift to keep the powered para-glider airborne. A powered para-glider, similar to the one involved in this incident, is shown in **Photo No. 1**.
